**COMBINATION LEAD BASED PAINT
INSPECTION AND
RISK ASSESSMENT SURVEY**

1008 Dupont

Flint, MI 48504

March 21, 2011

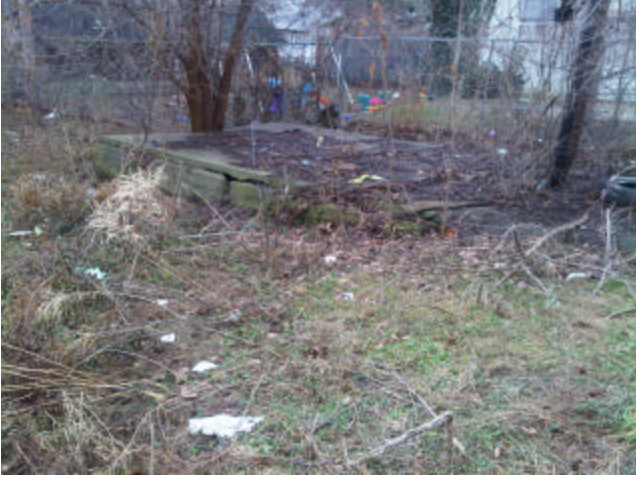
Identified Hazard	Severity	Priority	Abatement Options	Interim Control Options
Hazards on Property (Not Home)				
Visible paint chips and debris is present on the ground	High	High	Remove all visible paint chips and construction debris.	Remove all visible paint chips and construction debris.
Exterior House 13				
The exterior wood walls (exterior of Rear Entry 3) and trim components (entire house) including soffits, fascia, crown moldings window sills and casings (including basement), door casings, window and door lintels and all other wood trim work represents deteriorated lead paint surface hazard	Medium	Medium	1) Wrap walls with Tyvek or equivalent, apply foam insulation board, seal all seams and install a new vinyl or aluminum siding system, including wrapping and enclosure of all trim components with vinyl or aluminum, or 2) wet scrape/sand all surfaces, make necessary repairs, stabilize surfaces and encapsulate with a Michigan approved, exterior grade encapsulate or 3) strip all surfaces bare to the substrate, make necessary repairs, stabilize surfaces, and repaint or 5) replace individual lead painted components	1) Wet scrape / sand all surfaces, make necessary repairs, stabilize all surfaces and repaint or 2) stabilize painted surfaces and install vinyl or aluminum siding including wrapping all trim.

Back Yard

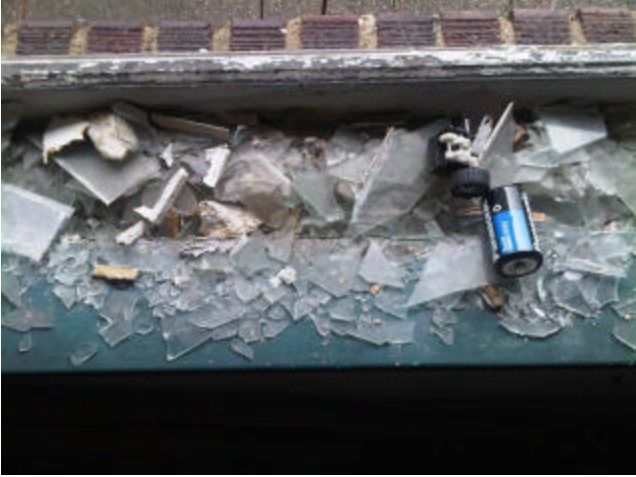
Identified Hazard	Severity	Priority	Abatement Options	Interim Control Options
Hazards throughout Home				
Dust levels in some window troughs / wells within the home were found to have elevated lead levels. Therefore, all window troughs should be considered to be lead contaminated.	High	High	The risk assessor believes that these high lead levels were caused by other lead hazards dealt with below. Therefore, after having completed all other abatement / interim control options, clean the entire house for lead dust thoroughly using the accepted HEPA-Wash-HEPA cleaning methods.	The risk assessor believes that these high lead levels were caused by other lead hazards dealt with below. Therefore, after having completed all other abatement / interim control options, clean the entire house for lead dust thoroughly using the accepted HEPA-Wash-HEPA cleaning methods.
Dust levels in some window sills / stools within the home were found to have elevated lead levels. Therefore, all window sills should be considered to be lead contaminated.	High	High	The risk assessor believes that these high lead levels were caused by other lead hazards dealt with below. Therefore, after having completed all other abatement / interim control options, clean the entire house for lead dust thoroughly using the accepted HEPA-Wash-HEPA cleaning methods.	The risk assessor believes that these high lead levels were caused by other lead hazards dealt with below. Therefore, after having completed all other abatement / interim control options, clean the entire house for lead dust thoroughly using the accepted HEPA-Wash-HEPA cleaning methods.

Window Trough

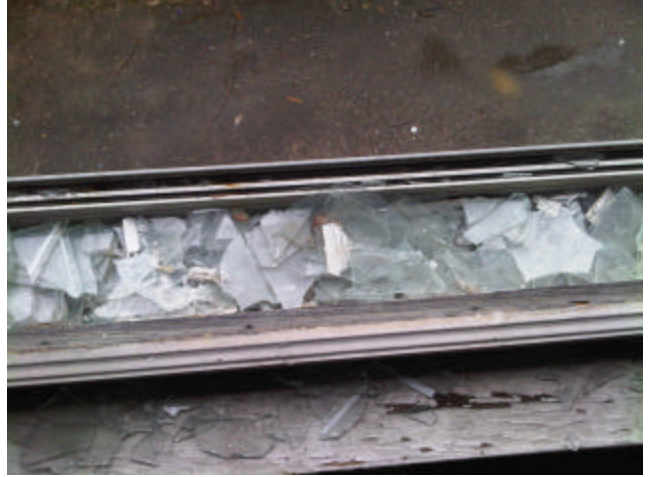
Window Trough 2
