**ADDENDUM # 1**  
**Request for Proposals – 2109 Barbara St. – General Contractors**  
**#LB 11-019**  
July 18, 2011

**COMBINATION LEAD BASED PAINT  
INSPECTION AND  
RISK ASSESSMENT SURVEY**

2109 Barbara Drive  
Flint, MI 48504

# Genesee County Rehabilitation Environmental Inspection Summary

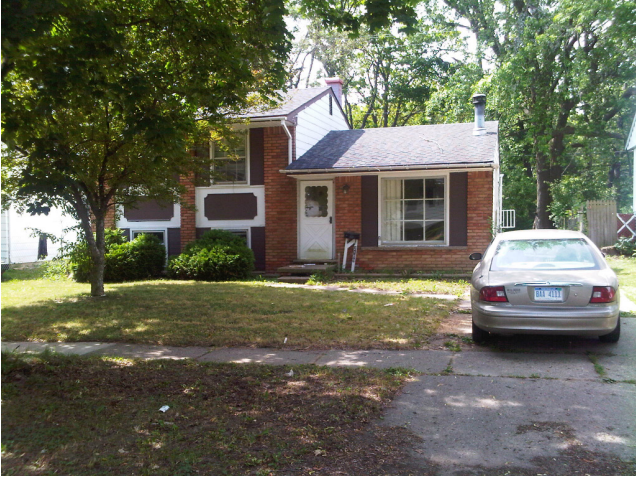
Front of Home (Side A)

- Room 1 side a stationary windows exterior—poor condition

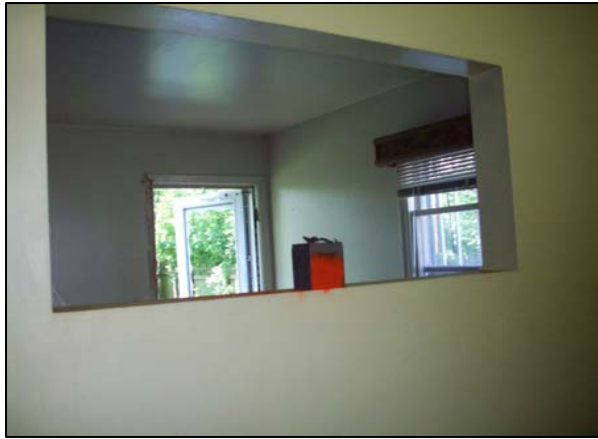
Battery  
Living Room

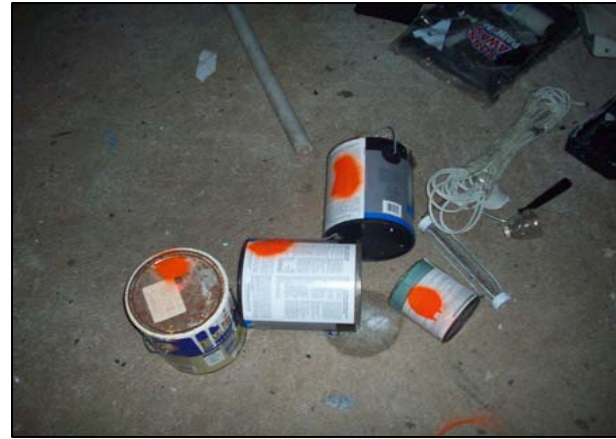
Paints  
Basement

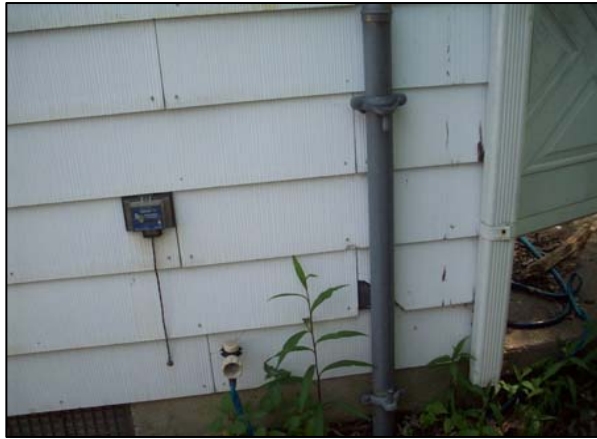
Example of Transite Siding  
Exterior Siding

**Bolded and Shaded materials contain asbestos and Global recommends the materials be removed prior to renovation/demolition activities.**

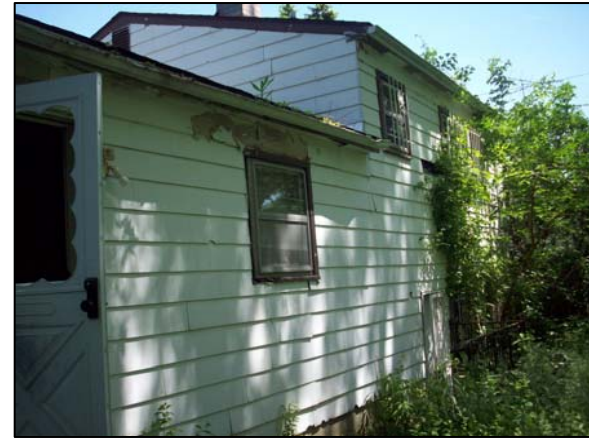
Example of Transite Siding  
Exterior Siding

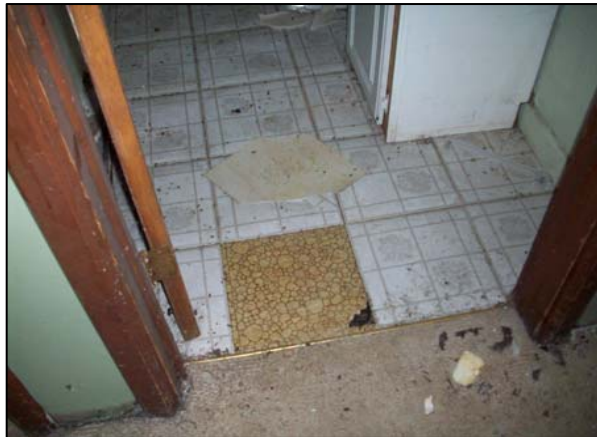
Linoleum Yellow Pebble Pattern and Black Mastic  
Throughout Basement
