**ADDENDUM # 1**  
**Request for Proposals – 2114 Barbara St. – General Contractors**  
**#LB 11-020**  
July 18, 2011

**COMBINATION LEAD BASED PAINT  
INSPECTION AND  
RISK ASSESSMENT SURVEY**

2114 Barbara Drive

# Genesee County Rehabilitation Environmental Inspection Summary

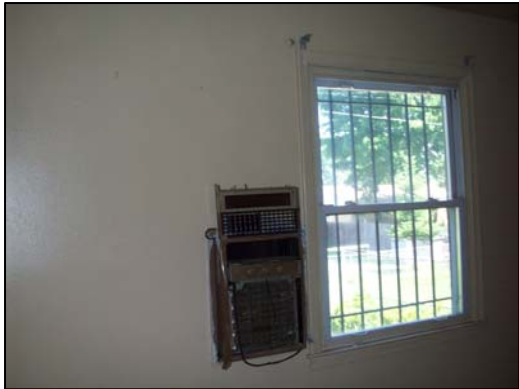
Air Conditioner  
Living Room

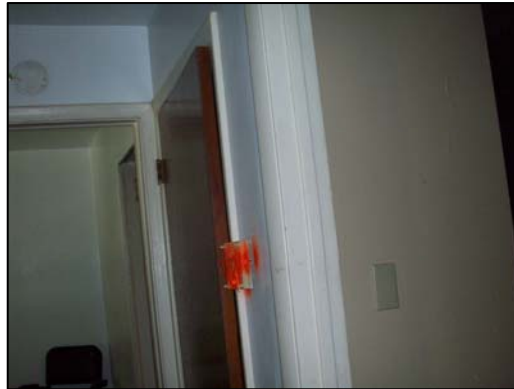
Mercury Thermostat  
Hallway

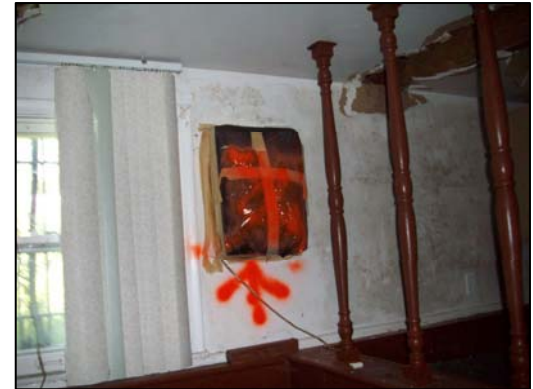
Air Conditioner  
Basement

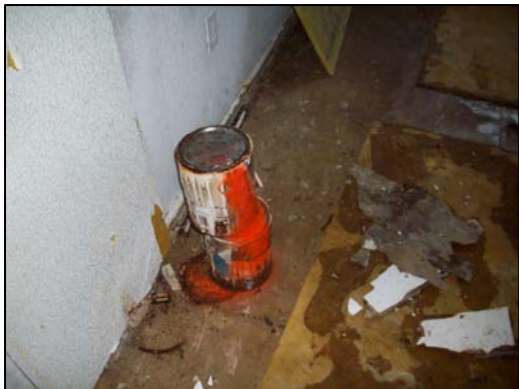
Paint  
Basement

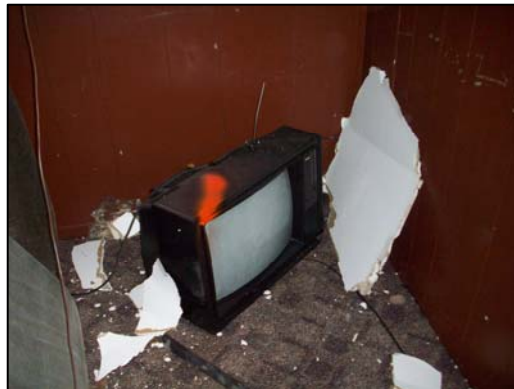
Television  
Basement

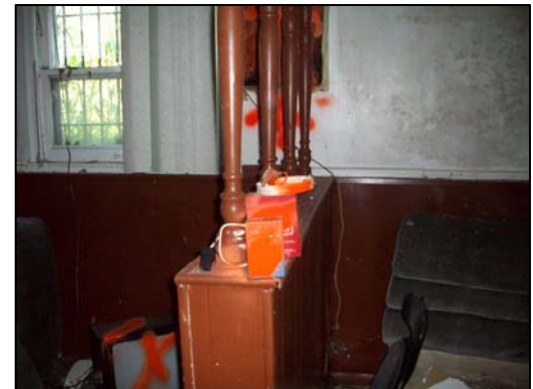
Battery and Smoke Detector  
Basement

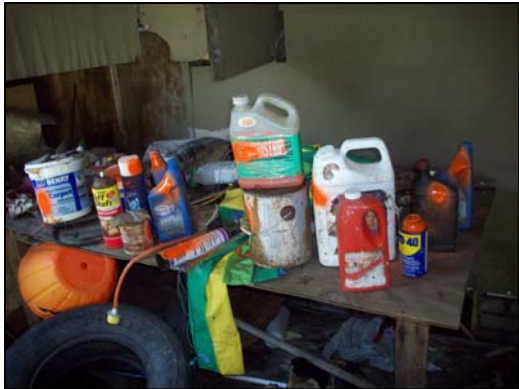
Paints, Automotive Fluids, Adhesives Etc.  
Garage

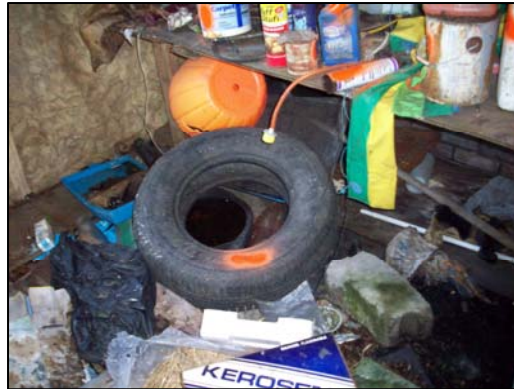
Tire  
Garage

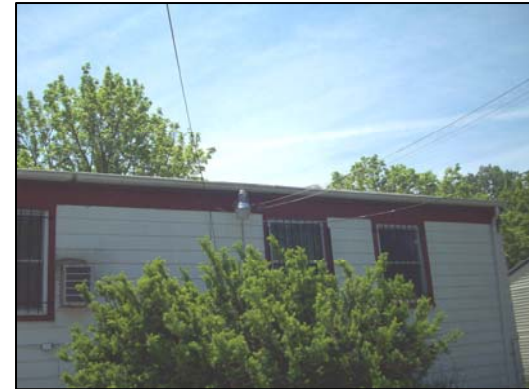
Mercury Light  
Back of House

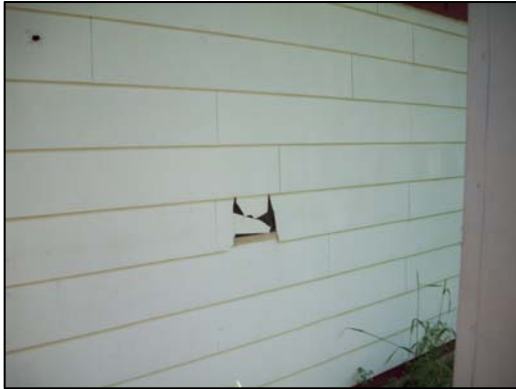
Transite Siding  
Exterior Siding

**Bolded and Shaded materials contain asbestos and Global recommends the materials be removed prior to renovation/demolition activities.**

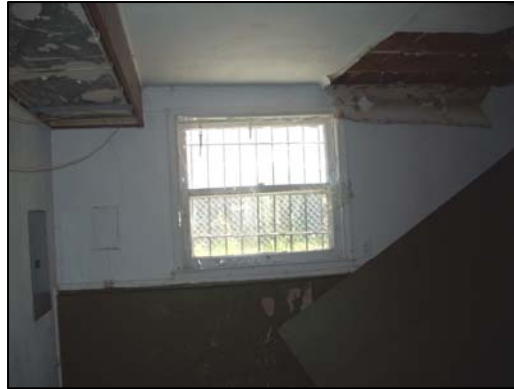
Window Caulk  
Basement Windows

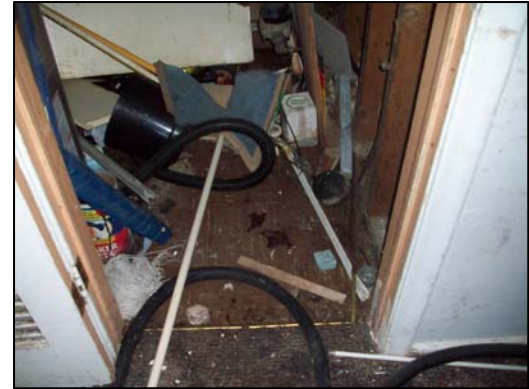
9-inch brown floor tile  
Basement
