Neighborhood Stabilization Program 2 (NSP2)

Invitation for Bids – General Contractor

2448 Thomas St., Flint, MI 48504

BID NUMBER: LB 11-025

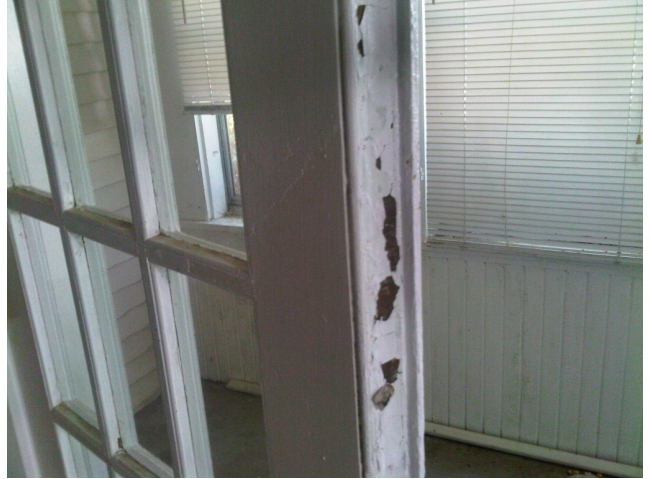
Identified Hazard	Severity	Priority	Abatement Options	Interim Control Options
Sun Room 2				
Door, jamb and threshold represent deteriorated lead paint friction/impact surface hazards	Low	High	1) Remove and replace with new door systems or 2) replace individual lead painted components or 3) strip all surfaces bare to the substrate, stabilize surfaces, and repaint.	1) Refit door to eliminate friction points, wet scrape/sand all surfaces, make necessary repairs, including installation of weatherstripping or other "soft" stop material, stabilize all surfaces and repaint 2) Use friction reduction treatments (jamb liners, weatherstripping, rubber padding, tread covers, etc.) to reduce wear or 3) Wet plane all friction / impact surfaces, wet scrape all remaining surfaces, make necessary repairs, stabilize all surfaces and repaint.
Floor represents a deteriorated lead paint friction/impact surface hazard	Medium	High	1) Enclose with Luann or other suitable flooring material or 2) Remove and replace flooring material or 3) strip all surfaces bare to the substrate, make necessary repairs and recoat. Note: Floors should be abated last.	Wet scrape / sand all surfaces, make necessary repairs, stabilize all surfaces, paint and cover with new floor covering (tread covers, carpet, vinyl tile, etc...) material.

Room 2 door

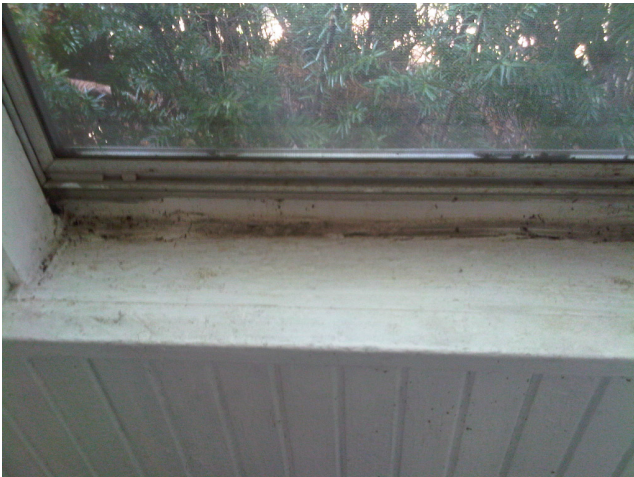
Window sills/troughs and jambs represent deteriorated lead paint surface hazards	Medium	High	1) Wet scrape/sand all surfaces, make necessary repairs, stabilize surfaces and encapsulate with a Michigan approved encapsulant or 2) enclose by wrapping with vinyl or aluminum and seal or 3) remove and replace with new components or 4) strip all surfaces bare to the substrate (either chemically or using mechanical wet methods), make necessary repairs and recoat.	1) Wet scrape / sand all surfaces, make necessary repairs, stabilize all surfaces and repaint or 2) stabilize all surfaces and wrap with aluminum or vinyl
Crown Moldings represent deteriorated lead paint surface hazards	Low	Low	1) Remove and replace with new components or 2) wet scrape/sand all surfaces, make necessary repairs, stabilize surfaces and encapsulate with a Michigan approved encapsulant or 3) strip all surfaces bare to the substrate (either chemically or using mechanical wet methods), make necessary repairs and recoat.	Wet scrape / sand all surfaces, make necessary repairs, stabilize all surfaces and repaint.

Room 2—window sill, trough

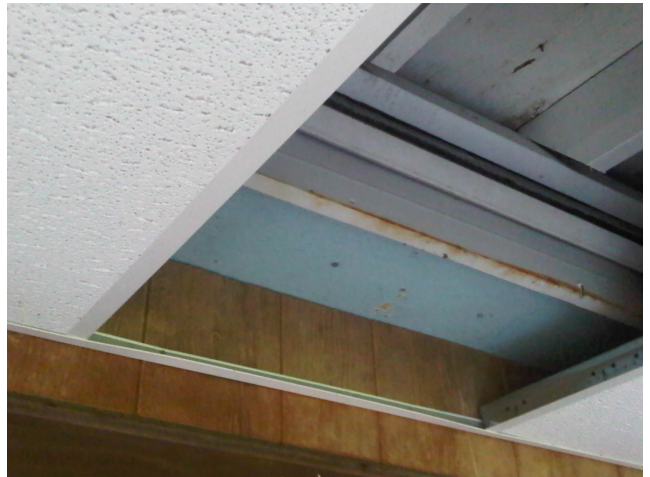
Identified Hazard	Severity	Priority	Abatement Options	Interim Control Options
Mud Room 5				
Soffits (these are the original exterior soffits and would normally be covered by the drop ceiling tiles-this area is currently exposed) represent deteriorated lead paint surface hazards	Medium	Low	1) Wet scrape/sand all surfaces, make necessary repairs, stabilize surfaces and encapsulate with a Michigan approved encapsulant or 2) enclose by wrapping with vinyl or aluminum and seal or 3) remove and replace with new components or 4) strip all surfaces bare to the substrate (either chemically or using mechanical wet methods), make necessary repairs and recoat.	1) Wet scrape / sand all surfaces, make necessary repairs, stabilize all surfaces and repaint or 2) stabilize all surfaces and replace ceiling tile or cover with a suitable wallboard material
Kitchen 6				
Window sash interiors represent deteriorated lead paint friction/impact surface hazards	Medium	Medium	1) Remove and replace with new replacement windows or 2) replace individual lead painted components 3) enclose all lead painted surfaces or 4) strip all surfaces bare to the substrate, make necessary repairs, stabilize surfaces, and repaint.	1) Use friction reduction treatments (jamb liners, weatherstripping, rubber padding, tread covers, etc.) to reduce wear or 2) Wet plane all friction / impact surfaces, wet scrape all remaining surfaces, make necessary repairs, stabilize all surfaces and repaint.

Room 5 soffit

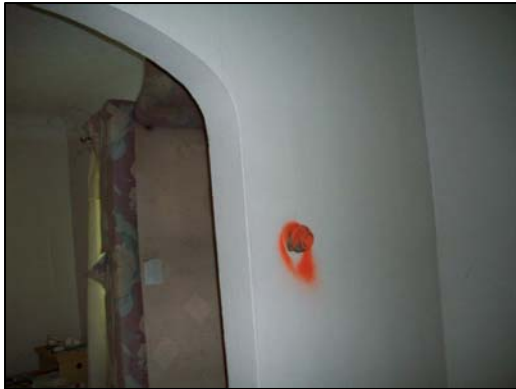
Mercury Thermostat
Dining room

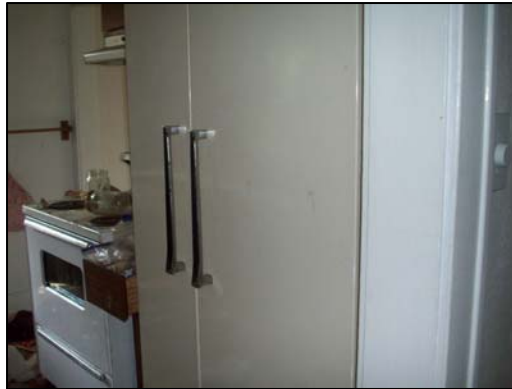
Refrigerator
Kitchen

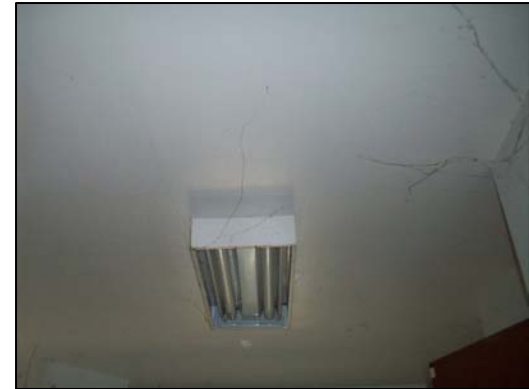
Fluorescent Lights
Kitchen

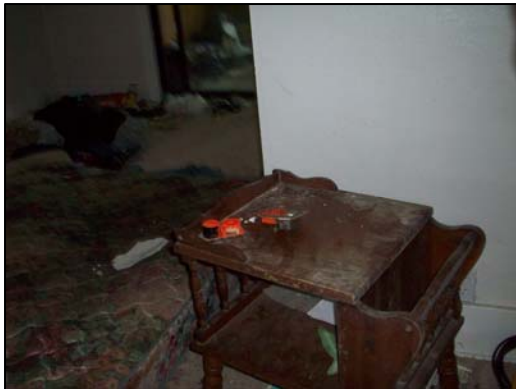
Smoke Detectors
Living Room

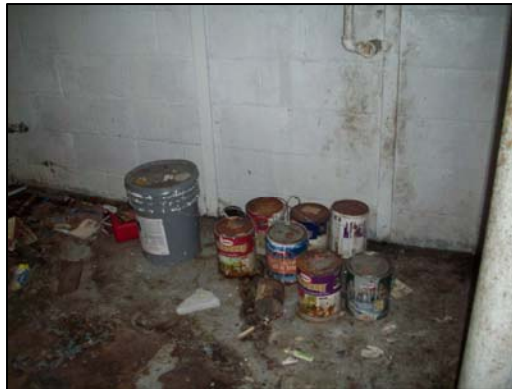
Paints and Sealer
Basement

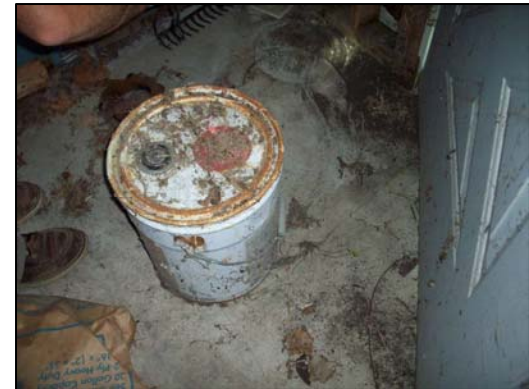
Polyurethane and Brake Cleaner
Garage

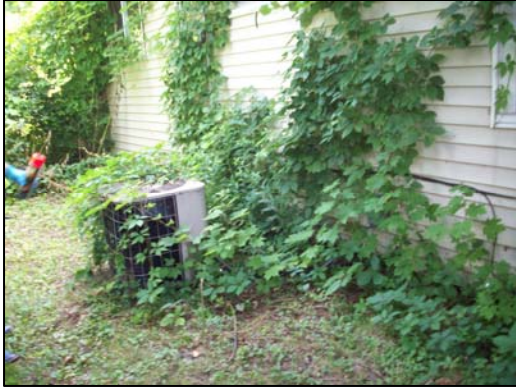
Air Conditioner
Side of House

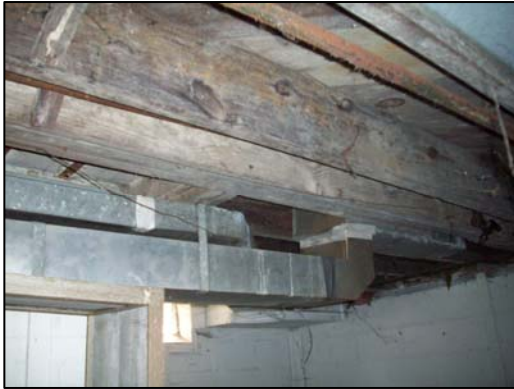
Example of Duct Wrap
Basement

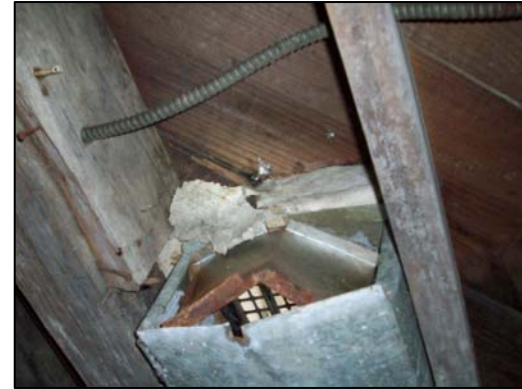
Example of Duct Wrap
Basement

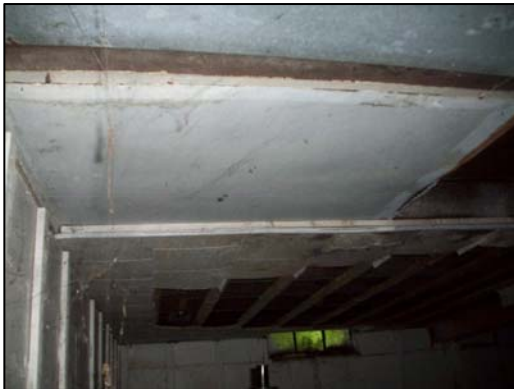
Example of Duct Wrap
Basement
