**Rehabilitation
Environmental Inspection Report
For:
Parcel Number: 46-26-231-053
6525 Dupont Street
Flint, Michigan 48505**

March 2011
Global Project No. F1438

Genesee County Rehabilitation Environmental Inspection Summary

Parcel No: 46-26-231-053
6525 Dupont Street
Flint, Michigan 48505

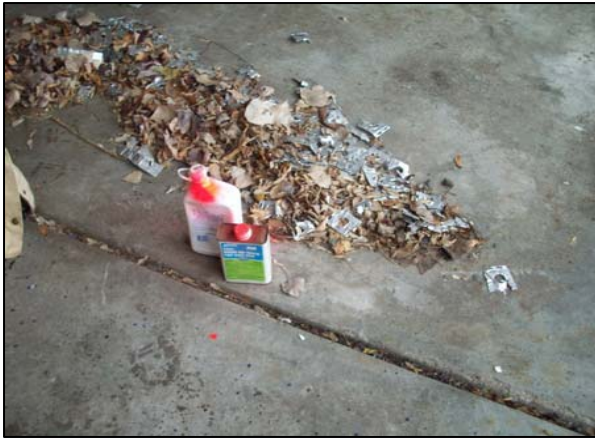
Motor Oil and Weed No More
Garage

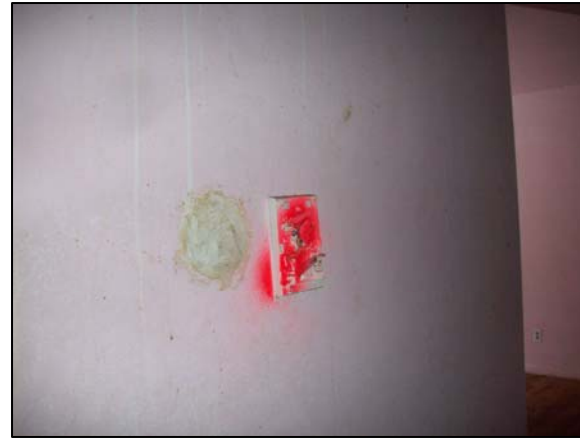
Mercury Thermostat
Dining Room

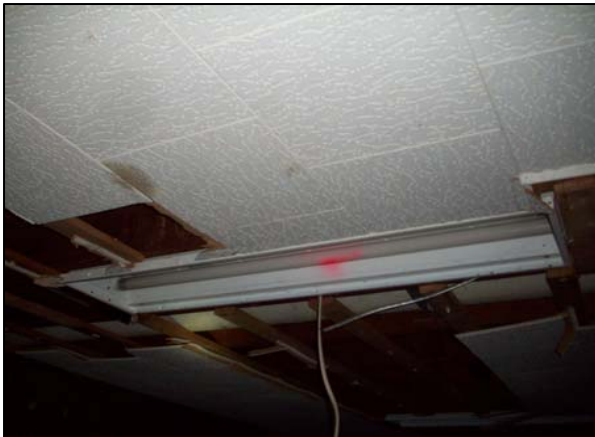
Fluorescent Lights and Ballasts
Basement

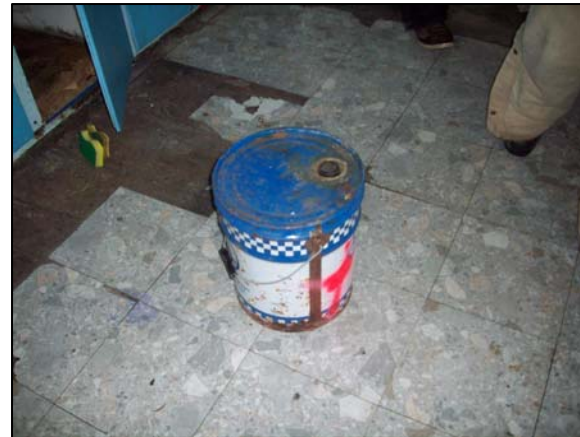
Sealer
Kitchen

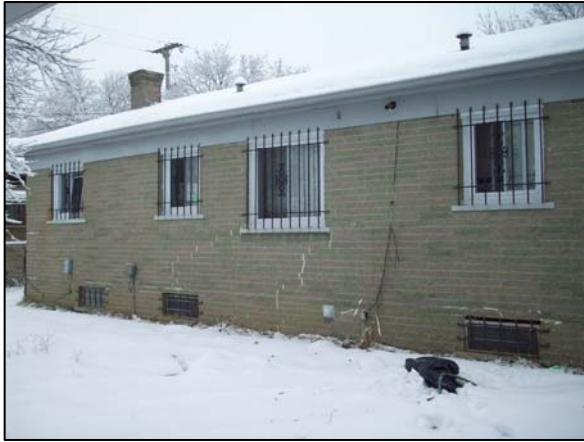
The results of the laboratory analysis indicated, two of the suspect materials sampled, the window caulk on the basement windows and the duct (pipe) wrap around the furnace and on the 4-inch, 6-inch and 8-inch pipes located in the basement running along the ceiling contain asbestos. A copy of the laboratory results is included as **Attachment 3**.

Example of Window Caulk
Basement Windows

The window caulk and duct (pipe) wrap should be properly removed and disposed by a licensed asbestos abatement contractor as part of the renovation project.

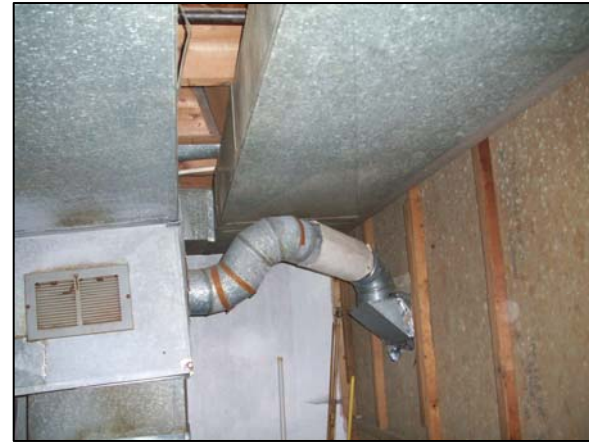
Example of Duct Wrap
Basement

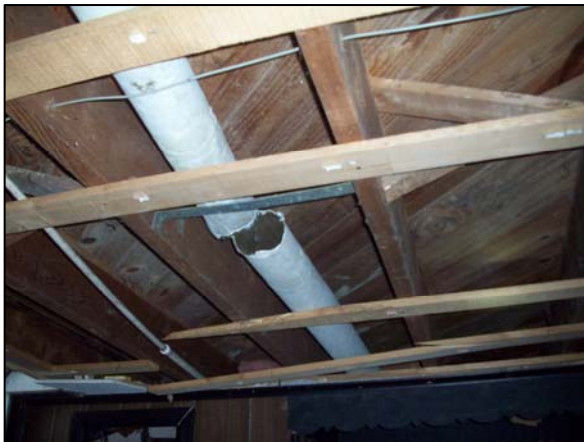
Example of Duct Wrap
Basement
