Invitation for Bids: 616 W University Avenue – Lead Abatement Contractor

BID NUMBER: LB11-005

**MULTI-FAMILY COMBINATION LEAD BASED PAINT
INSPECTION AND
RISK ASSESSMENT SURVEY**

Executive Summary Existing Lead Based Paint Hazards including Abatement and Interim Control Options			
<i>Client</i>	Global Environmental Engineering		
<i>Survey Location:</i>	616&618 University Ave., Flint, MI 48503		
<i>Survey Date:</i>	10/05/10		
<i>Inspector:</i>	Matt Duncan

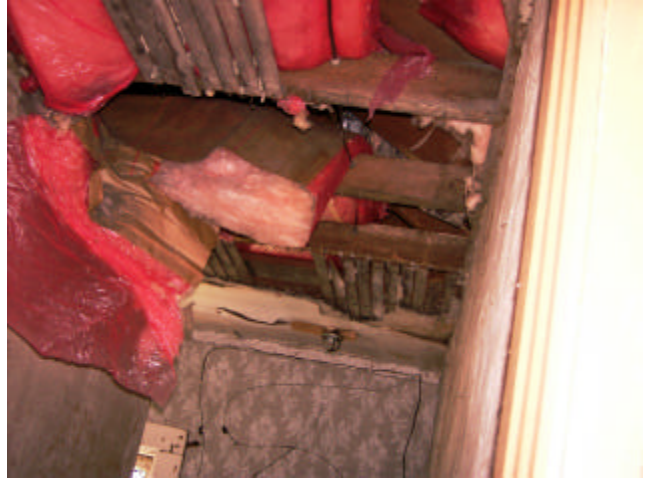
Damaged Ceilings

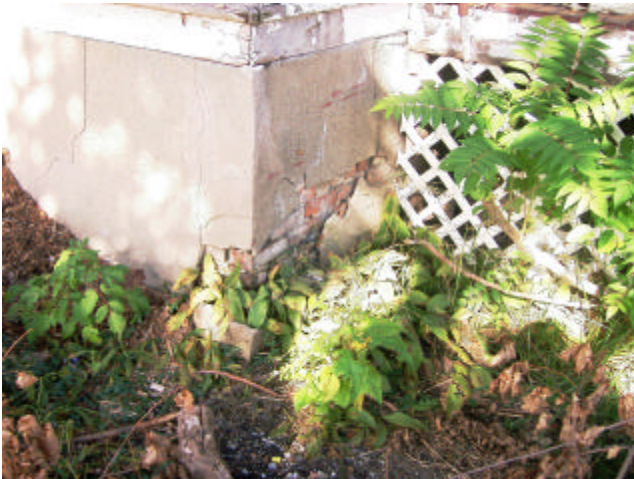
Deteriorated Foundation

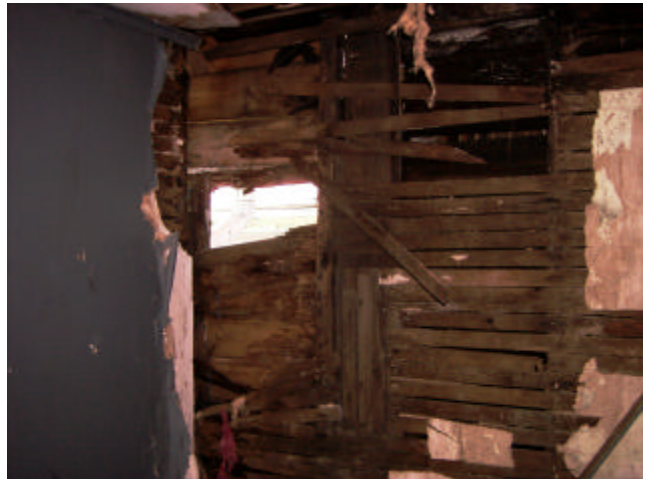
Deteriorated Wall—See Outside

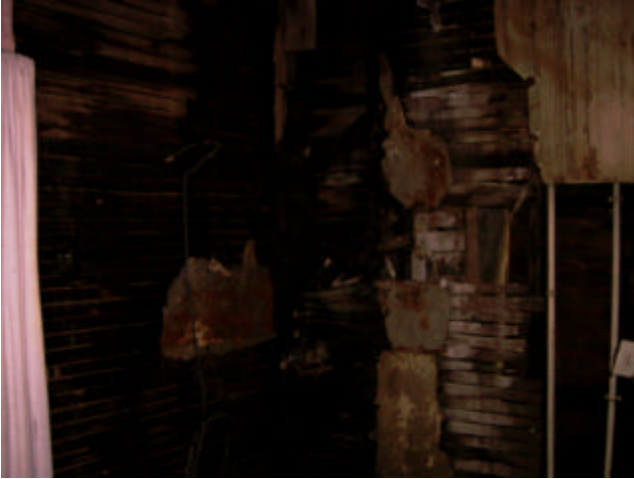
Deteriorated Walls

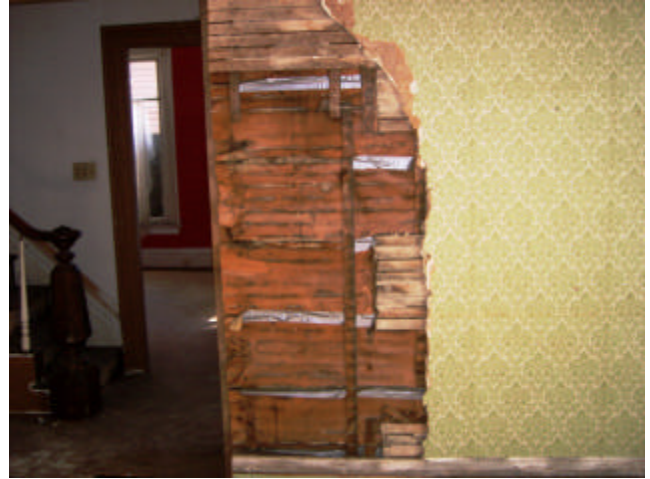
Door Frame Missing

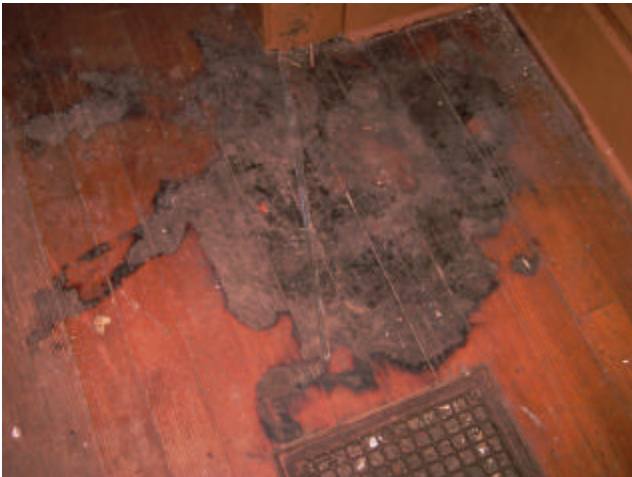
Fire Damage

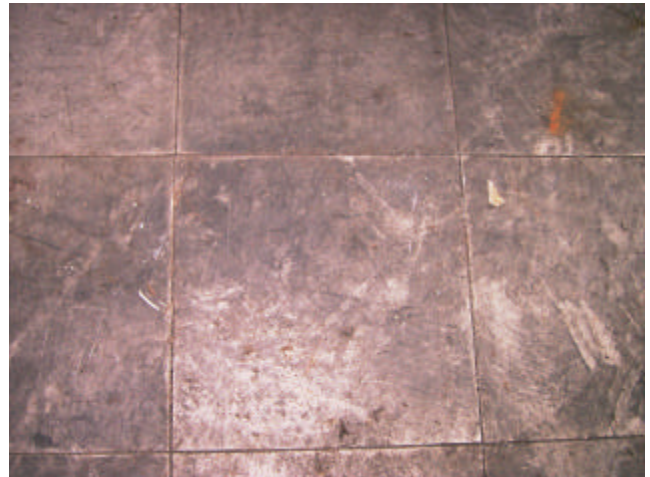
Grey dust on floor from lead activity

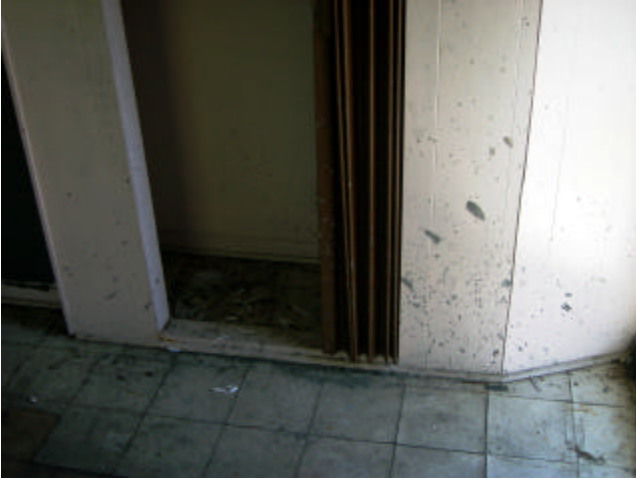
Lead on closet walls

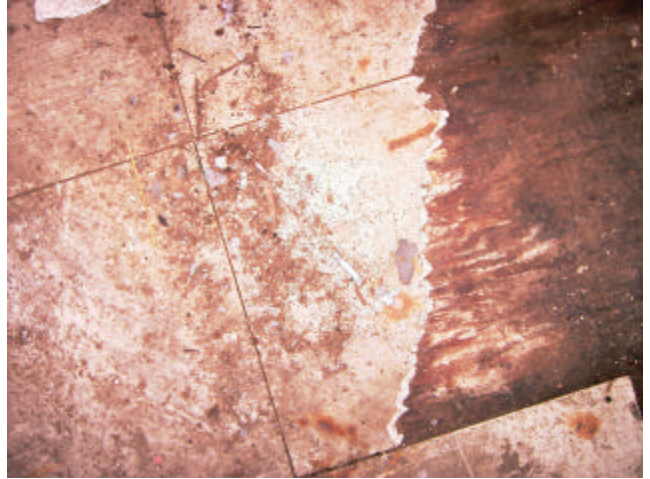
Lead debris on floor

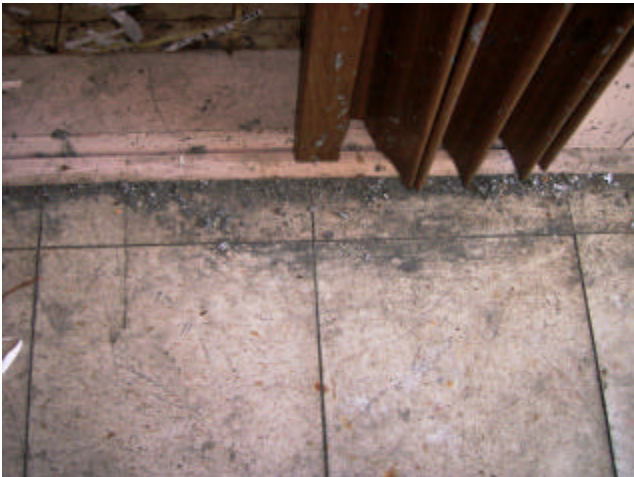
Lead Debris

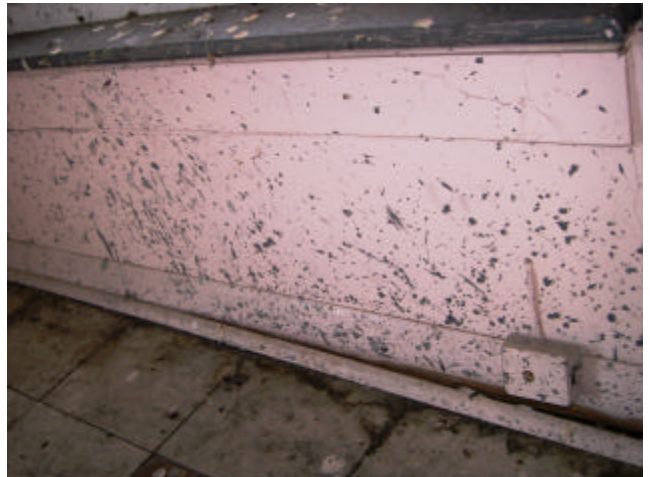
Lead on wall

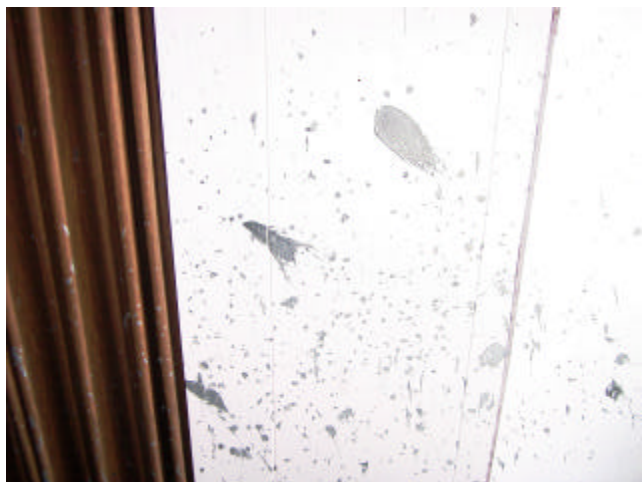
Lead Splatter on closet wall

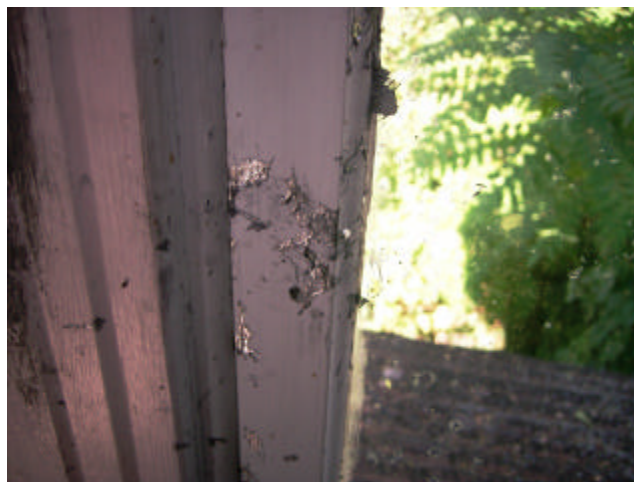
Lead Splatter on window

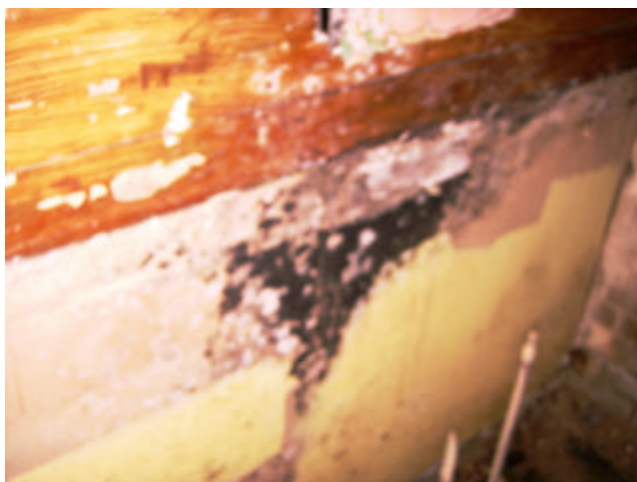
Mold growth

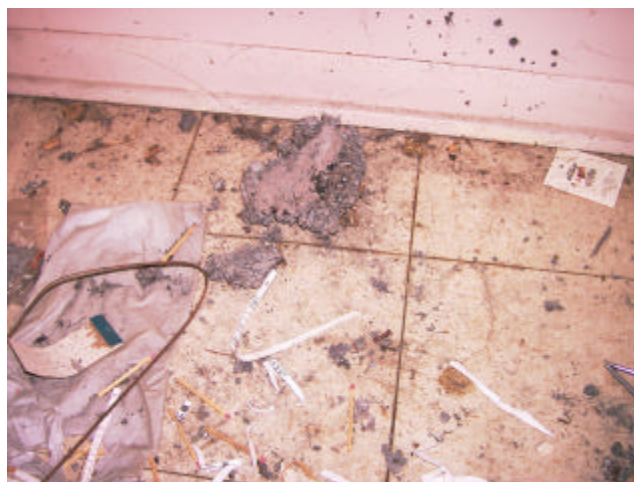
Lead debris

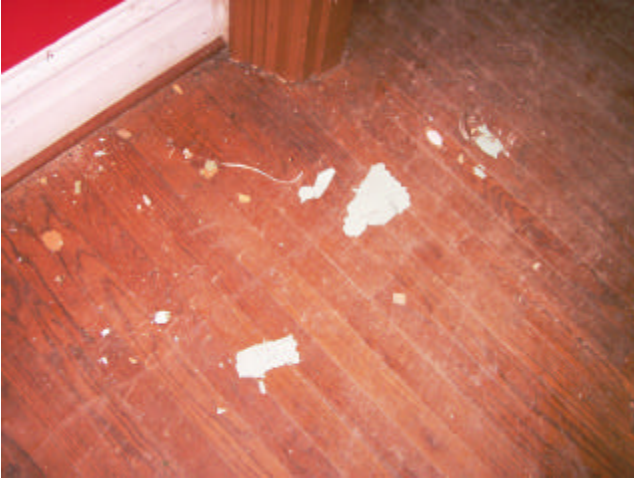
Paint chips on floor

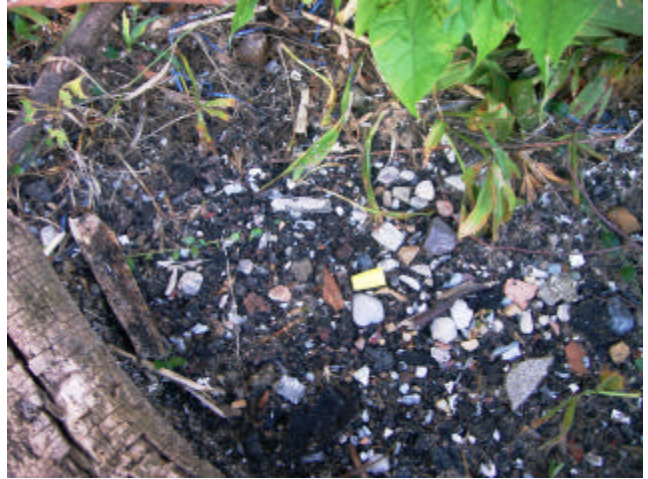
Paint chips on exterior ground

Hazards on Property Grounds			
Soil levels around the dripline of unit #616 were found to be elevated for lead content.	Critical	Restrict Access	<p>1) Remove top 6 inches of soil and replace with new soil then seed to grass, cover with ground cover or 2) enclose with concrete or asphalt</p> <p>Clean soil surface of any paint chips or LBP debris, blend top 6 inches of soils with those below by tilling, cover with landscape fabric and groundcover.</p>
Soil levels around the dripline of unit #618 were found to be elevated for lead content.	Critical	Restrict Access	<p>1) Remove top 6 inches of soil and replace with new soil then seed to grass, cover with ground cover or 2) enclose with concrete or asphalt</p> <p>Clean soil surface of any paint chips or LBP debris, blend top 6 inches of soils with those below by tilling, cover with landscape fabric and groundcover.</p>
Visible paint chips and construction debris are present on the ground all around the perimeters of the buildings.	Critical	Restrict Access	<p>After all lead abatement options have been completed, remove all visible paint chips and construction debris from the property.</p> <p>After all lead interim control options have been completed, remove all visible paint chips and construction debris from the property.</p>

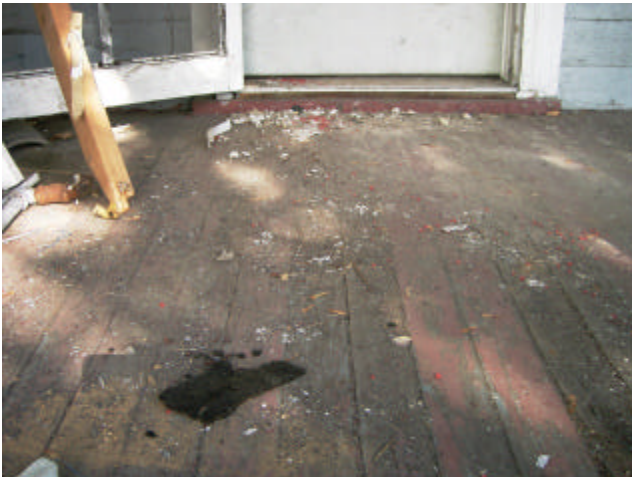
Paint chips on porch

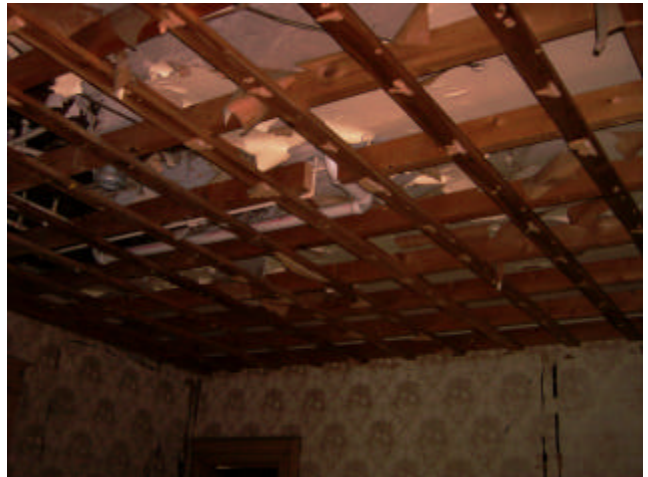
Plaster ceiling—poor condition—lead based

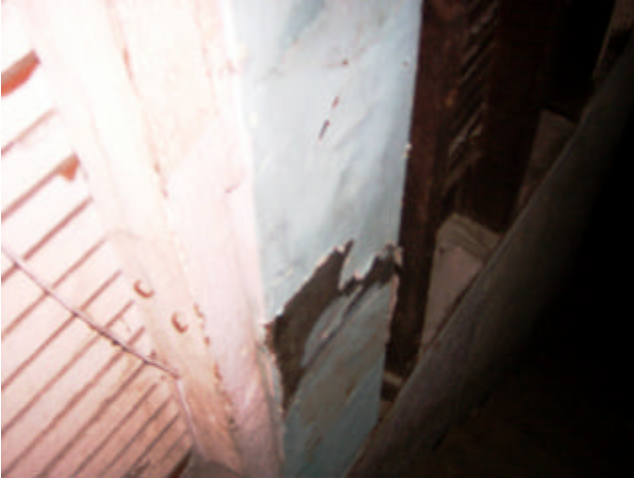
Possible Asbestos—Duct wrap, damaged

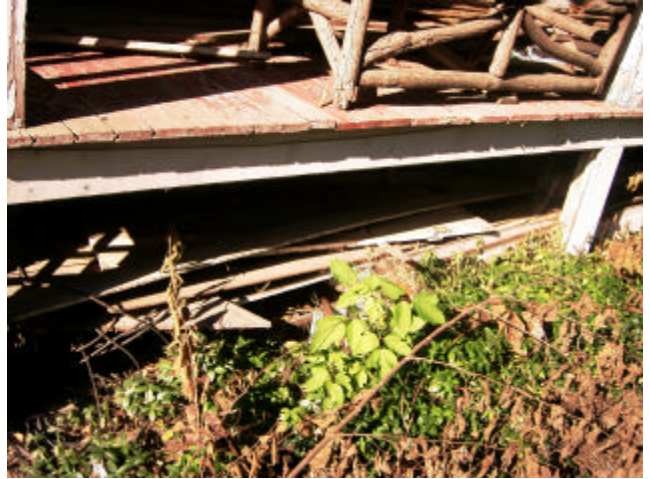
Renovation debris on the property
