ADDENDUM NO. 1

**"#LB 17-017, Environmental Abatement, Demolition and Site Restoration – Former Ross Oil, 2360 West Pierson Road, and Former FIA Building, 2320 West Pierson Road, City of Flint, Michigan"**

## PRE-DEMOLITION ASBESTOS/HAZARDOUS MATERIALS SURVEY

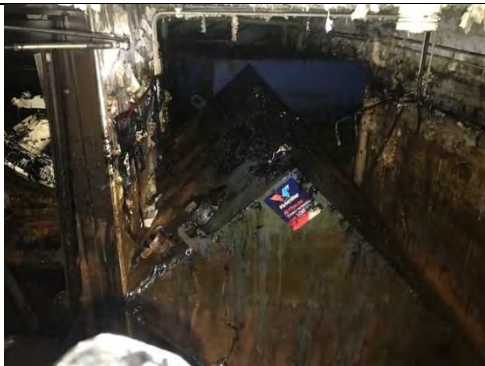
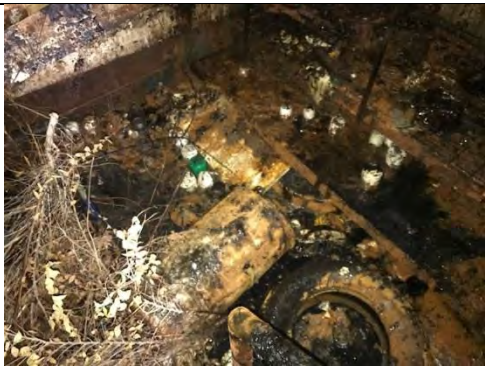
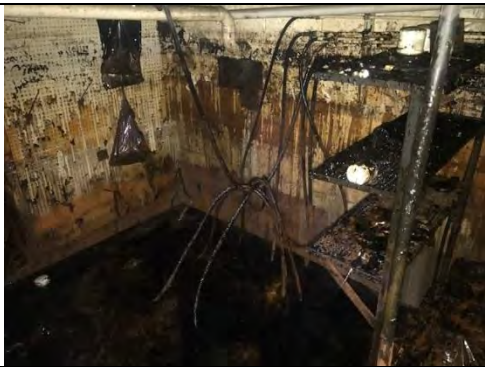
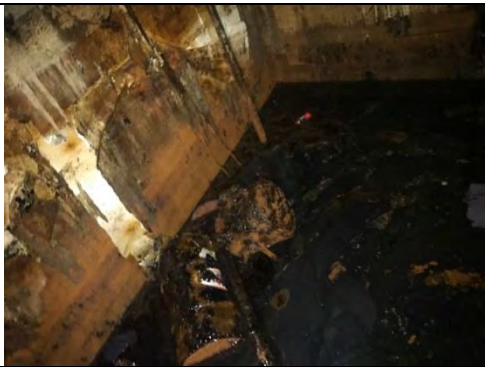
Basement View	Basement View

AKT Peerless conducted an inspection of the on-site basement on August 18, 2017. Based on AKT Peerless' observations, no suspect asbestos containing materials were observed within the basement; therefore, no samples/building materials were collected.

During the Hazardous Material Survey, AKT Peerless observed the existence of various types of potentially hazardous materials in the basement of the building. An inventory of hazardous building materials and containers was prepared and is included in the following table:

AKT Peerless recommends that qualified contractors perform the removal of these materials and follow appropriate special handling and disposal measures, which are required before general building demolition.

1. The materials included in above table and other items banned from landfill disposal, identified during the demolition should be properly removed and disposed of in accordance with applicable regulations.
2. The CONTRACTOR is responsible to remove all accumulated waste fluids and associated sludge materials in accordance with all state and federal regulations. Additionally, any potentially impacted building components, debris, materials, and/or concrete, must be appropriately handled and/or disposed of in accordance with all state and federal regulations. AKT Peerless conducted initial sampling of accumulated waste fluids within the basement of 2360 West Pierson Road, Flint, MI. Analytical data is included within the Phase II Survey, Appendix C of the Bid Specs for #LB 17-017.
