**ADDENDUM # 1**  
**Request for Proposals – 2114 Barbara St. – General Contractors**  
**#LB 11-020**  
July 18, 2011

**COMBINATION LEAD BASED PAINT  
INSPECTION AND  
RISK ASSESSMENT SURVEY**

2114 Barbara Drive

# Genesee County Rehabilitation Environmental Inspection Summary

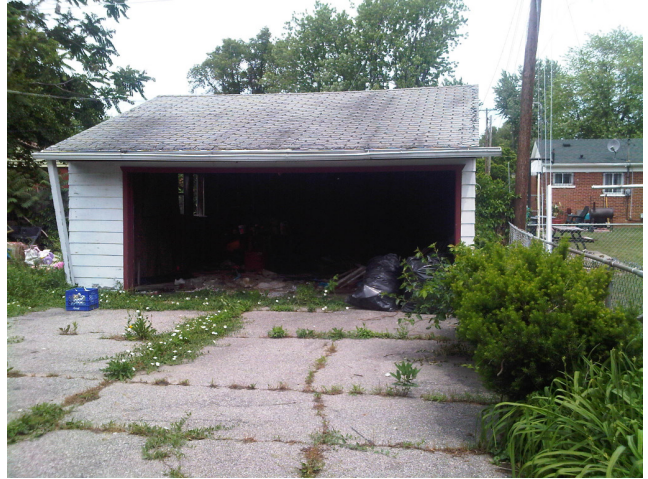
Garage Side A

Identified Hazard	Severity	Priority	Abatement Options	Interim Control Options
<b>Ext. Garage 14</b>				
<b>Walls and trimwork including soffits, fascia, door casings and window casings</b> represent deteriorated lead paint surface hazards	Medium	Low	1) Wrap walls with Tyvek or equivalent, apply foam insulation board, seal all seams and install a new vinyl or aluminum siding system or 2) wet scrape/sand all surfaces bare to the substrate, make necessary repairs, stabilize surfaces and encapsulate with a Michigan approved, exterior grade encapsulate or 3) strip all surfaces bare to the substrate, make necessary repairs, stabilize surfaces, and repaint.	1) Wet scrape / sand all surfaces, make necessary repairs, stabilize all surfaces and repaint or 2) stabilize all surfaces, install vinyl or aluminum siding and wrap components with aluminum or vinyl
<b>Entry and service door jambs</b> represent deteriorated lead paint friction/impact surface hazards	Medium	Low	1) Remove and replace with new components or 2) strip all surfaces bare to the substrate, make necessary repairs and recoat.	1) Use friction reduction treatments (jamb liners, weatherstripping, rubber padding, tread covers, etc.) to reduce wear or 2) Wet plane all friction / impact surfaces, wet scrape all remaining surfaces, make necessary repairs, stabilize all surfaces and repaint.
