**Rehabilitation
Environmental Inspection Report
For:
Parcel Number: 46-26-231-053
6525 Dupont Street
Flint, Michigan 48505**

March 2011
Global Project No. F1438

Genesee County Rehabilitation Environmental Inspection Summary

Parcel No: 46-26-231-053
6525 Dupont Street
Flint, Michigan 48505

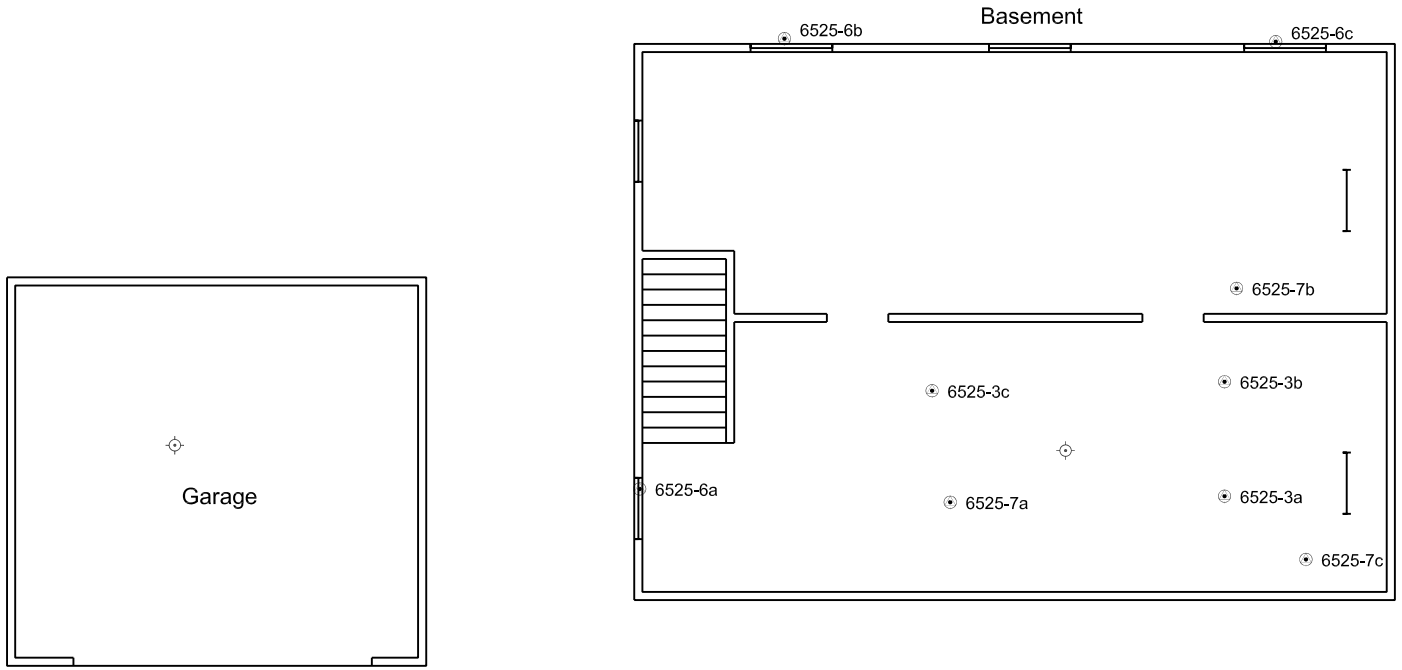
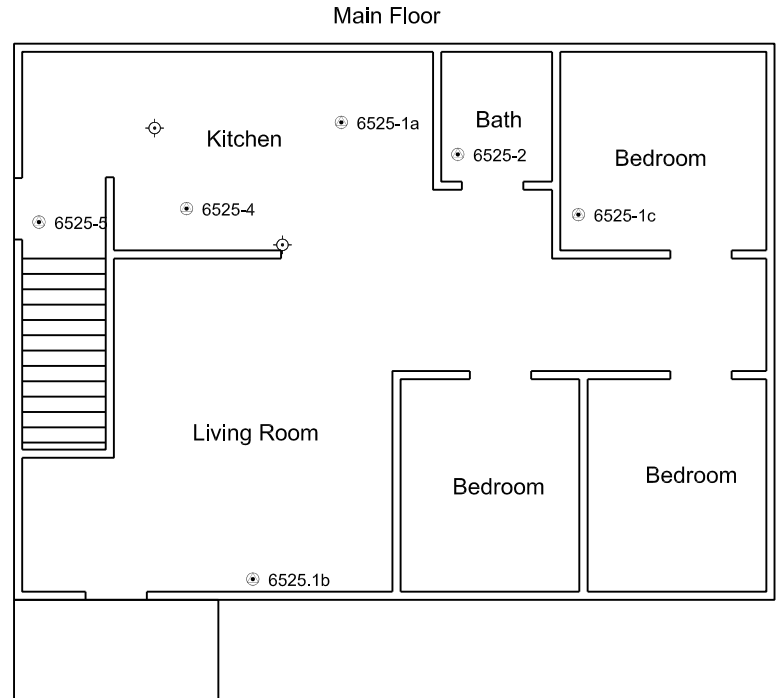
6525 Dupont Street Flint, Michigan	
House Floor Plan	
Last Modified:	Attachment No.:
March 2011	2
Project No.:	
F1438

- Window Caulk - Basement Windows
- Duct Wrap 4" Pipes - Basement
- Duct Wrap 6" Pipes - Basement
- Duct Wrap 8" Pipes - Basement

Shaded and Bolded materials contain asbestos and Global recommends the materials be removed prior to renovation/demolition activities.
