# Genesee County Land Bank Authority

## Neighborhood Stabilization Program 2 (NSP2)

### Invitation for Bids: 407 W. Fifth St. Ct. – General Contractor

The Genesee County Land Bank Authority (GCLBA) is seeking sealed bids for the rehabilitation of 407 W. Fifth St. Ct., Flint, MI 48503. This property is being rehabilitated as single-family residential homes to be sold to income eligible buyers under the Neighborhood Stabilization Program 2 (NSP2). The GCLBA has received NSP 2 grant funding from the MSHDA for this purpose. The NSP 2 funds are provided to MSHDA from the U.S. Department of Housing and Urban Development (HUD).

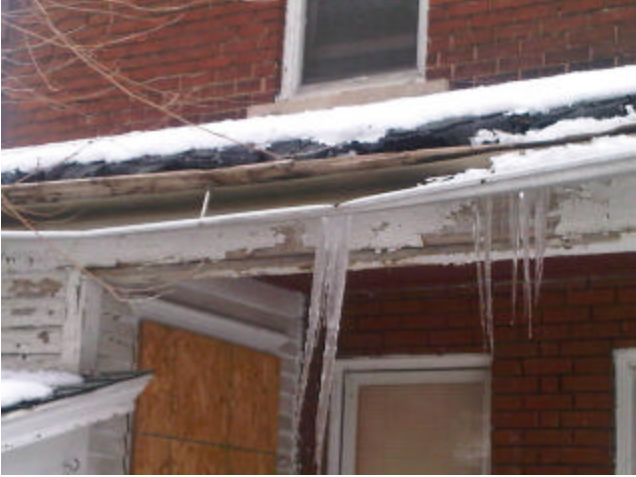
Side C– Porch Roof

| <b>Summary of<br/>Existing Lead Based Paint Hazards including<br/>Abatement and Interim Control Options</b> | | | | |
|---|--|---|---|--|
| <b>Side C porch ceiling</b> represents a deteriorated lead paint surface hazard | High | Medium | 1) Enclose by wrapping with vinyl or aluminum and seal or 2) wet scrape/sand all surfaces, make necessary repairs, stabilize surfaces and encapsulate with a Michigan approved, exterior grade encapsulate or 3) Remove and replace with new components or 4) strip surfaces bare to the substrate, make necessary repairs, stabilize surfaces, and repaint | 1) Wet scrape / sand all surfaces, make necessary repairs, stabilize all surfaces and repaint or 2) stabilize all surfaces and wrap with vinyl or aluminum |

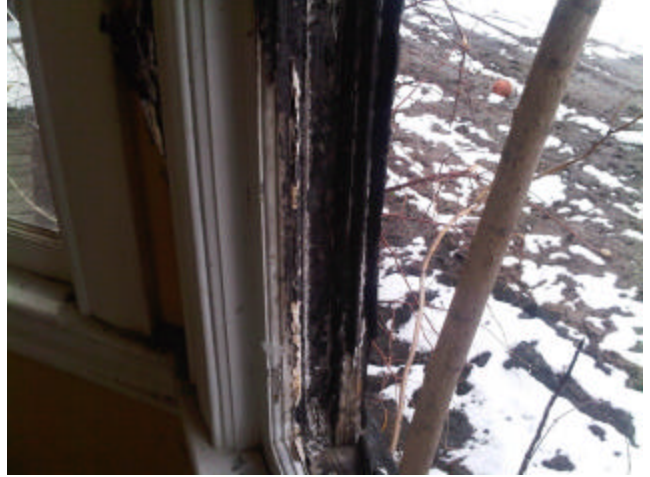
Fire Damage

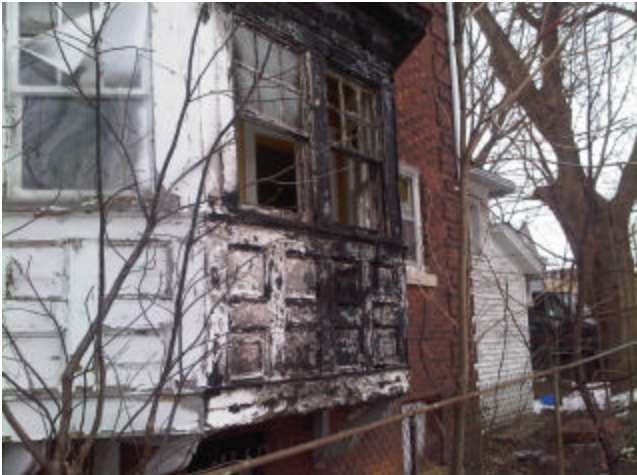
Stair 8– Jut Out

| <b>Summary of<br/>Existing Lead Based Paint Hazards including<br/>Abatement and Interim Control Options</b> | | | | |
|---|--|---|---|--|
| <b>Exterior walls (at Rear/Basement Entry, Stair up jut out and dormer) and trimwork around the entire house including the soffits, fascias, frieze boards, crown moldings, window sills and casings, door casings, window and door lintels, jut out supports, corner boards and all other wood trim</b> represents deteriorated lead paint surface hazards | High | Low | 1) Wrap walls with Tyvek or equivalent, apply foam insulation board, seal all seams and install a new vinyl or aluminum siding system, including wrapping and enclosure of all trim components with vinyl or aluminum, or 2) wet scrape/sand all surfaces, make necessary repairs, stabilize surfaces and encapsulate with a Michigan approved, exterior grade encapsulate or 4) strip all surfaces bare to the substrate, make necessary repairs, stabilize surfaces, and repaint or 5) replace individual lead painted components | 1) Wet scrape / sand all surfaces, make necessary repairs, stabilize all surfaces and repaint or 2) stabilize all surfaces and install vinyl or aluminum siding and wrap all trim components with vinyl or aluminum |

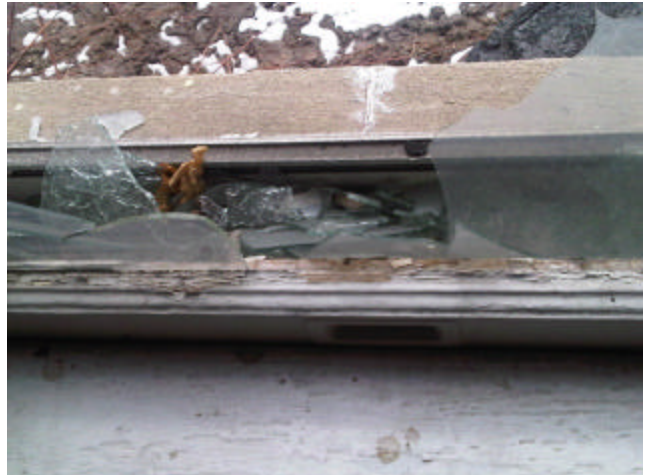
Window Trough

| <b>Summary of<br/>Existing Lead Based Paint Hazards including<br/>Abatement and Interim Control Options</b> | | | | |
|---|--|---|---|---|
| <b>Dust levels in some window troughs / wells</b> within the home were found to have elevated lead levels. Therefore, <b>all</b> window troughs should be considered to be lead contaminated. | High | High | The risk assessor believes that these high lead levels were caused by other lead hazards dealt with below. Therefore, after having completed all other abatement / interim control options, clean the entire house for lead dust thoroughly using the accepted HEPA-Wash-HEPA cleaning methods. | The risk assessor believes that these high lead levels were caused by other lead hazards dealt with below. Therefore, after having completed all other abatement / interim control options, clean the entire house for lead dust thoroughly using the accepted HEPA-Wash-HEPA cleaning methods. |

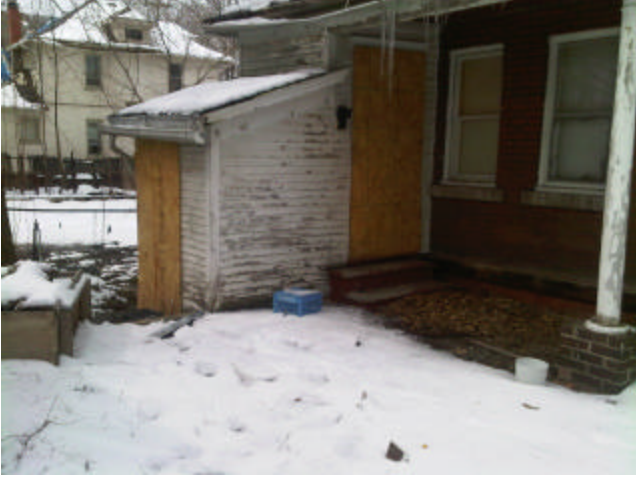
Basement Entrance

| <b>Summary of<br/>Existing Lead Based Paint Hazards including<br/>Abatement and Interim Control Options</b> | | | | |
|---|--|---|--|--|
| <b>Entry door and jamb</b> represent deteriorated lead paint friction/impact surface hazards | High | High | 1) Remove and replace with new door systems or 2) replace individual lead painted components or 3) strip all surfaces bare to the substrate, stabilize surfaces, and repaint. | 1) Refit door to eliminate friction points, wet scrape/sand all surfaces, make necessary repairs,including installation of weatherstripping or other "soft" stop material, stabilize all surfaces and repaint 2) Use friction reduction treatments (jamb liners, weatherstripping, rubber padding, tread covers, etc.) to reduce wear or 3) Wet plane all friction / impact surfaces, wet scrape all remaining surfaces, make necessary repairs, stabilize all surfaces and repaint. |

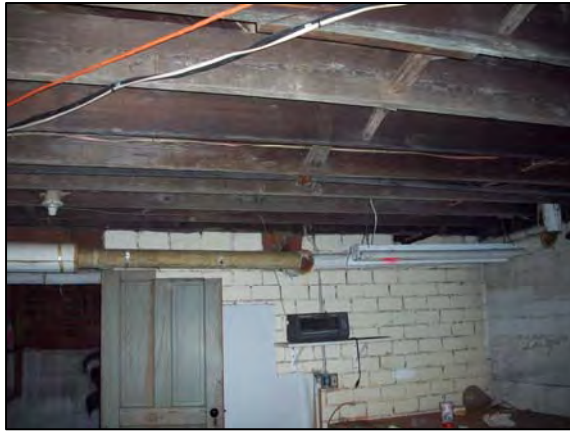
Fluorescent Lights  
Basement

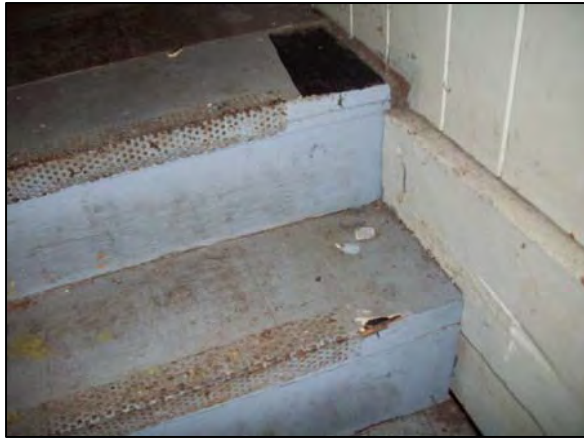
Floor Tiles w/ Mastic  
Basement Stairs

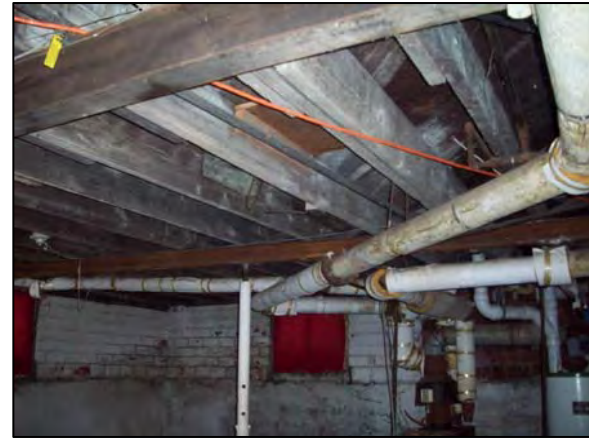
Mag Straight Run and Mag Fittings  
Basement

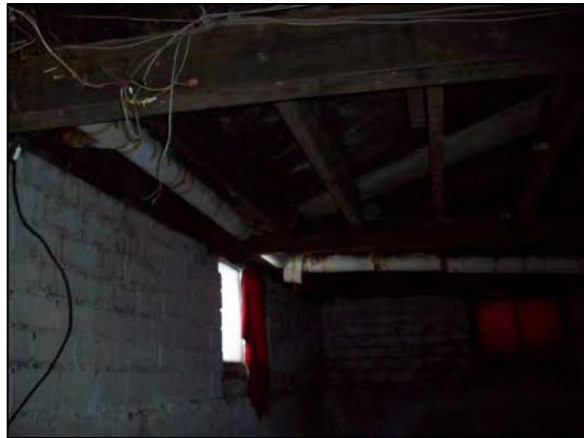
Mag Straight Run and Mag Fittings  
Basement

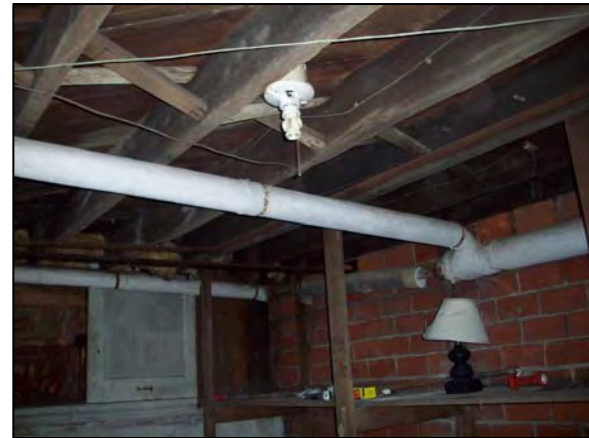
Mag Straight Run and Mag Fittings  
Basement
