Neighborhood Stabilization Program 2 (NSP2)

Invitation for Bids – General Contractor

818 Lyon St., Flint, MI 48503

INVITATION FOR BIDS: 818 LYON ST. – GENERAL CONTRACTOR

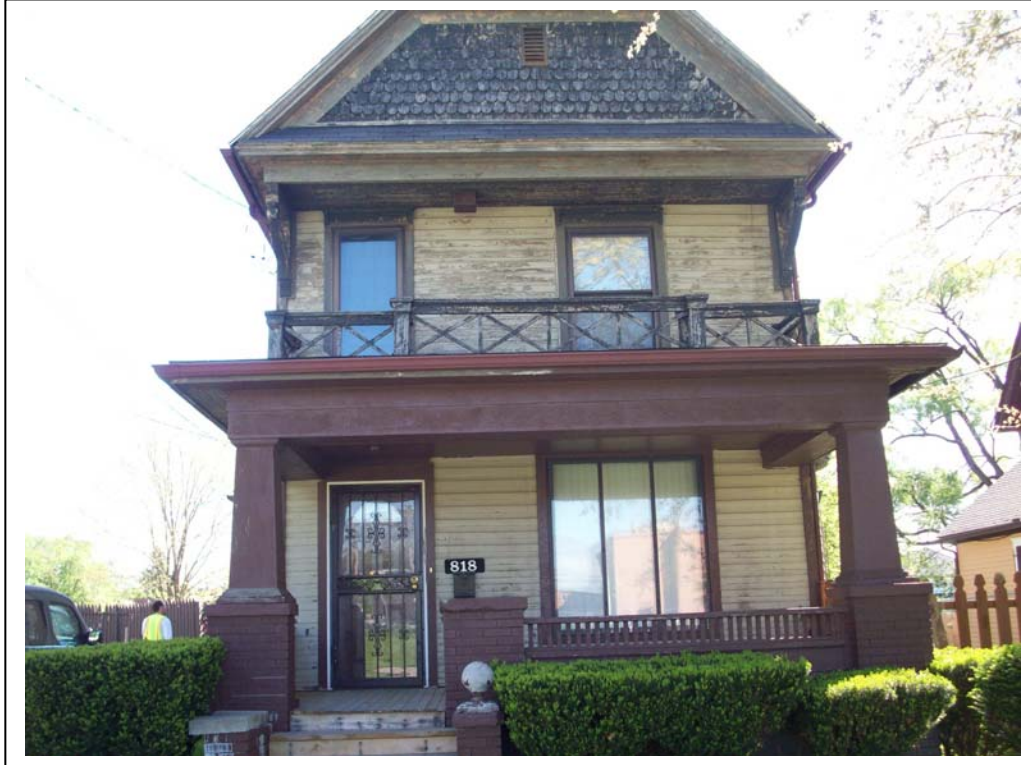
40-12-406-016
818 Lyon Street
Flint, Michigan 48503

Year Built:	Unknown	Square Footage:	1,500
Latitude:	N 43° 01'19.67"	Longitude:	W 83° 41'55.97"
Gas:	Connected	Electric:	Connected

Comments: A two-story wood framed residential structure with wood siding and a basement. The basement was flooded and could not be fully inspected.

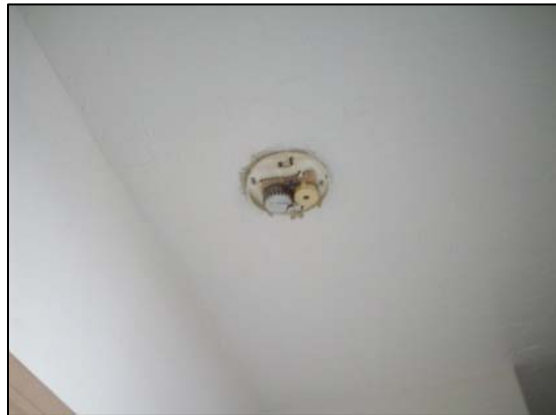
Smoke Detector
Dining Room

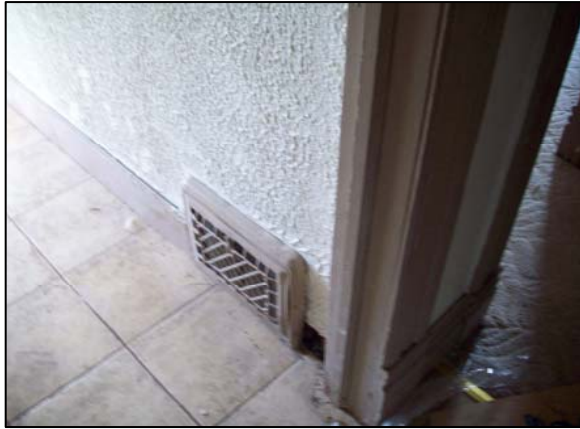
Example of Duct Wrap
Register Boots/Runs Throughout

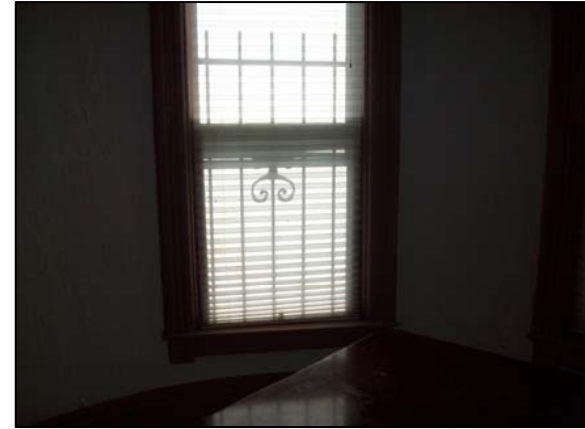
Window Caulk
Windows Throughout
