# Genesee County Land Bank Authority

### Invitation for Bids – Geothermal Heating and Cooling System

924 Eddy St., Flint, MI 48503

Genesee County Land Bank & University of Michigan-Flint  
Urban Alternatives House  
renovations to 924 Eddy Street, Flint, MI 48503

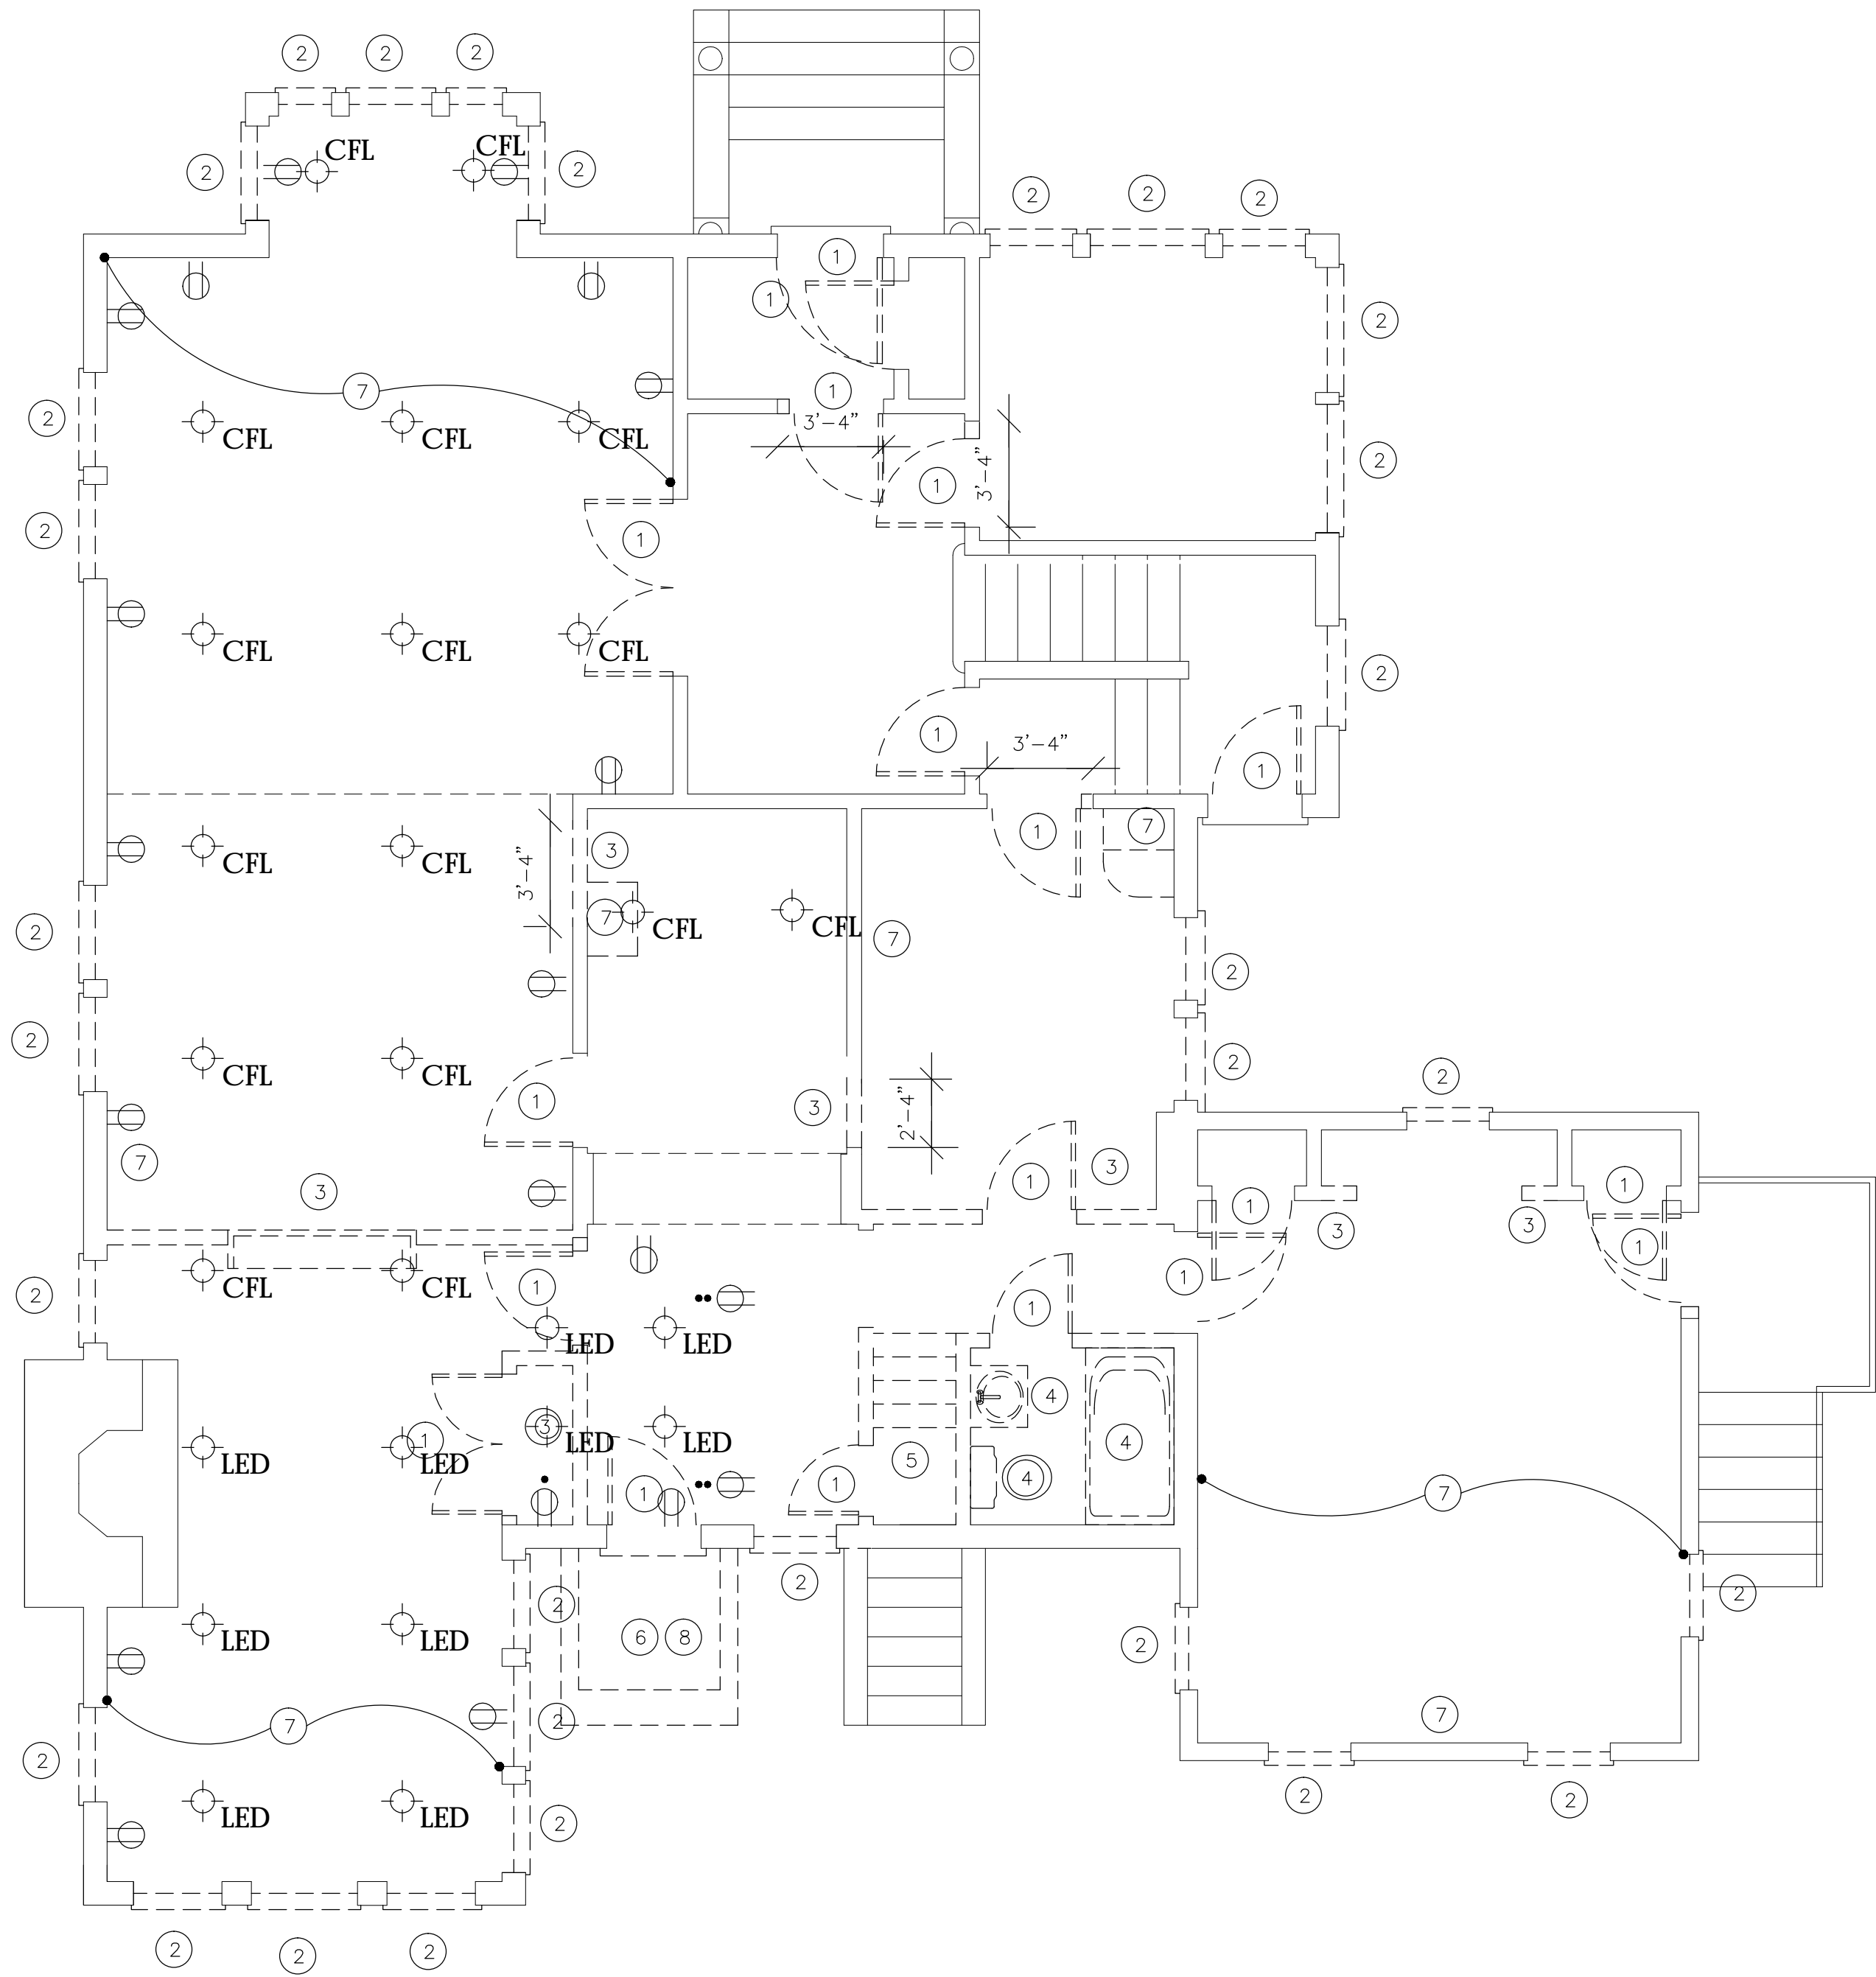
Urban Alternatives House  
**LOWER DEMOLITION PLAN**  
scale: 1/4"=1'-0"

1. DEMOLITION NOTES ARE NOT ALL-INCLUSIVE - CONTRACTOR TO REMOVE OTHER ITEMS AS NEEDED TO COMPLETE NEW WORK
2. HAZARDOUS WASTE REMOVAL REQUIRED RE: SPEC

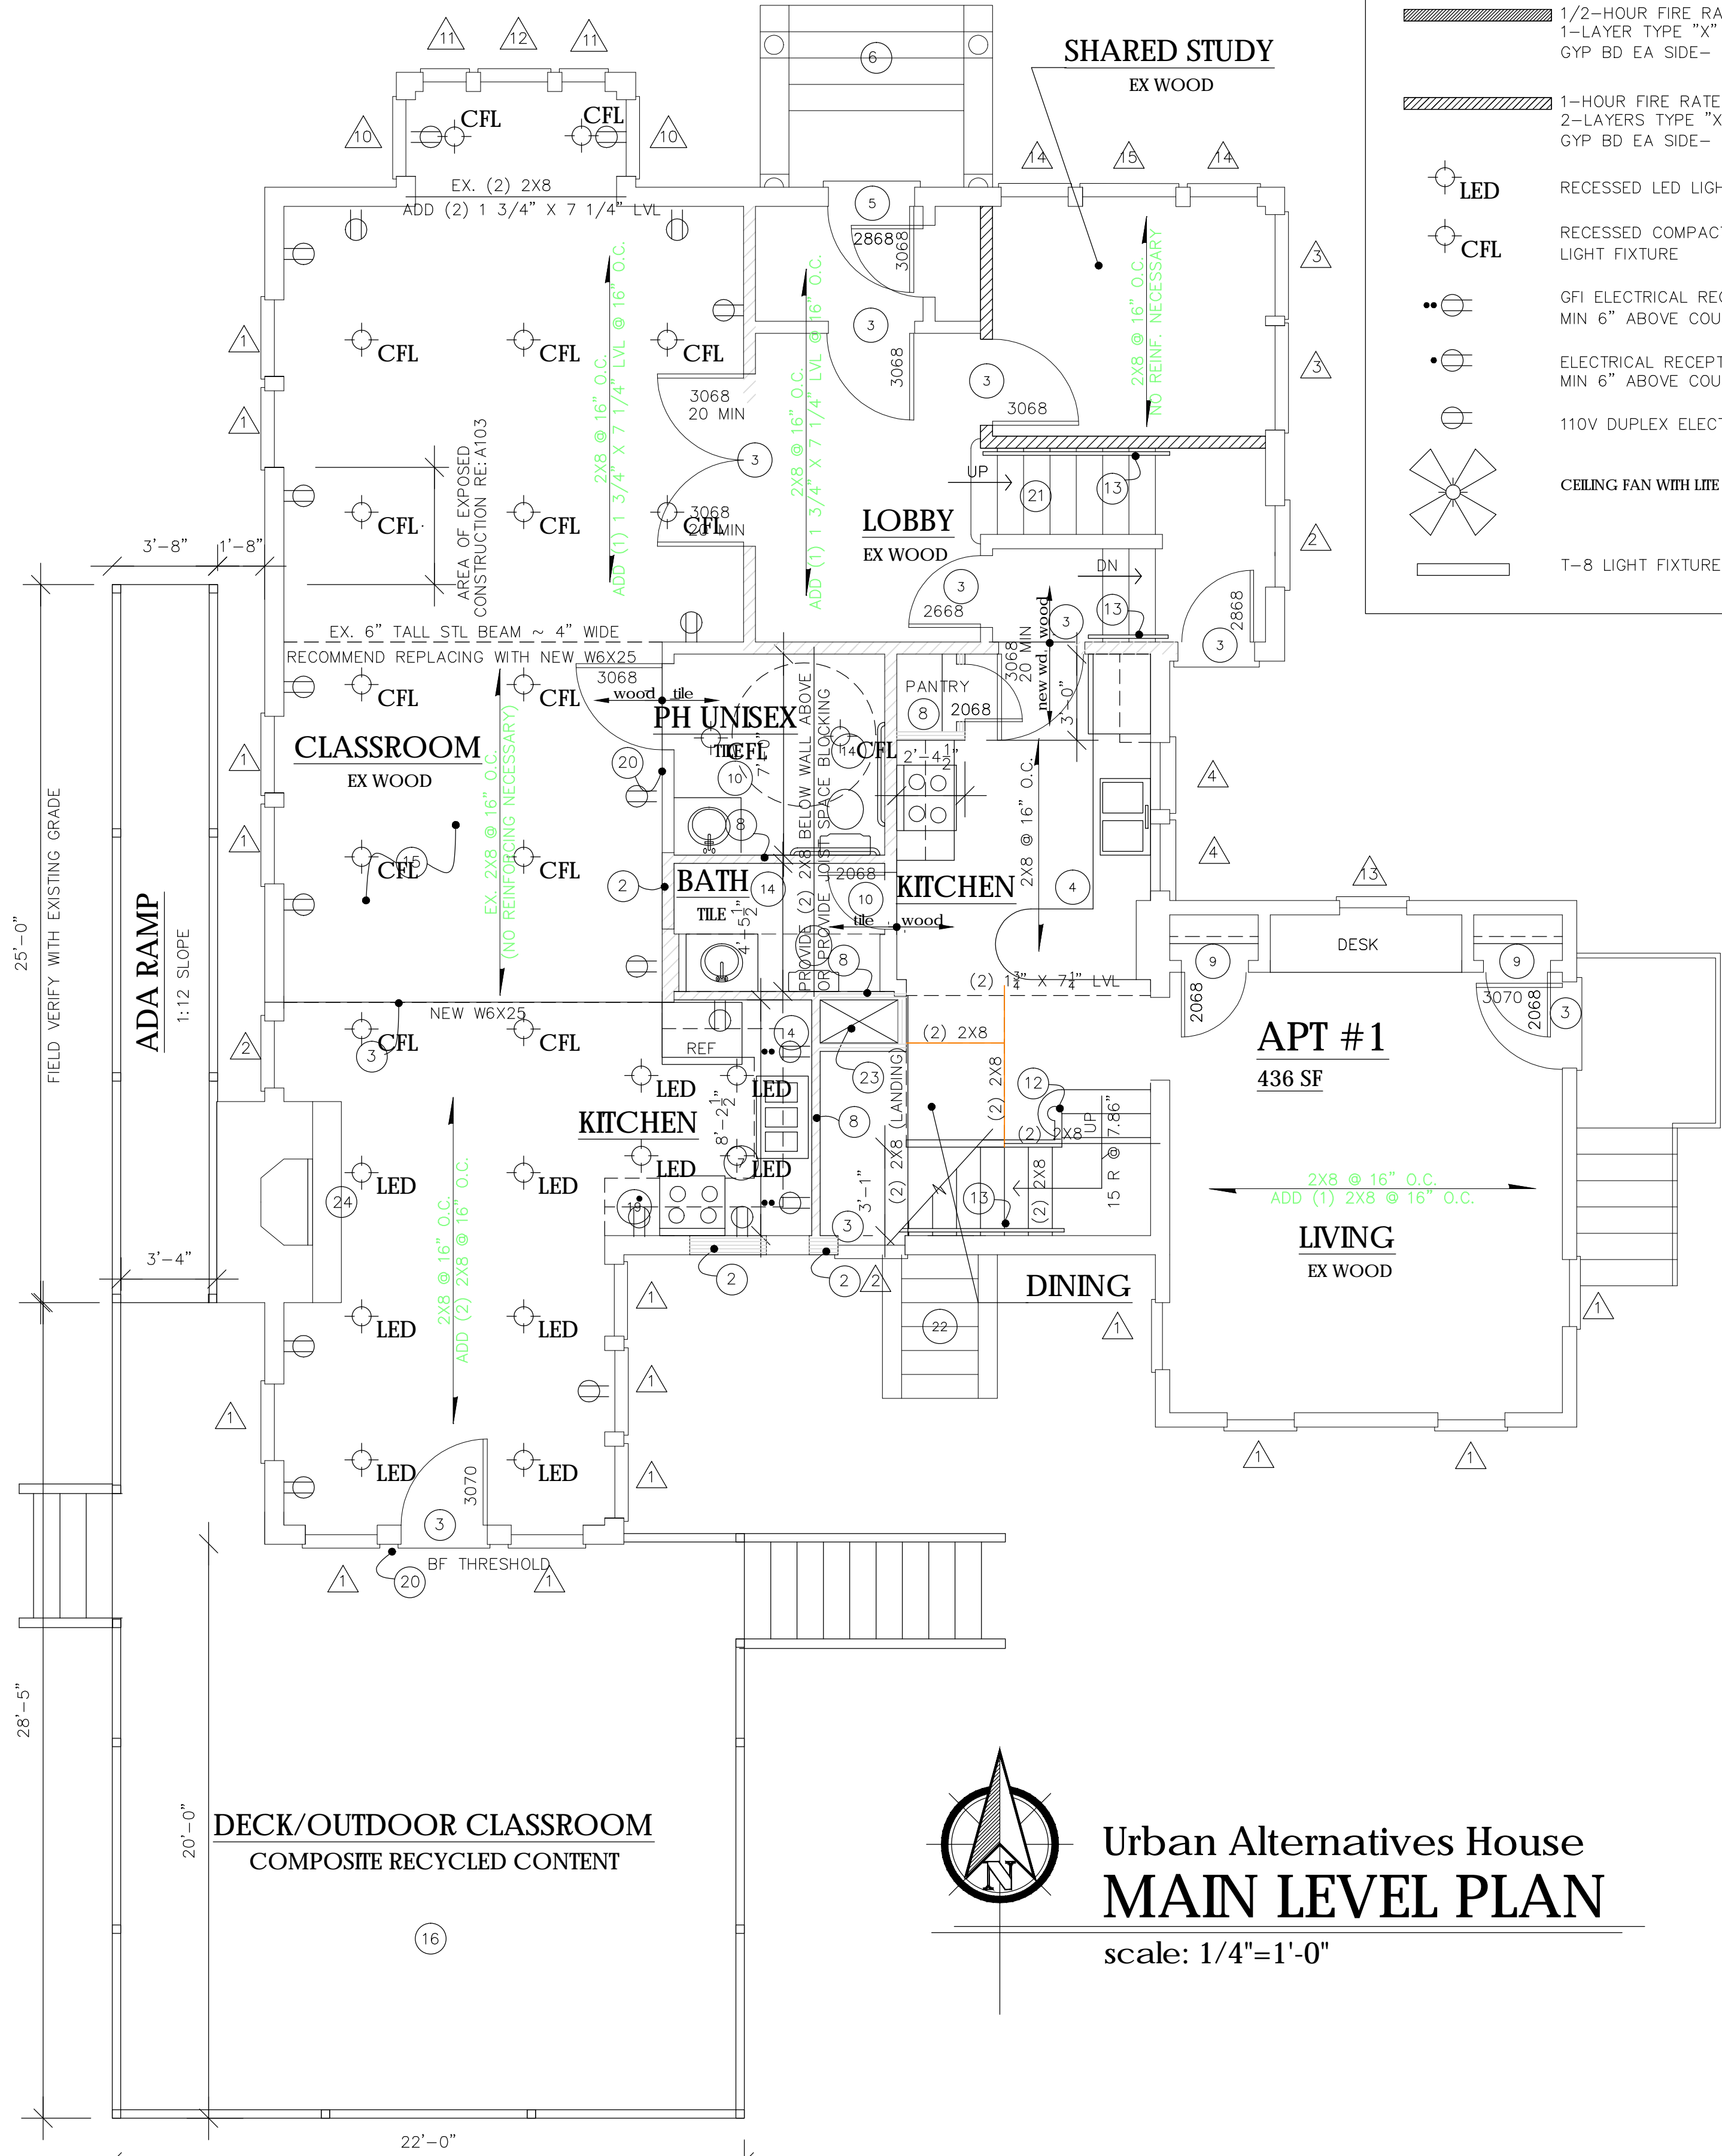
Urban Alternatives House  
MAIN LEVEL PLAN  
scale: 1/4"=1'-0"

- PROVIDE NEW (2) 2x8 HEADER
- NEW CABINETRY BY MANUFACTURER RE: SPEC
- NEW WOOD ROUND TOP ENTRANCE DOOR & FRAME
- PROVIDE NEW WOOD BASE UNDER EXISTING COLUMNS. PROVIDE NEW BRICK PORCH (MATCH CHIMNEY) RE-USE LIMESTONE CAPS; REPLACE 2 LIMESTONE TREADS AND RISERS

- NEW 3 COMPARTMENT STAINLESS STEEL SINK RE:SPEC
- NEW 3 1/2" WOOD STUD WALL
- COAT ROD & SHELF
- VINYL TILE W/ WOOD BASE
- NEW STACKABLE WASHER/DRYER COMBO RE:SPEC

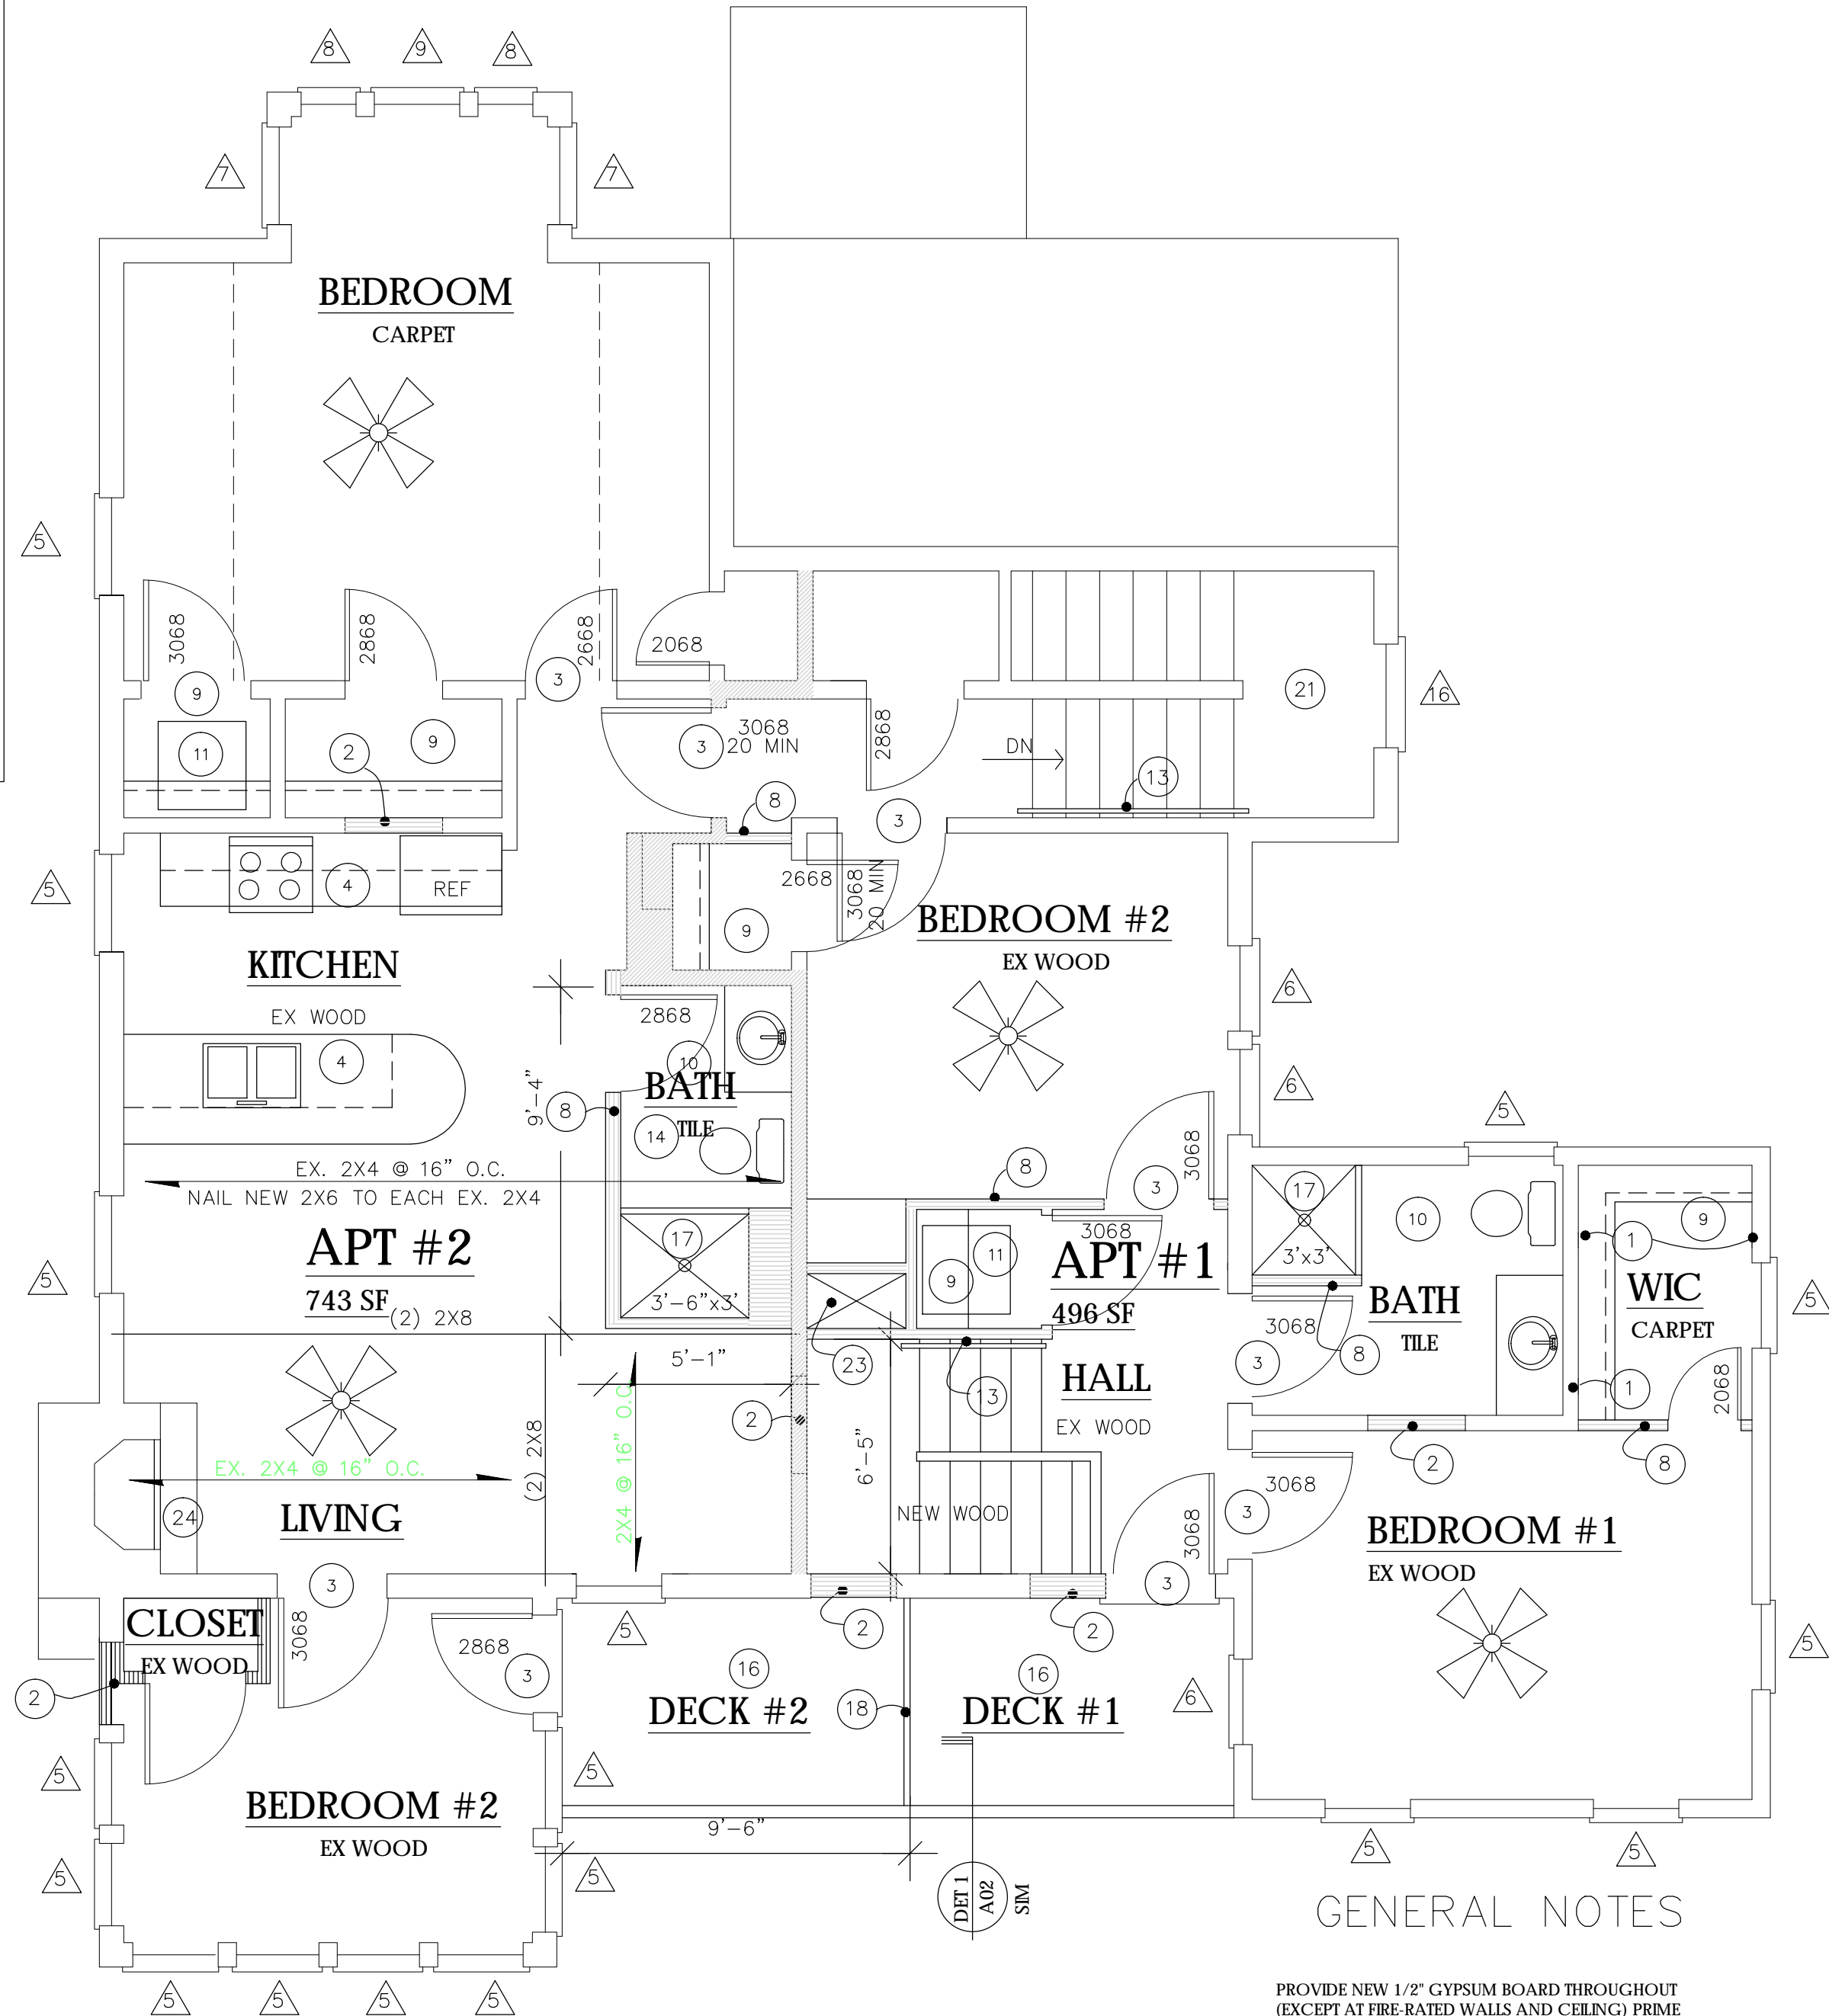
Urban Alternatives House  
UPPER LEVEL PLAN  
scale: 1/4"=1'-0"

- FIBERGLASS SHOWER INSERT RE:SPEC
- WOOD PRIVACY SCREEN
- KITCHEN CABINETS RE: SPEC
- PH SIGN DETAIL THIS SHEET
- PATCH / REPAIR EXISTING WOOD STAIR AS REQUIRED

- PATCH / REPAIR EXISTING CONC STEPS AS REQUIRED
- VERTICAL MECHANICAL CHASE - 1 HR RATED
- PROVIDE AIRTIGHT FIREPLACE ENCLOSURE RE: SPEC

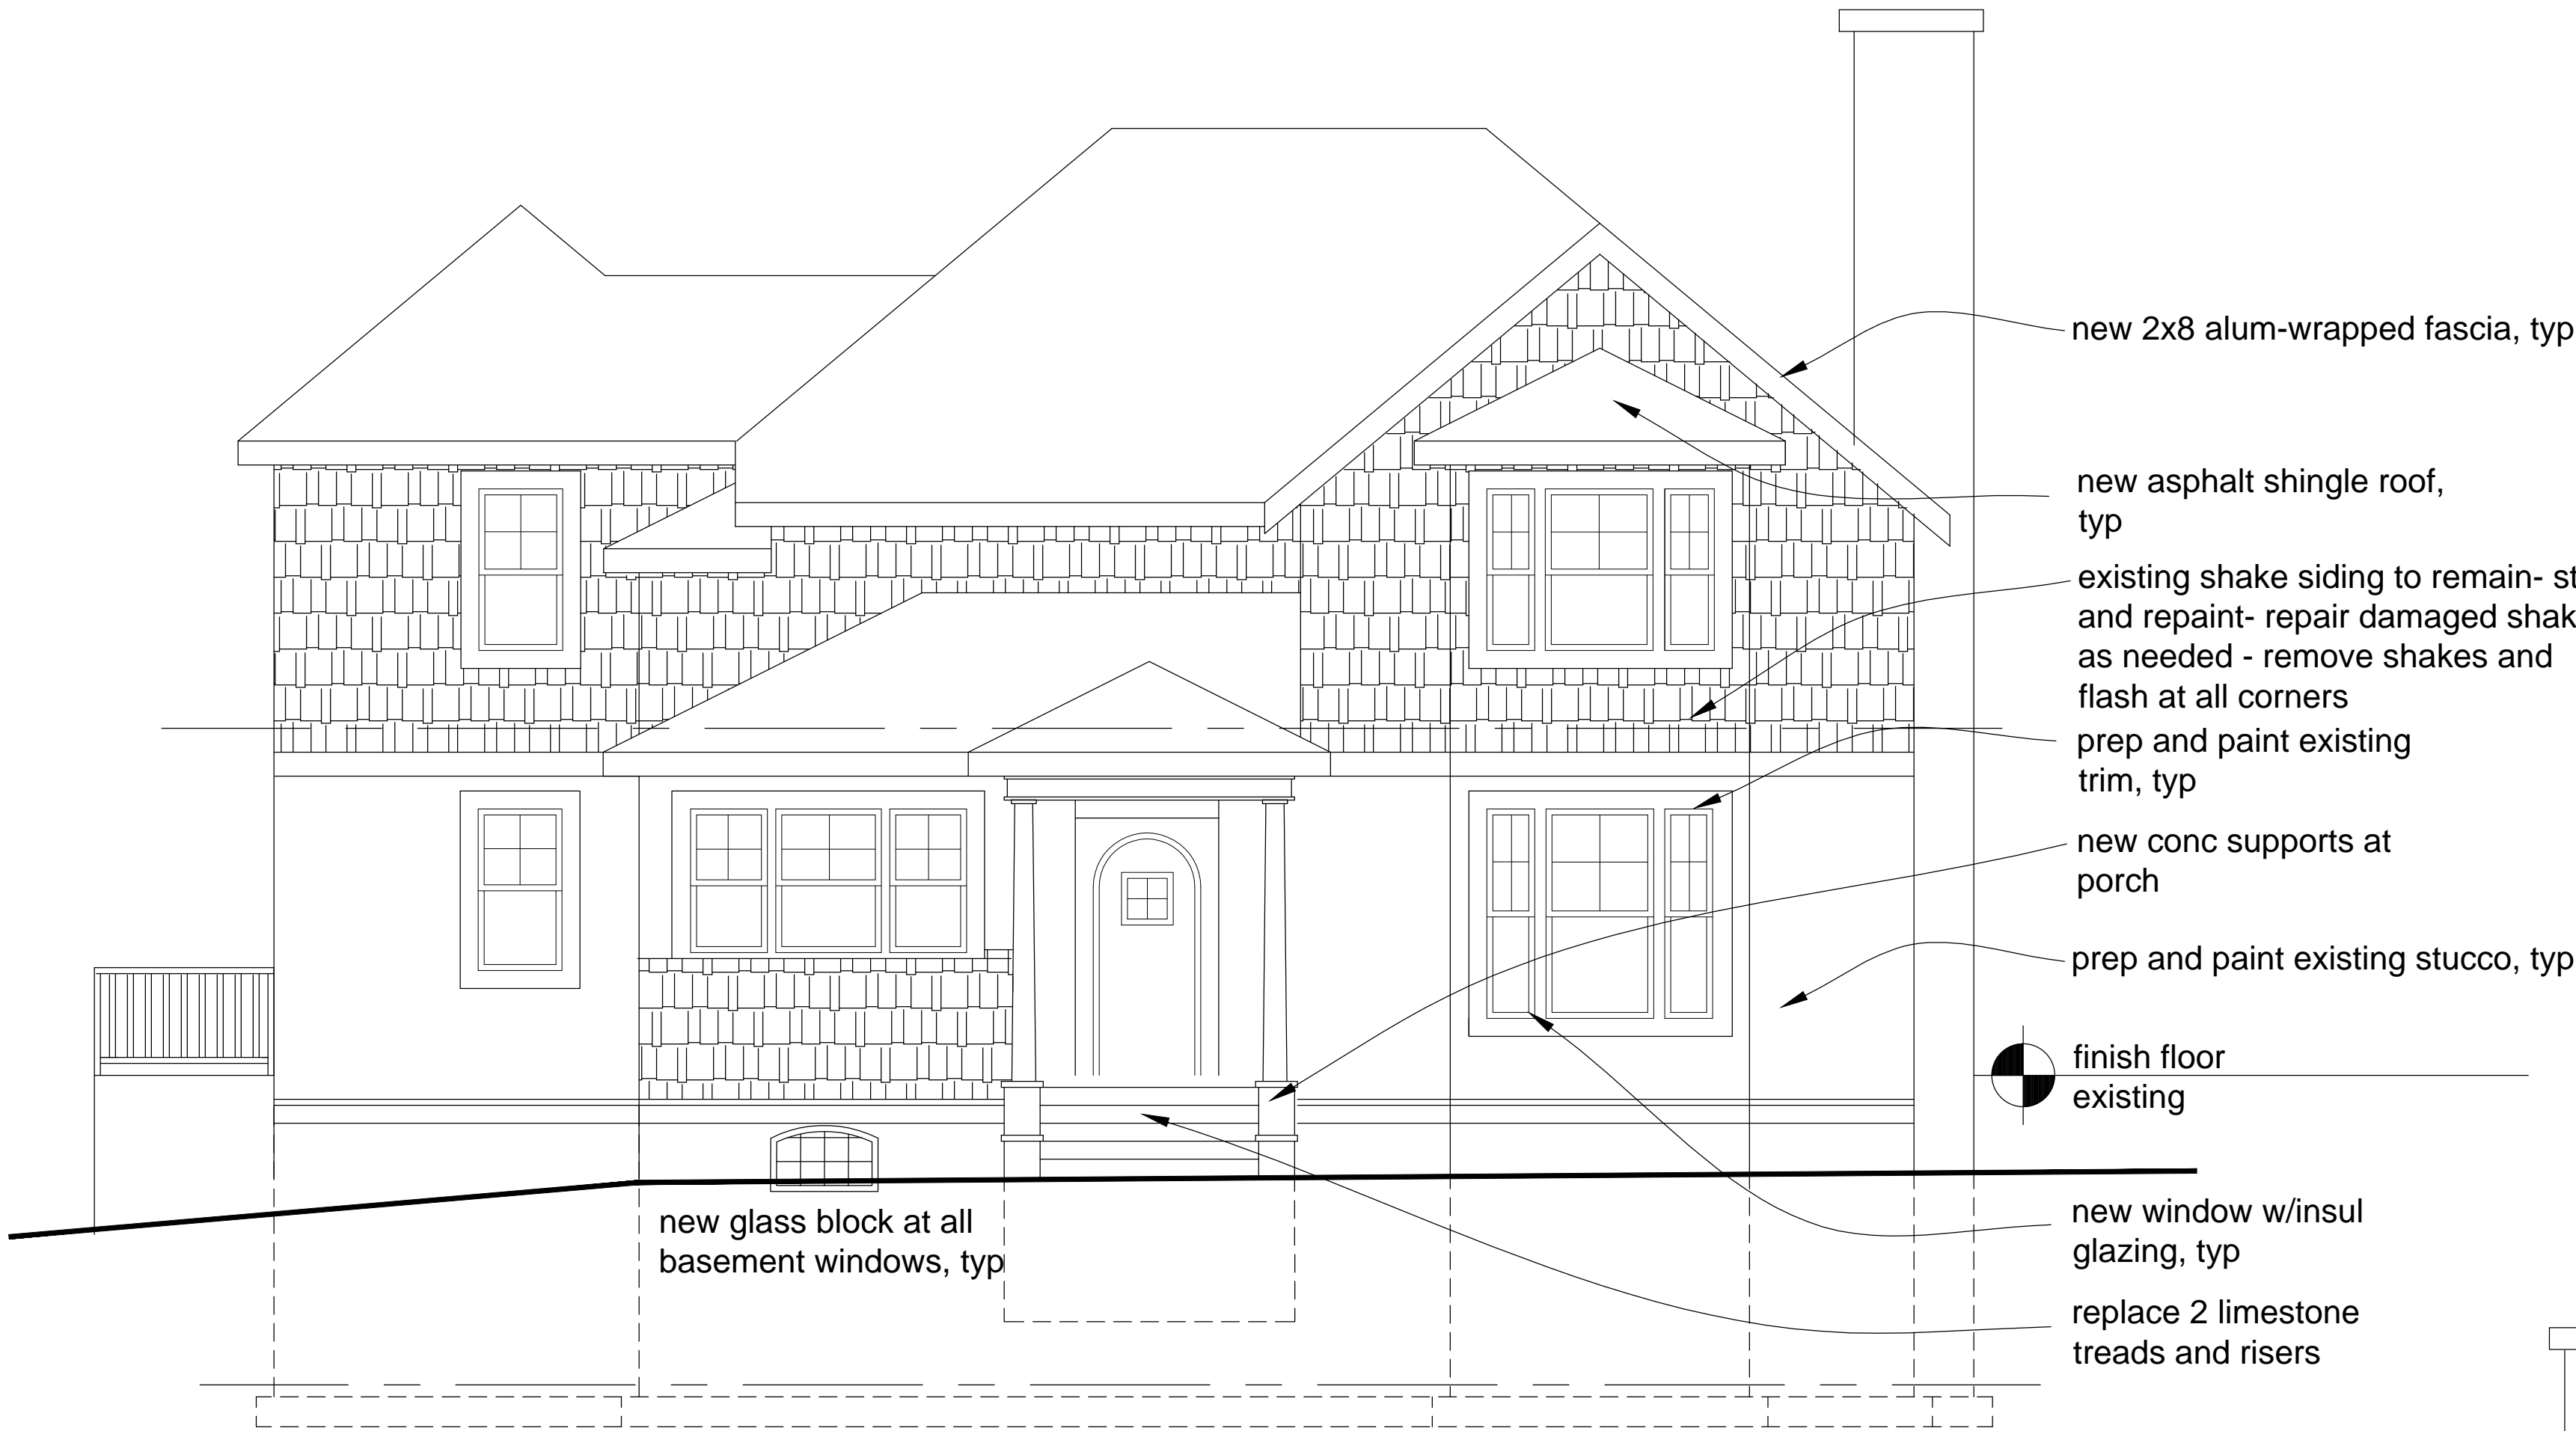
Urban Alternatives House  
**NORTH ELEVATION**

AT CLASSROOM SPACE- LEAVE 3'X7' PORTION OF WALL EXPOSED UNDER 1/4" TEMPERED GLASS TO SHOW WALL INSUL & CONSTRUCTION AS BELOW

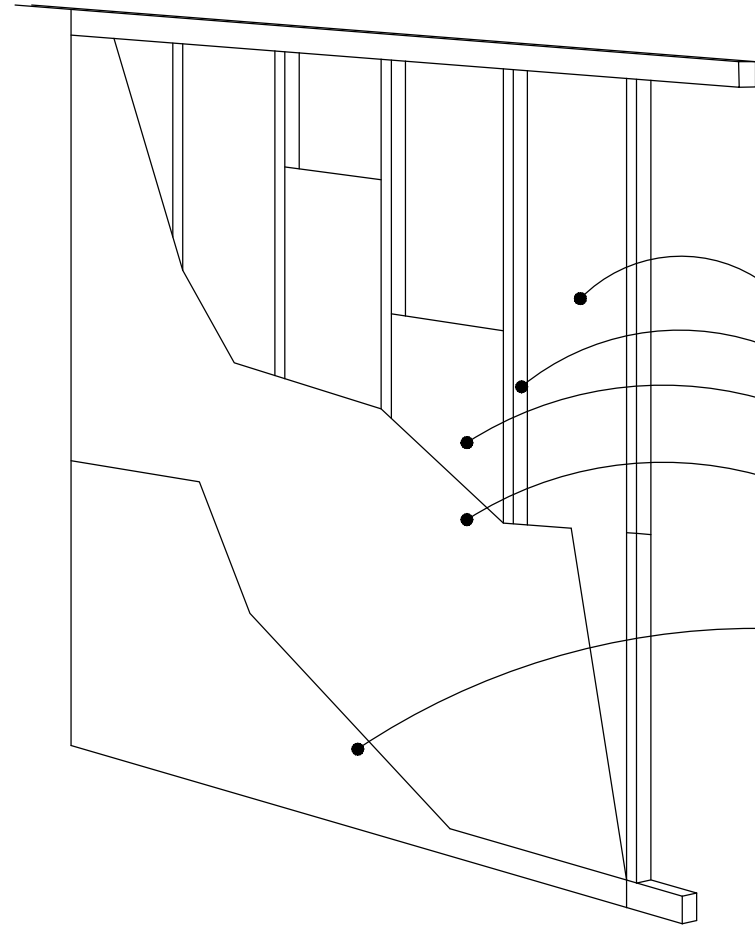
Urban Alternatives House  
**INTERIOR WALL ELEVATION**  
NTS

EXISTING EXTERIOR SHEATHING  
EXISTING WALL STUDS  
NEW R-15 WALL INSULATION  
NEW 1" R-4 RIGID INSULATION BD  
NEW 5/8" PAINTED GYP BD

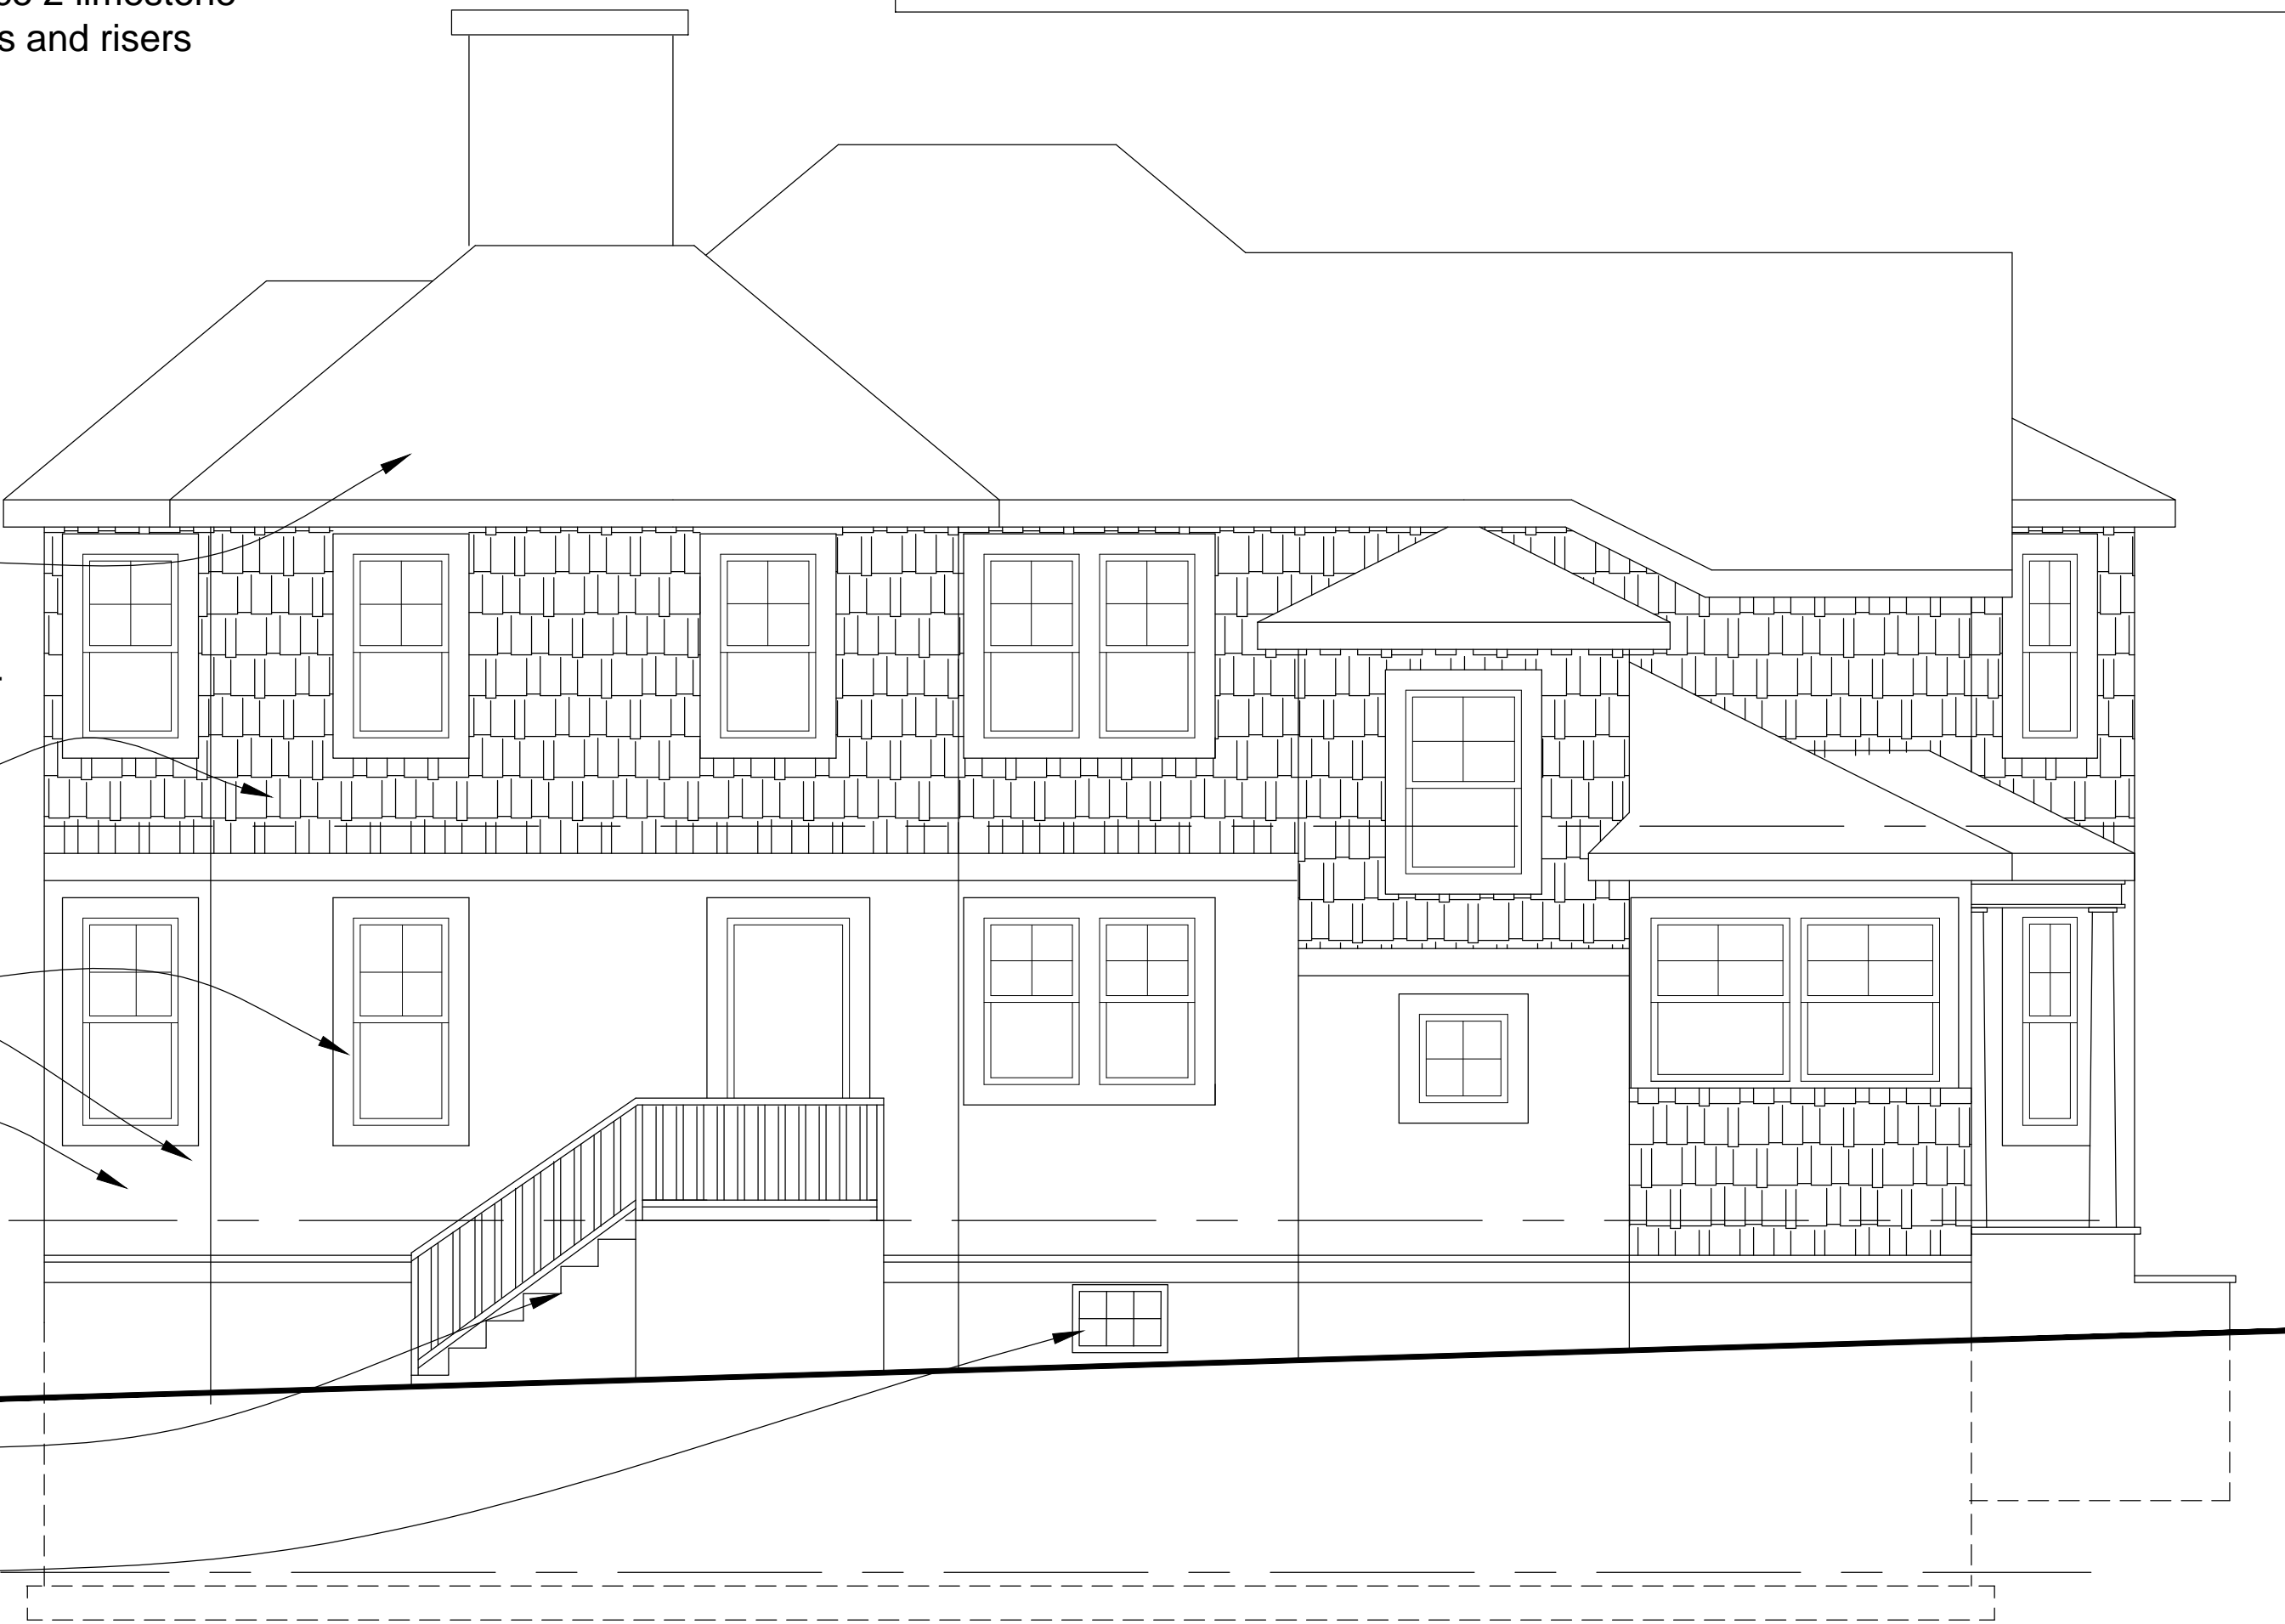
Urban Alternatives House  
**EAST ELEVATION**  
scale: 1/4"=1'-0"

new asphalt shingle roof  
existing shake siding to remain- strip and repaint- repair damaged shakes as needed provide new flashing at all corners  
prep and paint existing trim, typ  
prep and paint existing stucco, typ  
finish floor existing  
existing conc stair and railing to remain  
new glass block at basement windows, typ

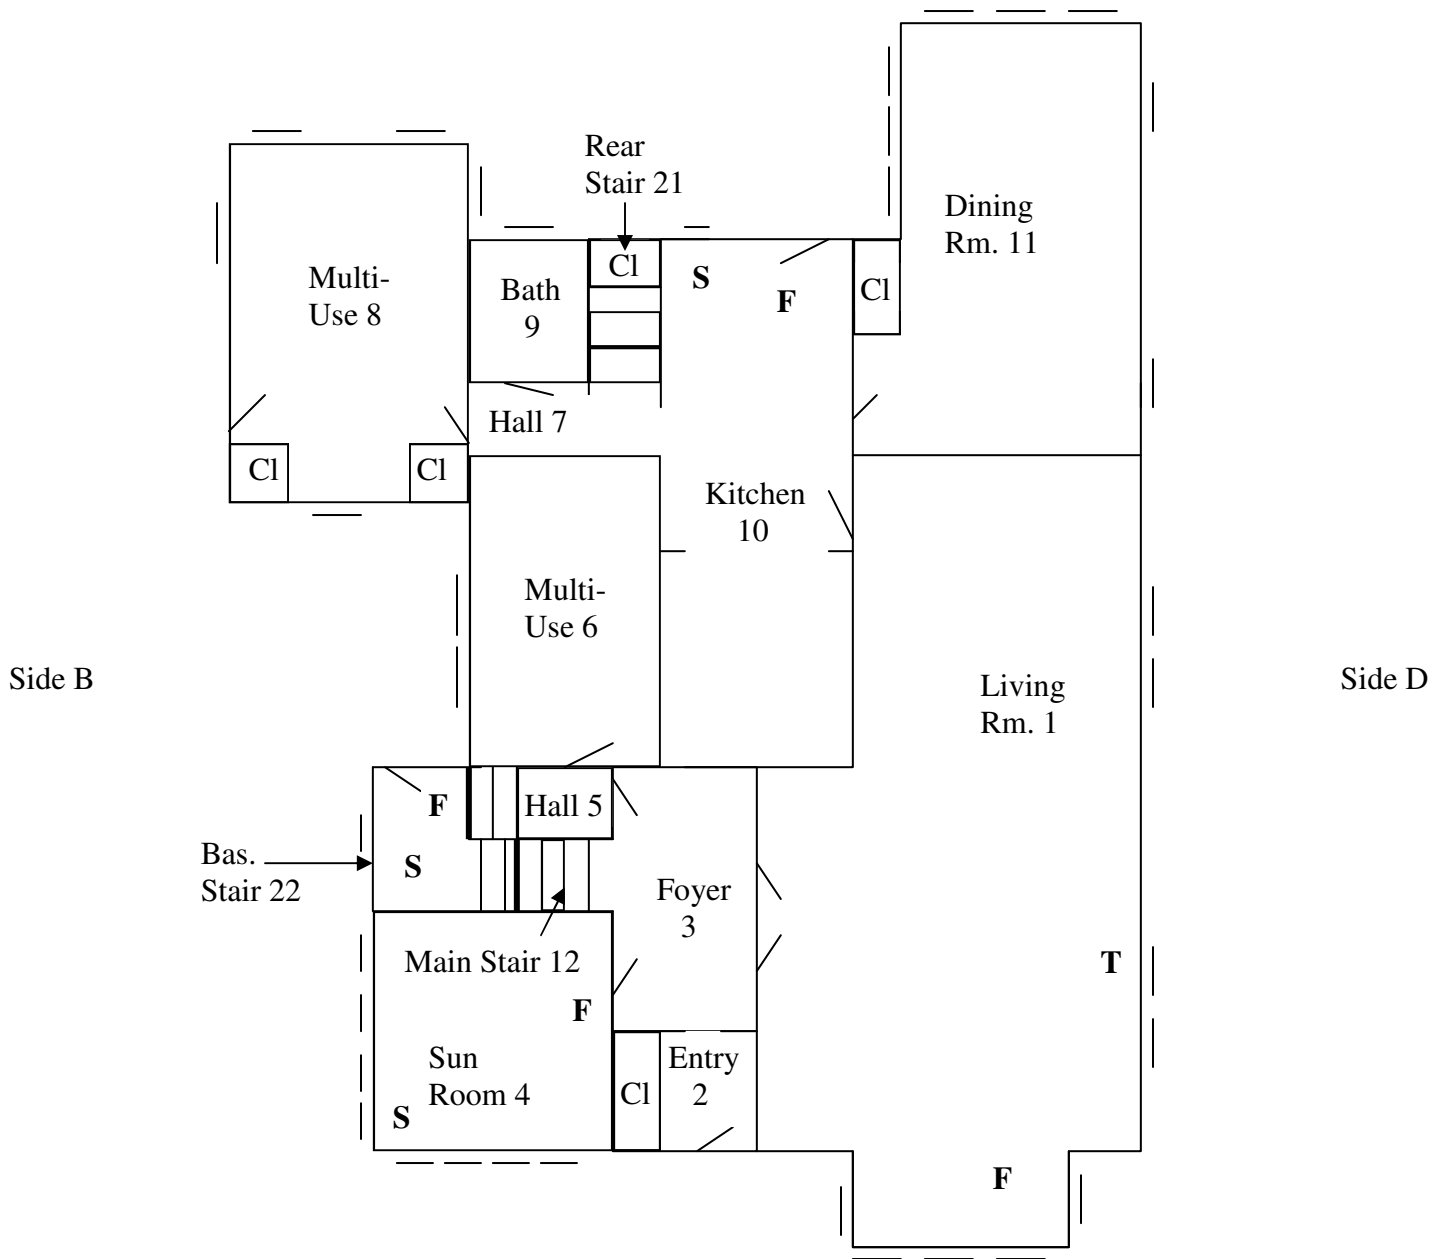
## 1st Floor

F = Floor Dust Wipe Sample  
S = Windowsill Dust Wipe Sample  
T = Window Trough Dust Wipe Sample  
W = Wood windows  
V = Vinyl windows  
A = Aluminum windows  
M = Metal windows  
GB = Glass block windows

Please Note: This is a rough floor plan only. All items, (doorways, Windows, etc.) may not be included in this illustration. Also, room and component sizes are not drawn to scale.

For identifying the rooms and other areas of the interior of the house, a numbering system is used. Most rooms, with the exception of the kitchen and bath could be used for different purposes. When numbers are used, deciphering which room is called what will not be required. See dwelling map and labeling to determine the locations of the tests and hazards.
