# Genesee County Land Bank Authority

### Invitation for Bids – Geothermal Heating and Cooling System

924 Eddy St., Flint, MI 48503

Genesee County Land Bank & University of Michigan-Flint  
Urban Alternatives House  
renovations to 924 Eddy Street, Flint, MI 48503

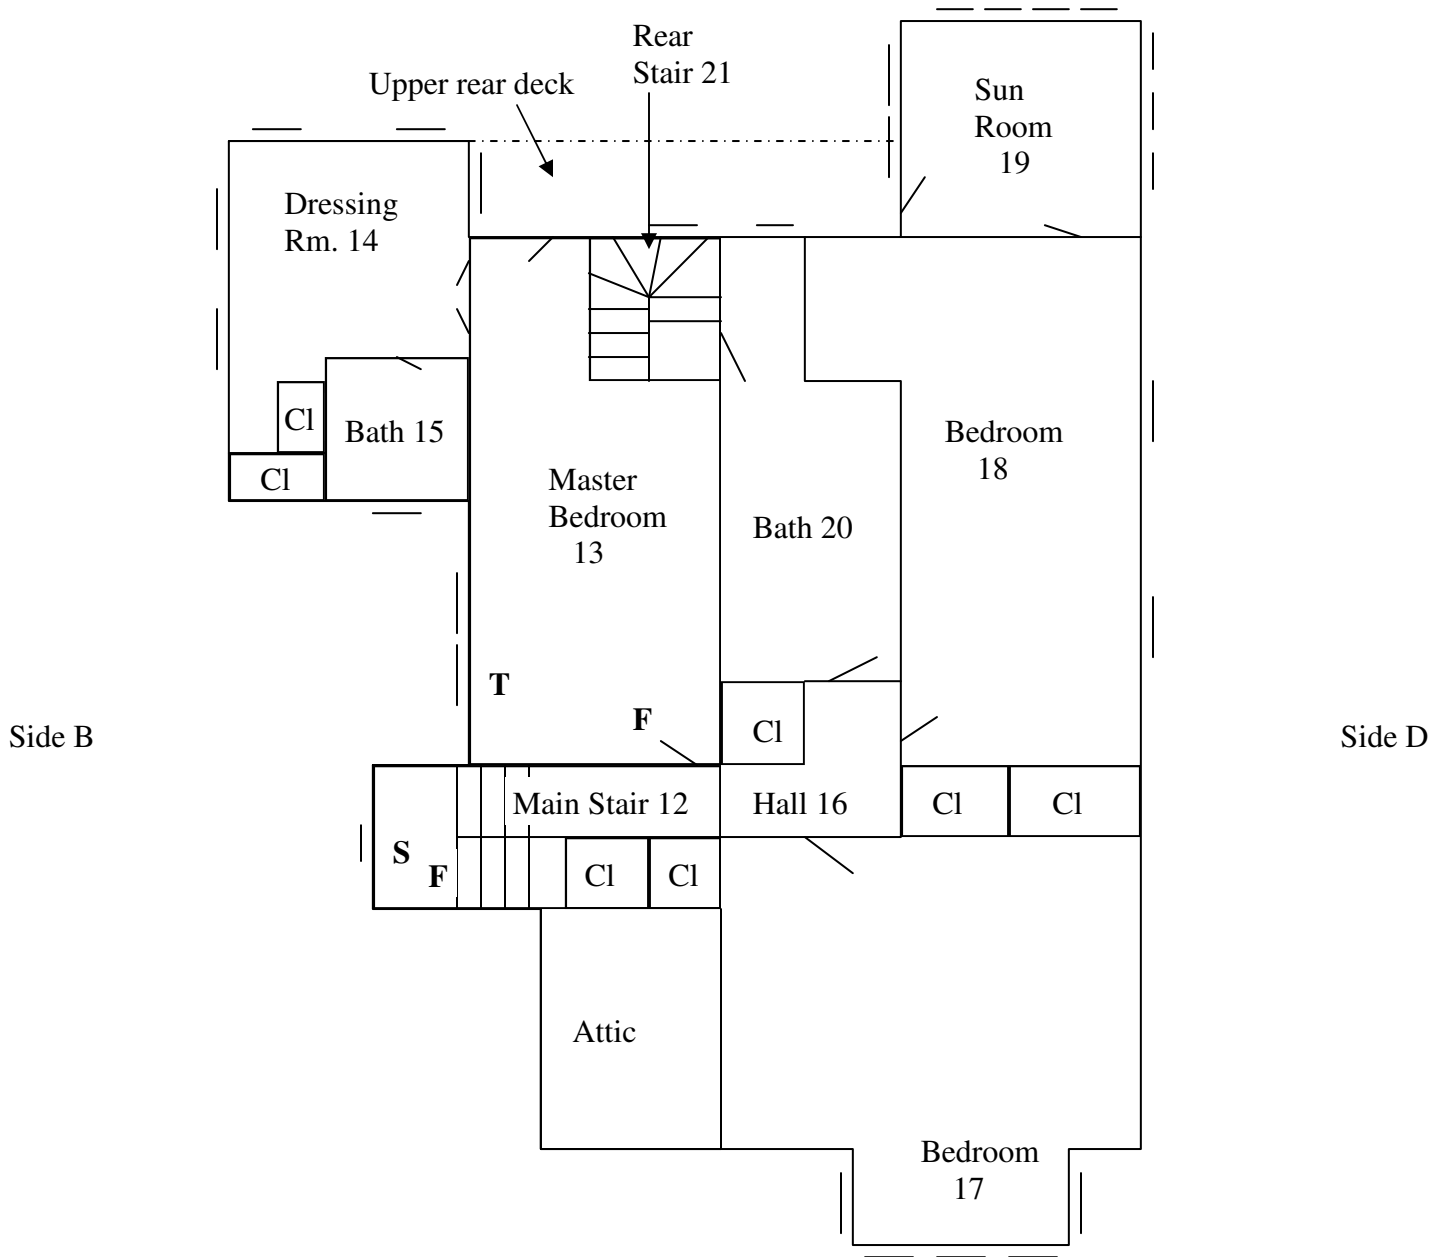
## 2nd Floor

F = Floor Dust Wipe Sample  
S = Windowsill Dust Wipe Sample  
T = Window Trough Dust Wipe Sample  
W = Wood windows  
V = Vinyl windows  
A = Aluminum windows  
M = Metal windows  
GB = Glass block windows

Please Note: This is a rough floor plan only. All items, (doorways, Windows, etc.) may not be included in this illustration. Also, room and component sizes are not drawn to scale.

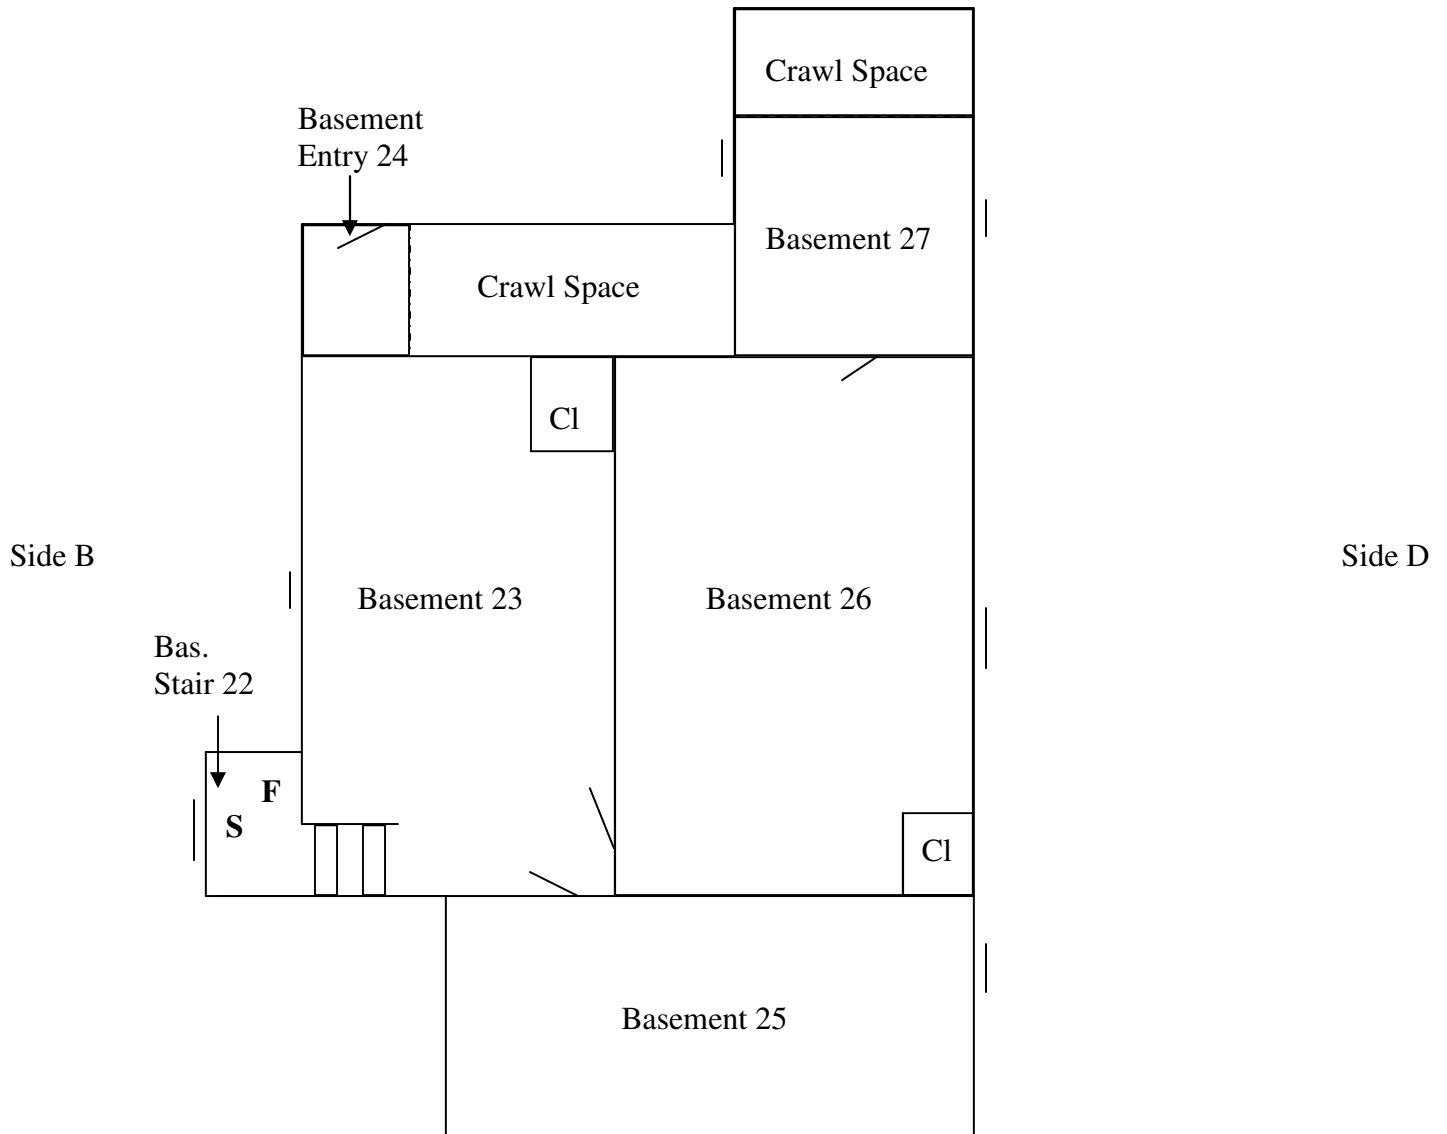
## Basement Level

F = Floor Dust Wipe Sample  
S = Windowsill Dust Wipe Sample  
T = Window Trough Dust Wipe Sample  
W = Wood windows  
V = Vinyl windows  
A = Aluminum windows  
M = Metal windows  
GB = Glass block windows

Please Note: This is a rough floor plan only. All items, (doorways, Windows, etc.) may not be included in this illustration. Also, room and component sizes are not drawn to scale.

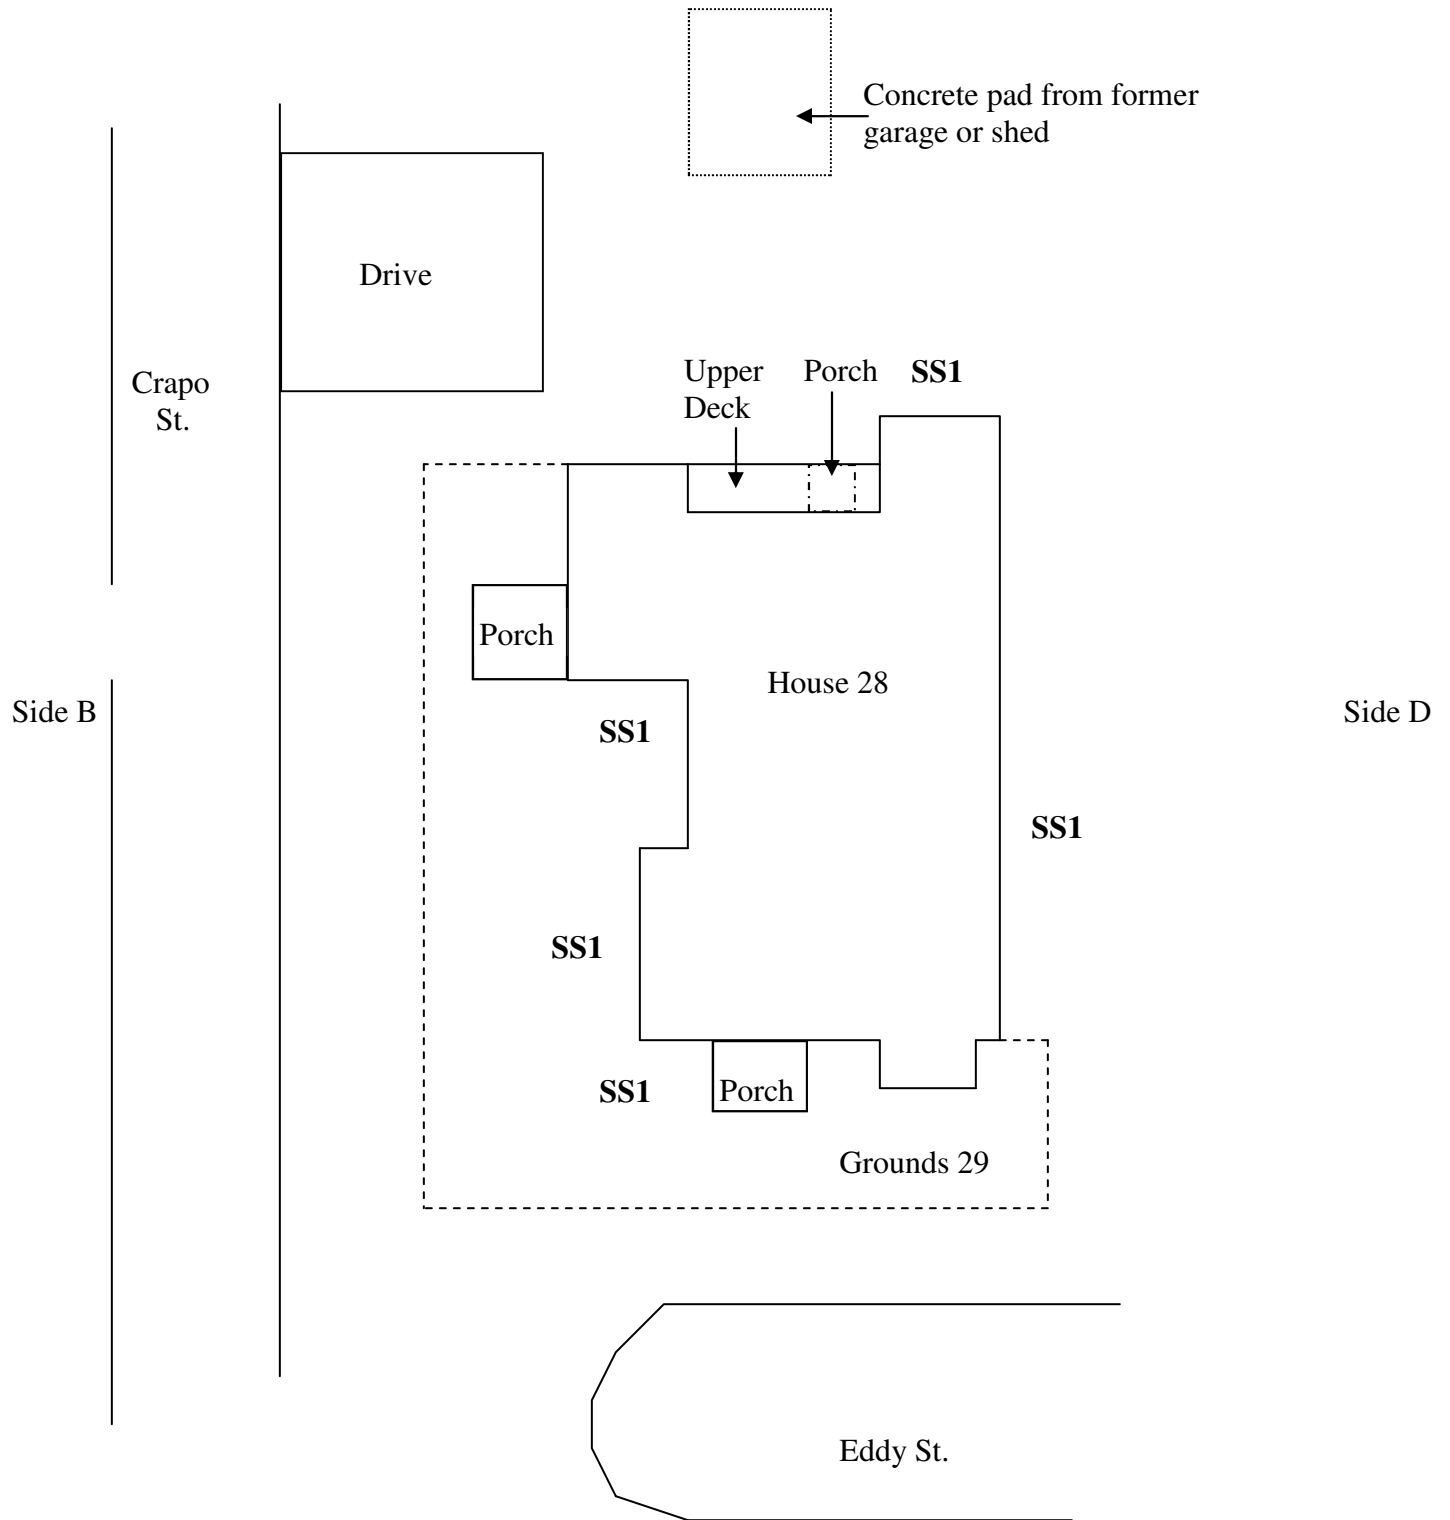
Side C  
**Site Layout**

SS = Soil Sample

Please Note: This is a rough site plan only. All items may not be included in this illustration. Not drawn to scale.

<b>Hazards on Property (Not Home)</b>				
Soil levels around the <b>perimeter of the house</b> were found to be elevated for lead content.	Medium	Low	1) Remove top 6 inches of soil and replace with new soil then seed to grass, cover with ground cover or 2) enclose with concrete or asphalt	Clean soil surface of any paint chips or LBP debris, blend top 6 inches of soils with those below by tilling, cover with landscape fabric and groundcover (woodchips, decorative stone, etc...).
Visible <b>paint chips and debris</b> is present on the ground	High	High	Remove all visible paint chips and construction debris.	Remove all visible paint chips and construction debris.

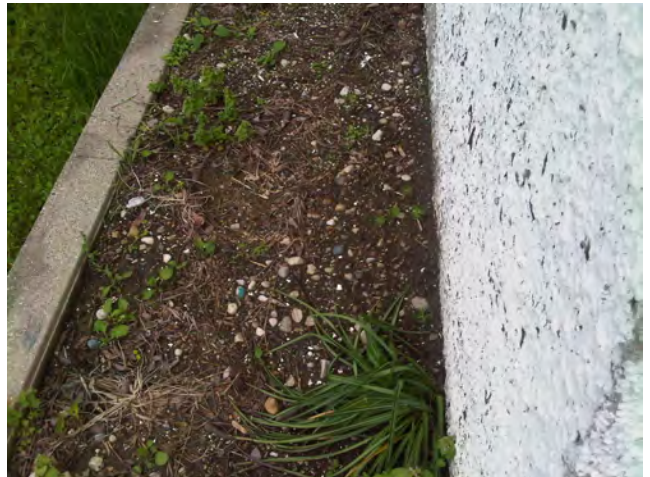
House Perimeter—Paint Chips

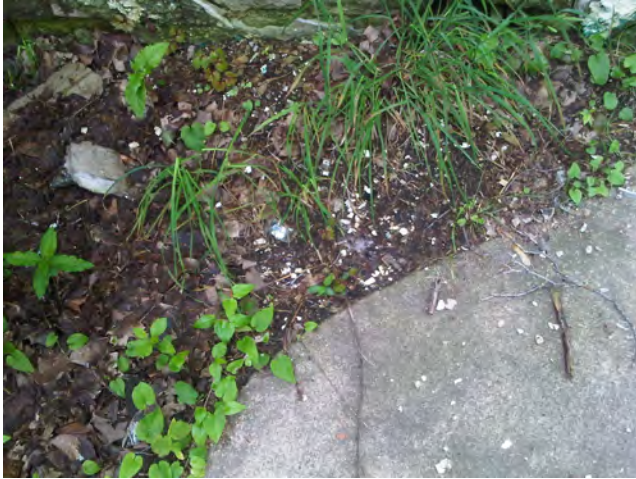
House Perimeter—Paint Chips
