Genesee County Land Bank Authority
452 S. Saginaw St. 2nd Floor, Flint, MI 48502
Neighborhood Stabilization Program 2 (NSP2)

Invitation for Bids – General Contractor
522 Mason St., Flint, MI 48503

BID NUMBER: LB 12-007

INVITATION FOR BIDS: 522 MASON ST. – GENERAL CONTRACTOR

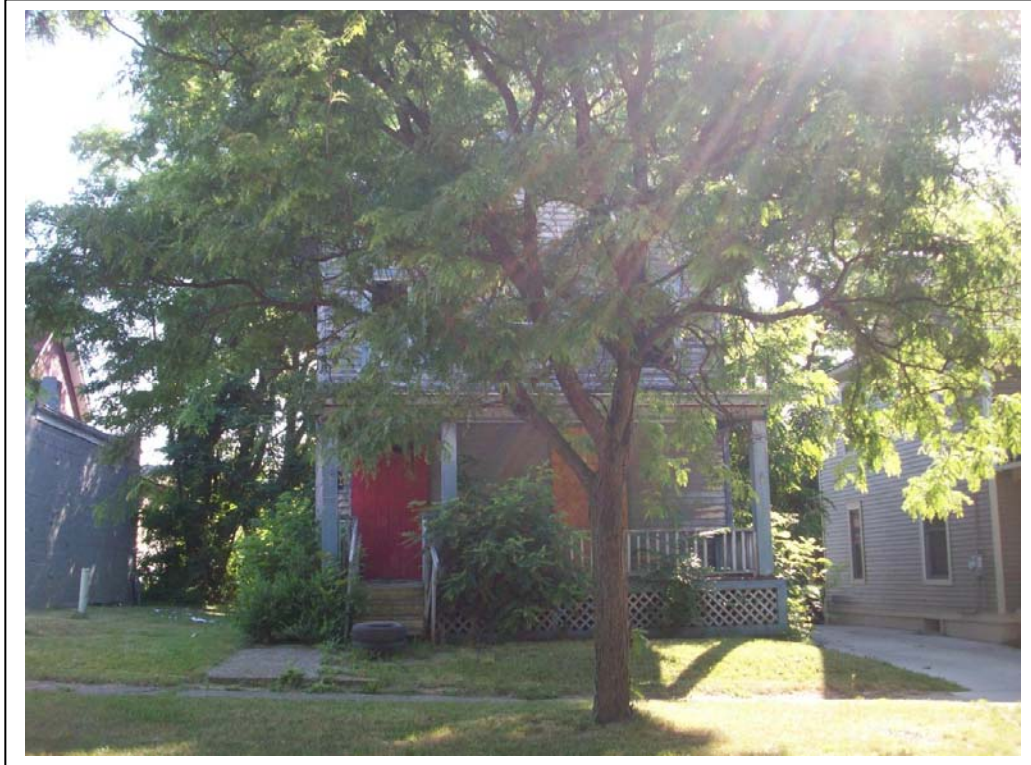
40-12-477-044
522 Mason Street
Flint, Michigan 48503

Year Built:	Unknown	Square Footage:	1,407
Latitude:	N 43° 01'08.88"	Longitude:	W 83° 41'52.51"
Gas:	Disconnected	Electric:	Disconnected

Comments: A two story wood framed residential structure with wood siding and a basement.
