**Genesee County Land Bank Authority Blight Elimination Program
Request for Proposals- LB 18-005 Environmental Abatement, Demolition and Restoration of
810 S Ballenger Hwy
ADDENDUM #1**

GCLBA COMMERCIAL DEMO
810 S. BALLENGER HIGHWAY
FLINT, MICHIGAN

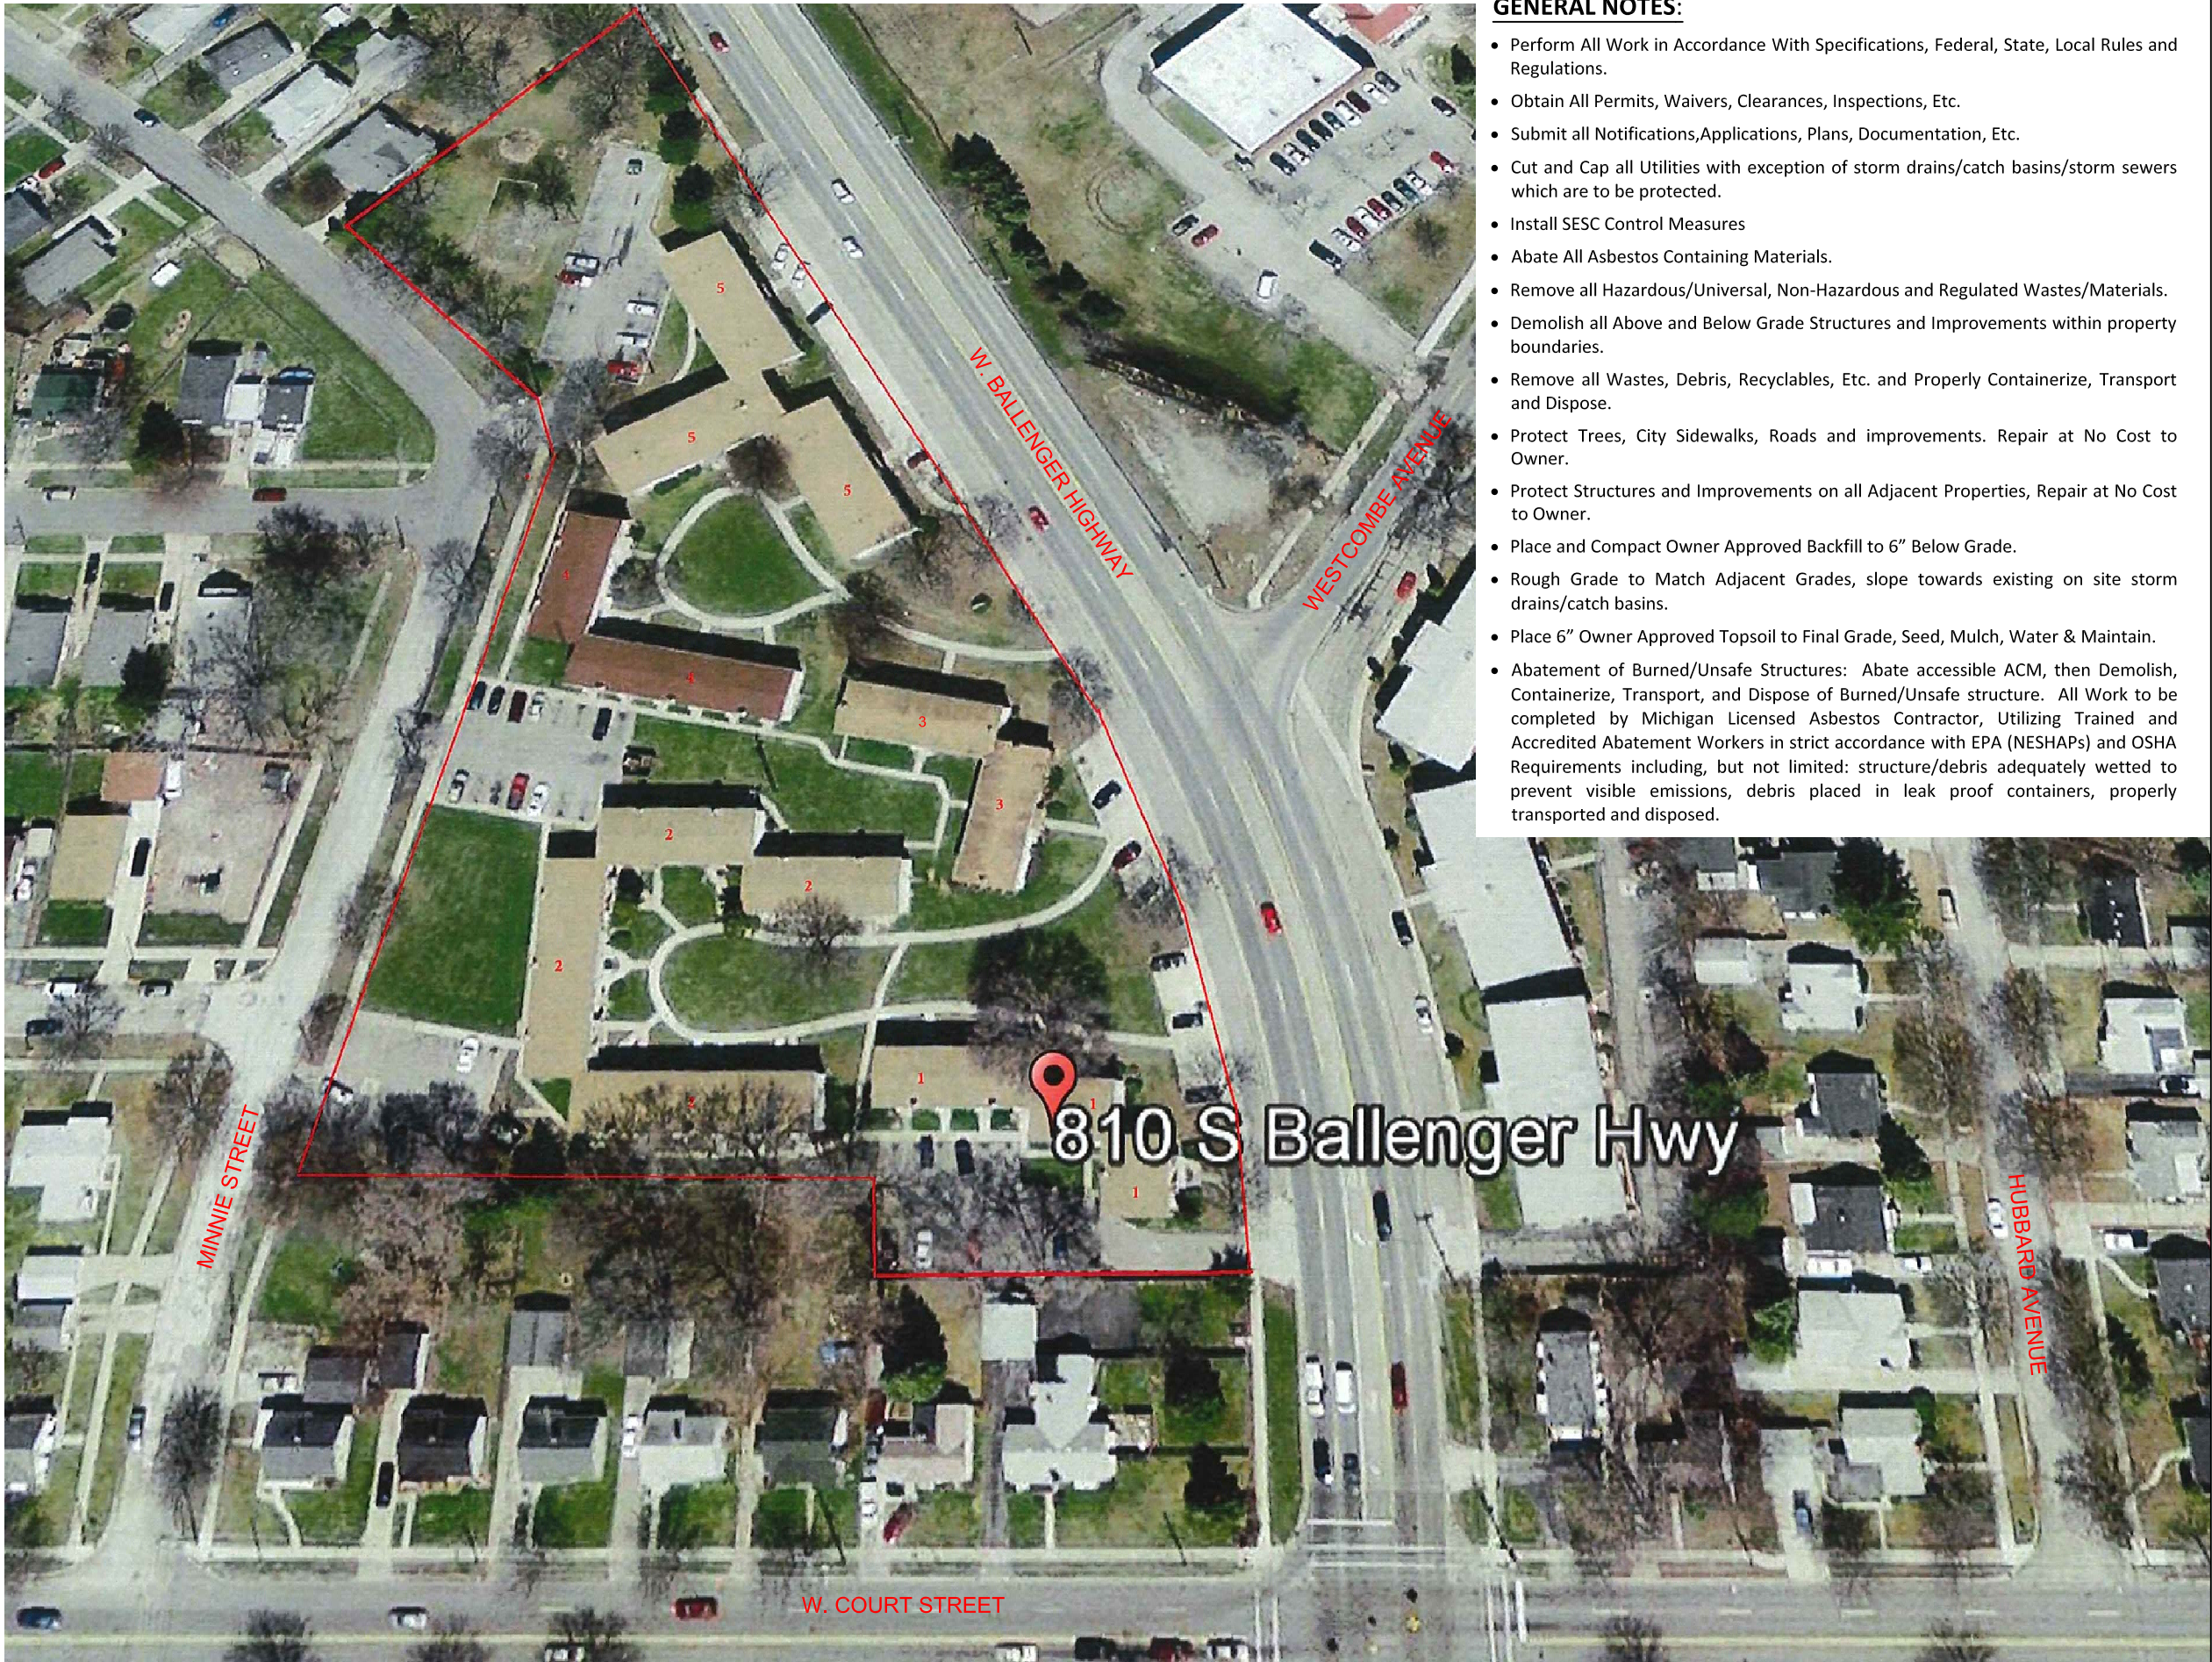
SITE MAP

- Place 6" Owner Approved Topsoil to Final Grade, Seed, Mulch, Water & Maintain.
- Abatement of Burned/Unsafe Structures: Abate accessible ACM, then Demolish, Containerize, Transport, and Dispose of Burned/Unsafe structure. All Work to be completed by Michigan Licensed Asbestos Contractor, Utilizing Trained and Accredited Abatement Workers in strict accordance with EPA (NESHAPs) and OSHA Requirements including, but not limited: structure/debris adequately wetted to prevent visible emissions, debris placed in leak proof containers, properly transported and disposed.

1. **Figures:** Please refer to Attachment 1 for Figures 1-4: Site Maps.
2. **Supplemental Asbestos Survey:** ATC Group Services has been retained by Genesee County Land Bank Authority to assist in bid specification preparation and to conduct project oversight. ATC has completed supplemental sampling of suspect asbestos containing materials. Supplement survey is attached as Attachment 2. Abatement of all identified ACM is to be incorporated into Bid Item 2 and Section 02 82 13.41 ASBESTOS ABATEMENT AND HAZARDOUS/REGULATED MATERIAL REMOVAL FOR TOTAL DEMOLITION PROJECTS.

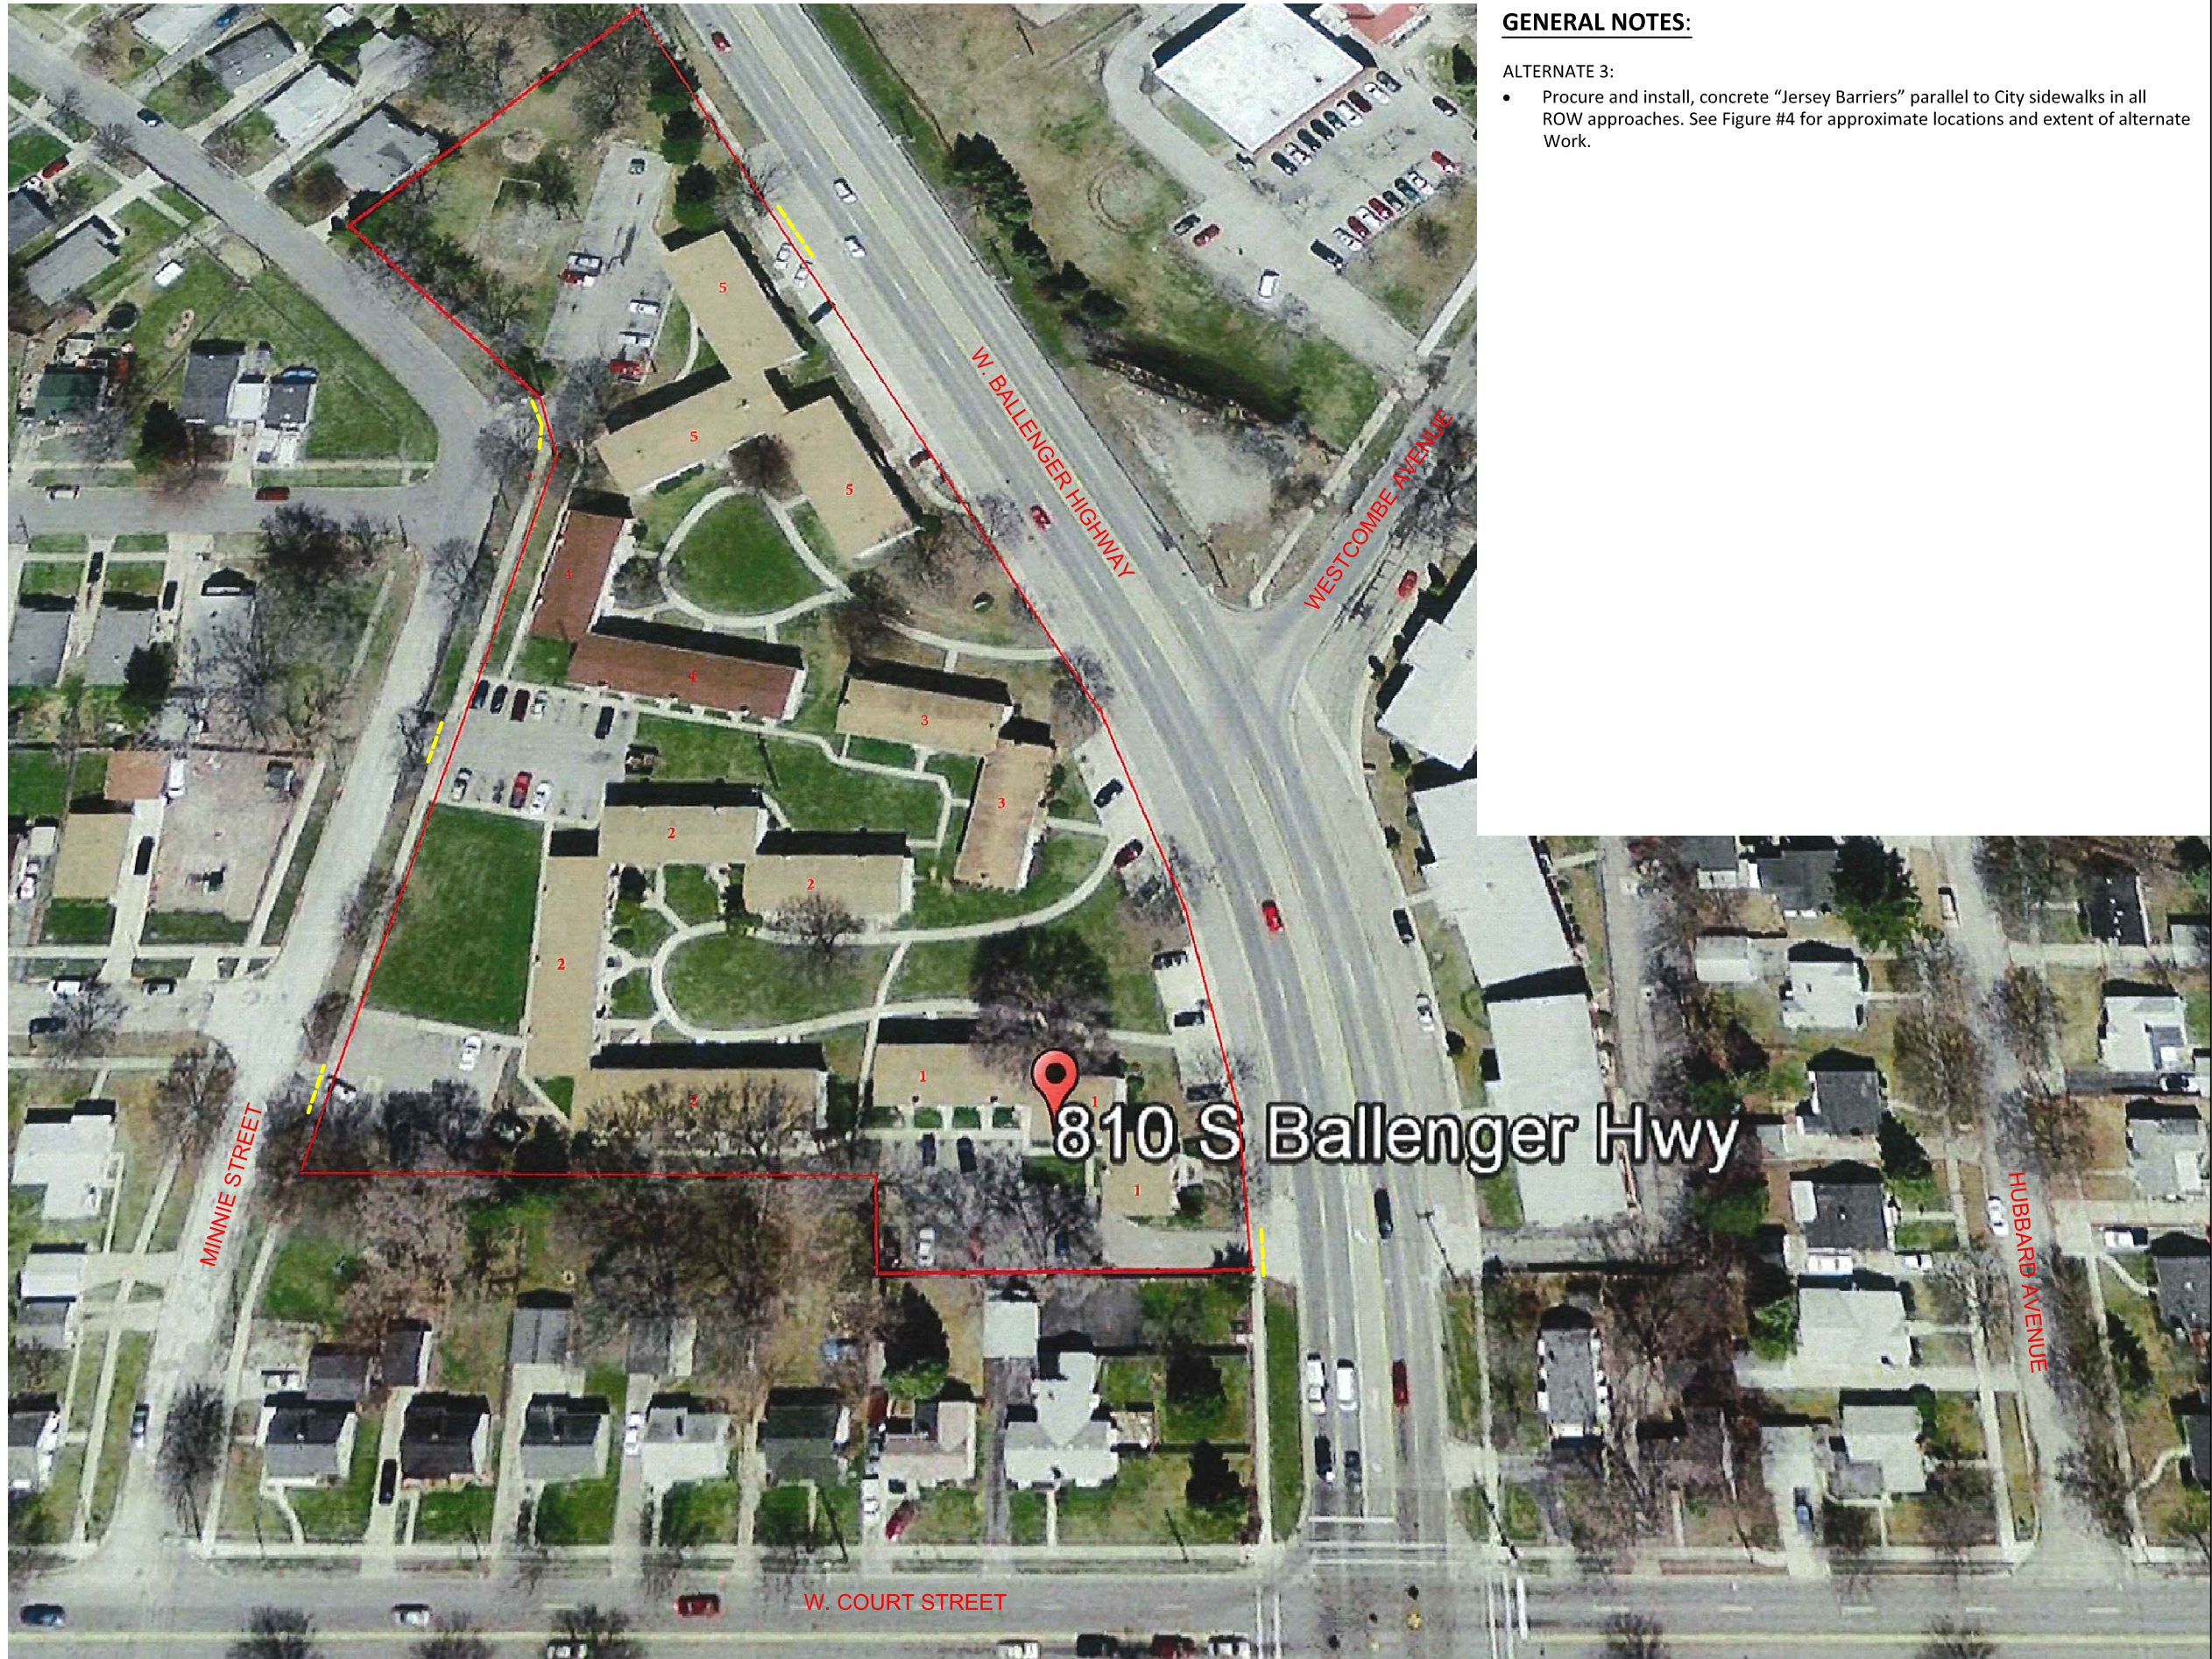
FIGURE 4

- ALTERNATE 3:
- Procure and install, concrete “Jersey Barriers” parallel to City sidewalks in all ROW approaches. See Figure #4 for approximate locations and extent of alternate Work.

ALTERNATE #3

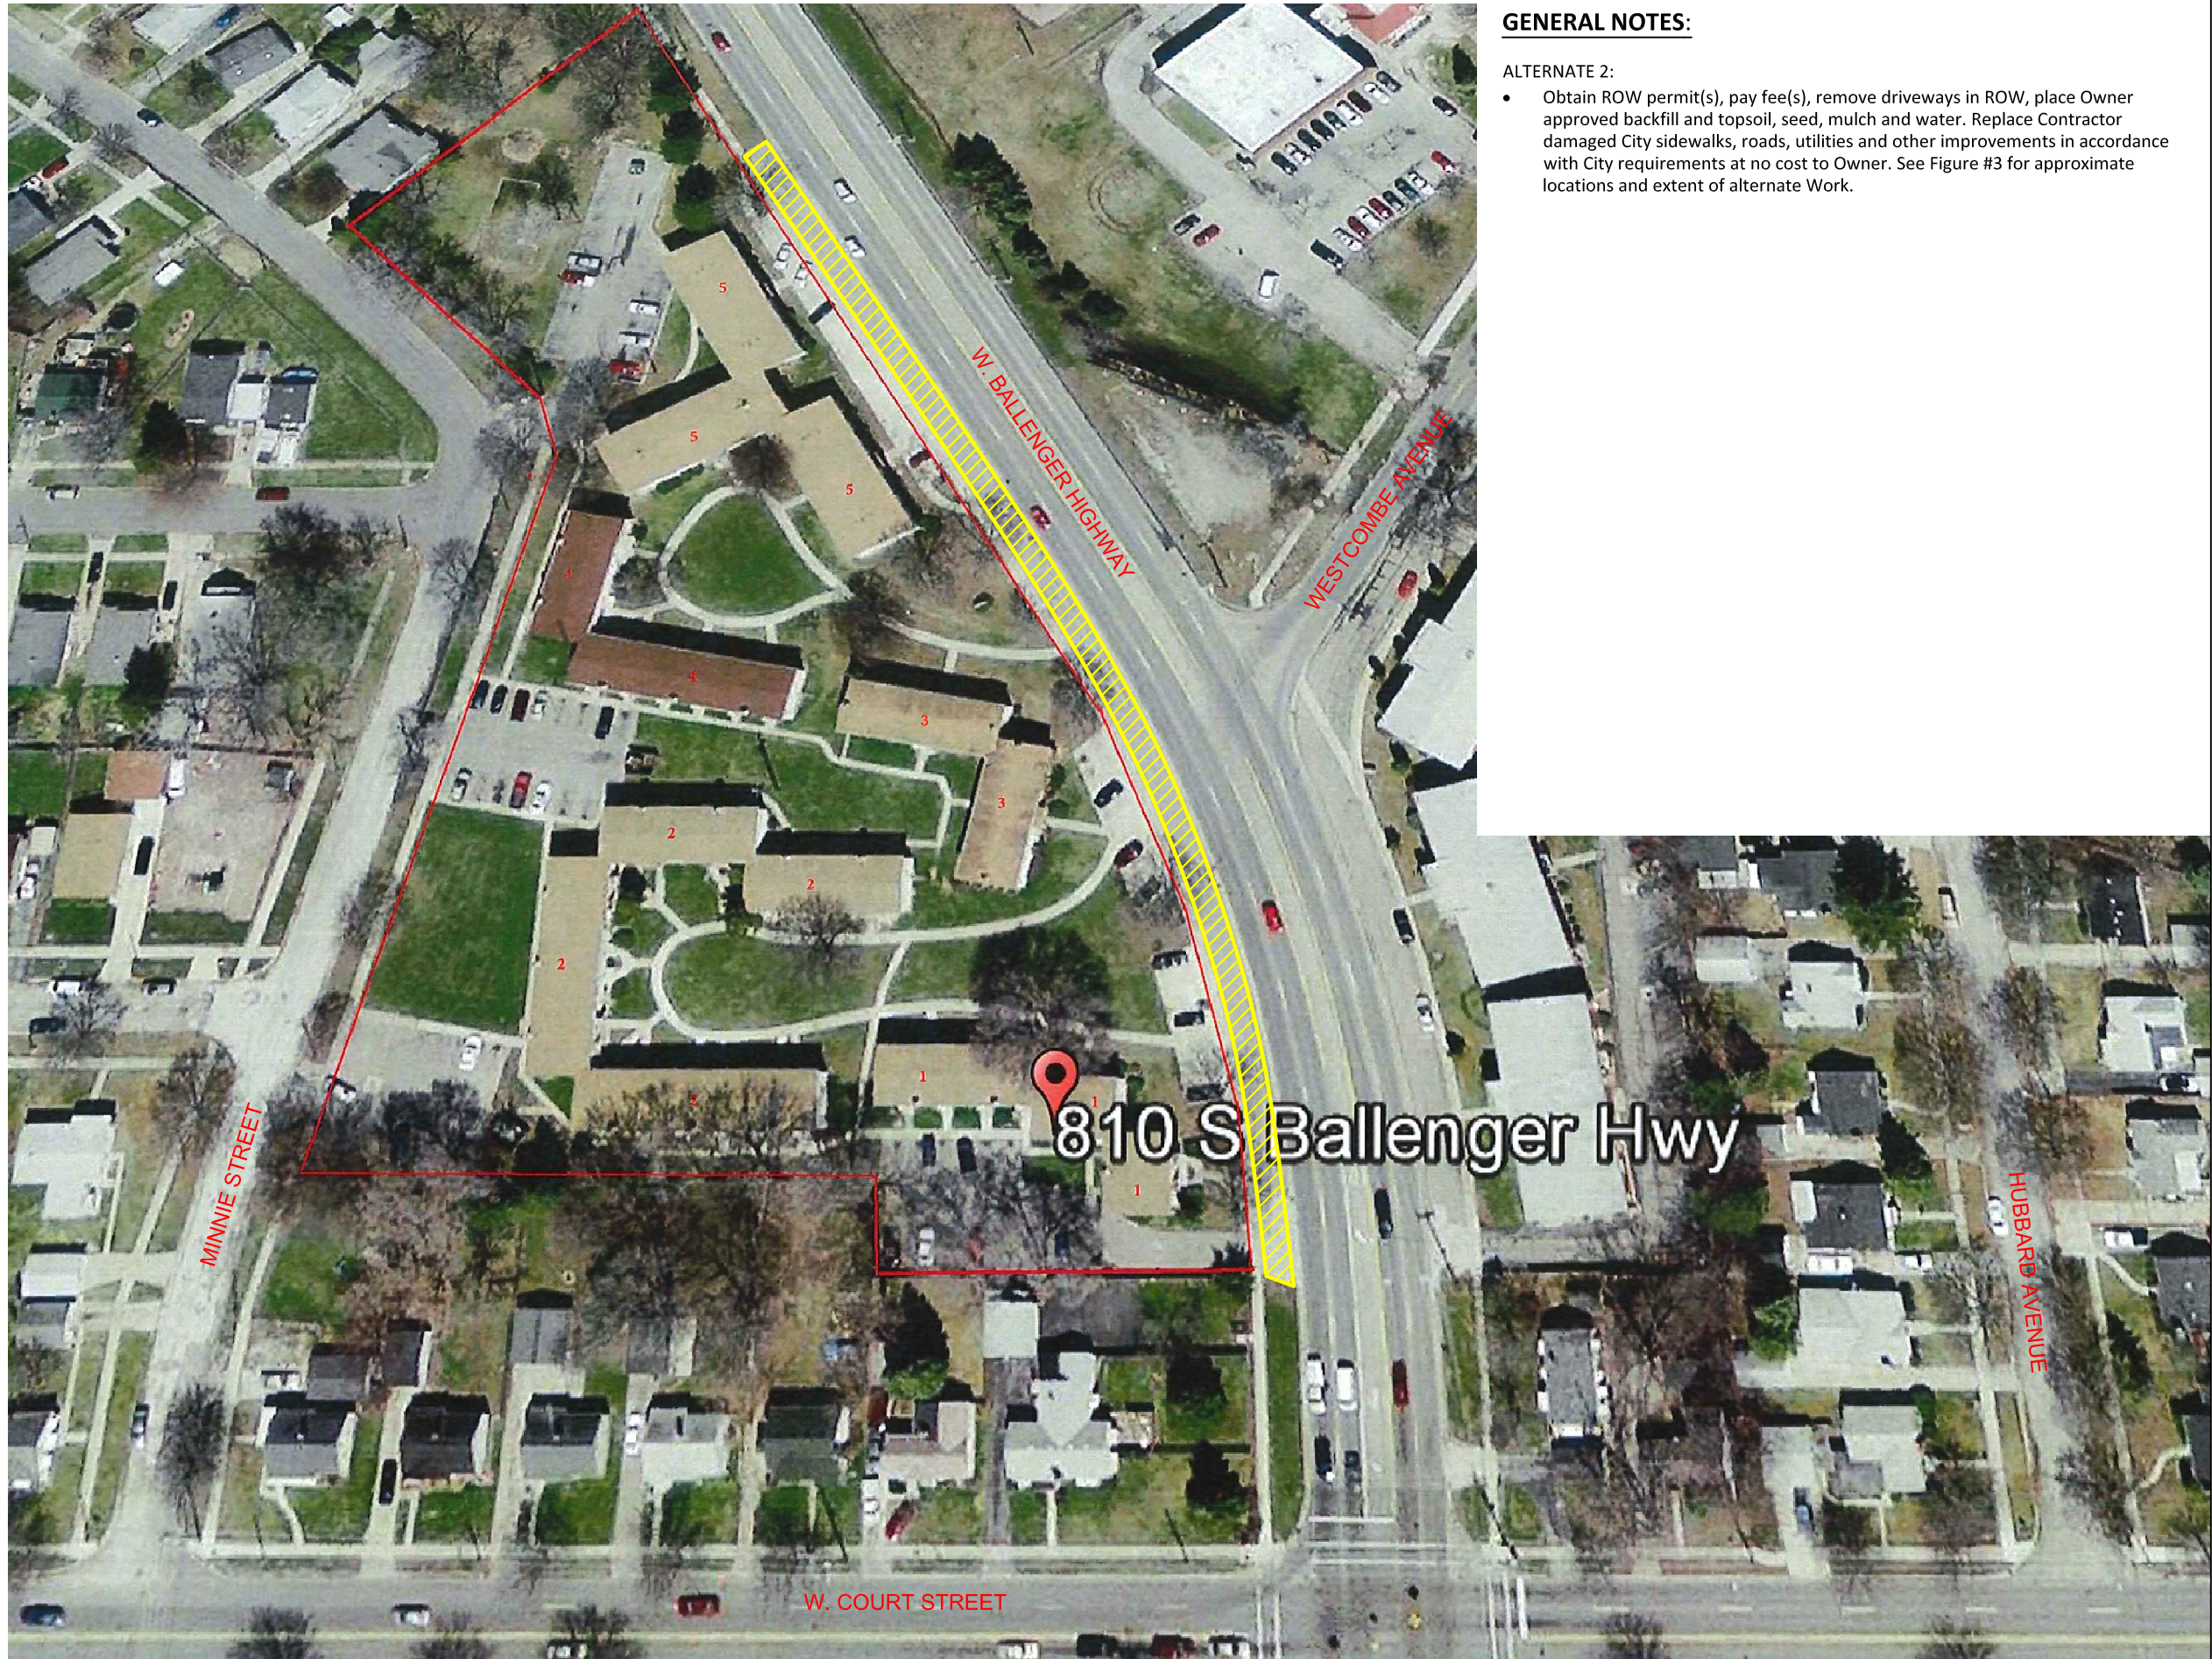
DATE: 3/27/18	PROJECT NO.: 188BS18146
DRAWN BY: LJH	NO SCALE
REVIEWED BY: MG	FIGURE 3

- ALTERNATE 2:
- Obtain ROW permit(s), pay fee(s), remove driveways in ROW, place Owner approved backfill and topsoil, seed, mulch and water. Replace Contractor damaged City sidewalks, roads, utilities and other improvements in accordance with City requirements at no cost to Owner. See Figure #3 for approximate locations and extent of alternate Work.

ALTERNATE #2

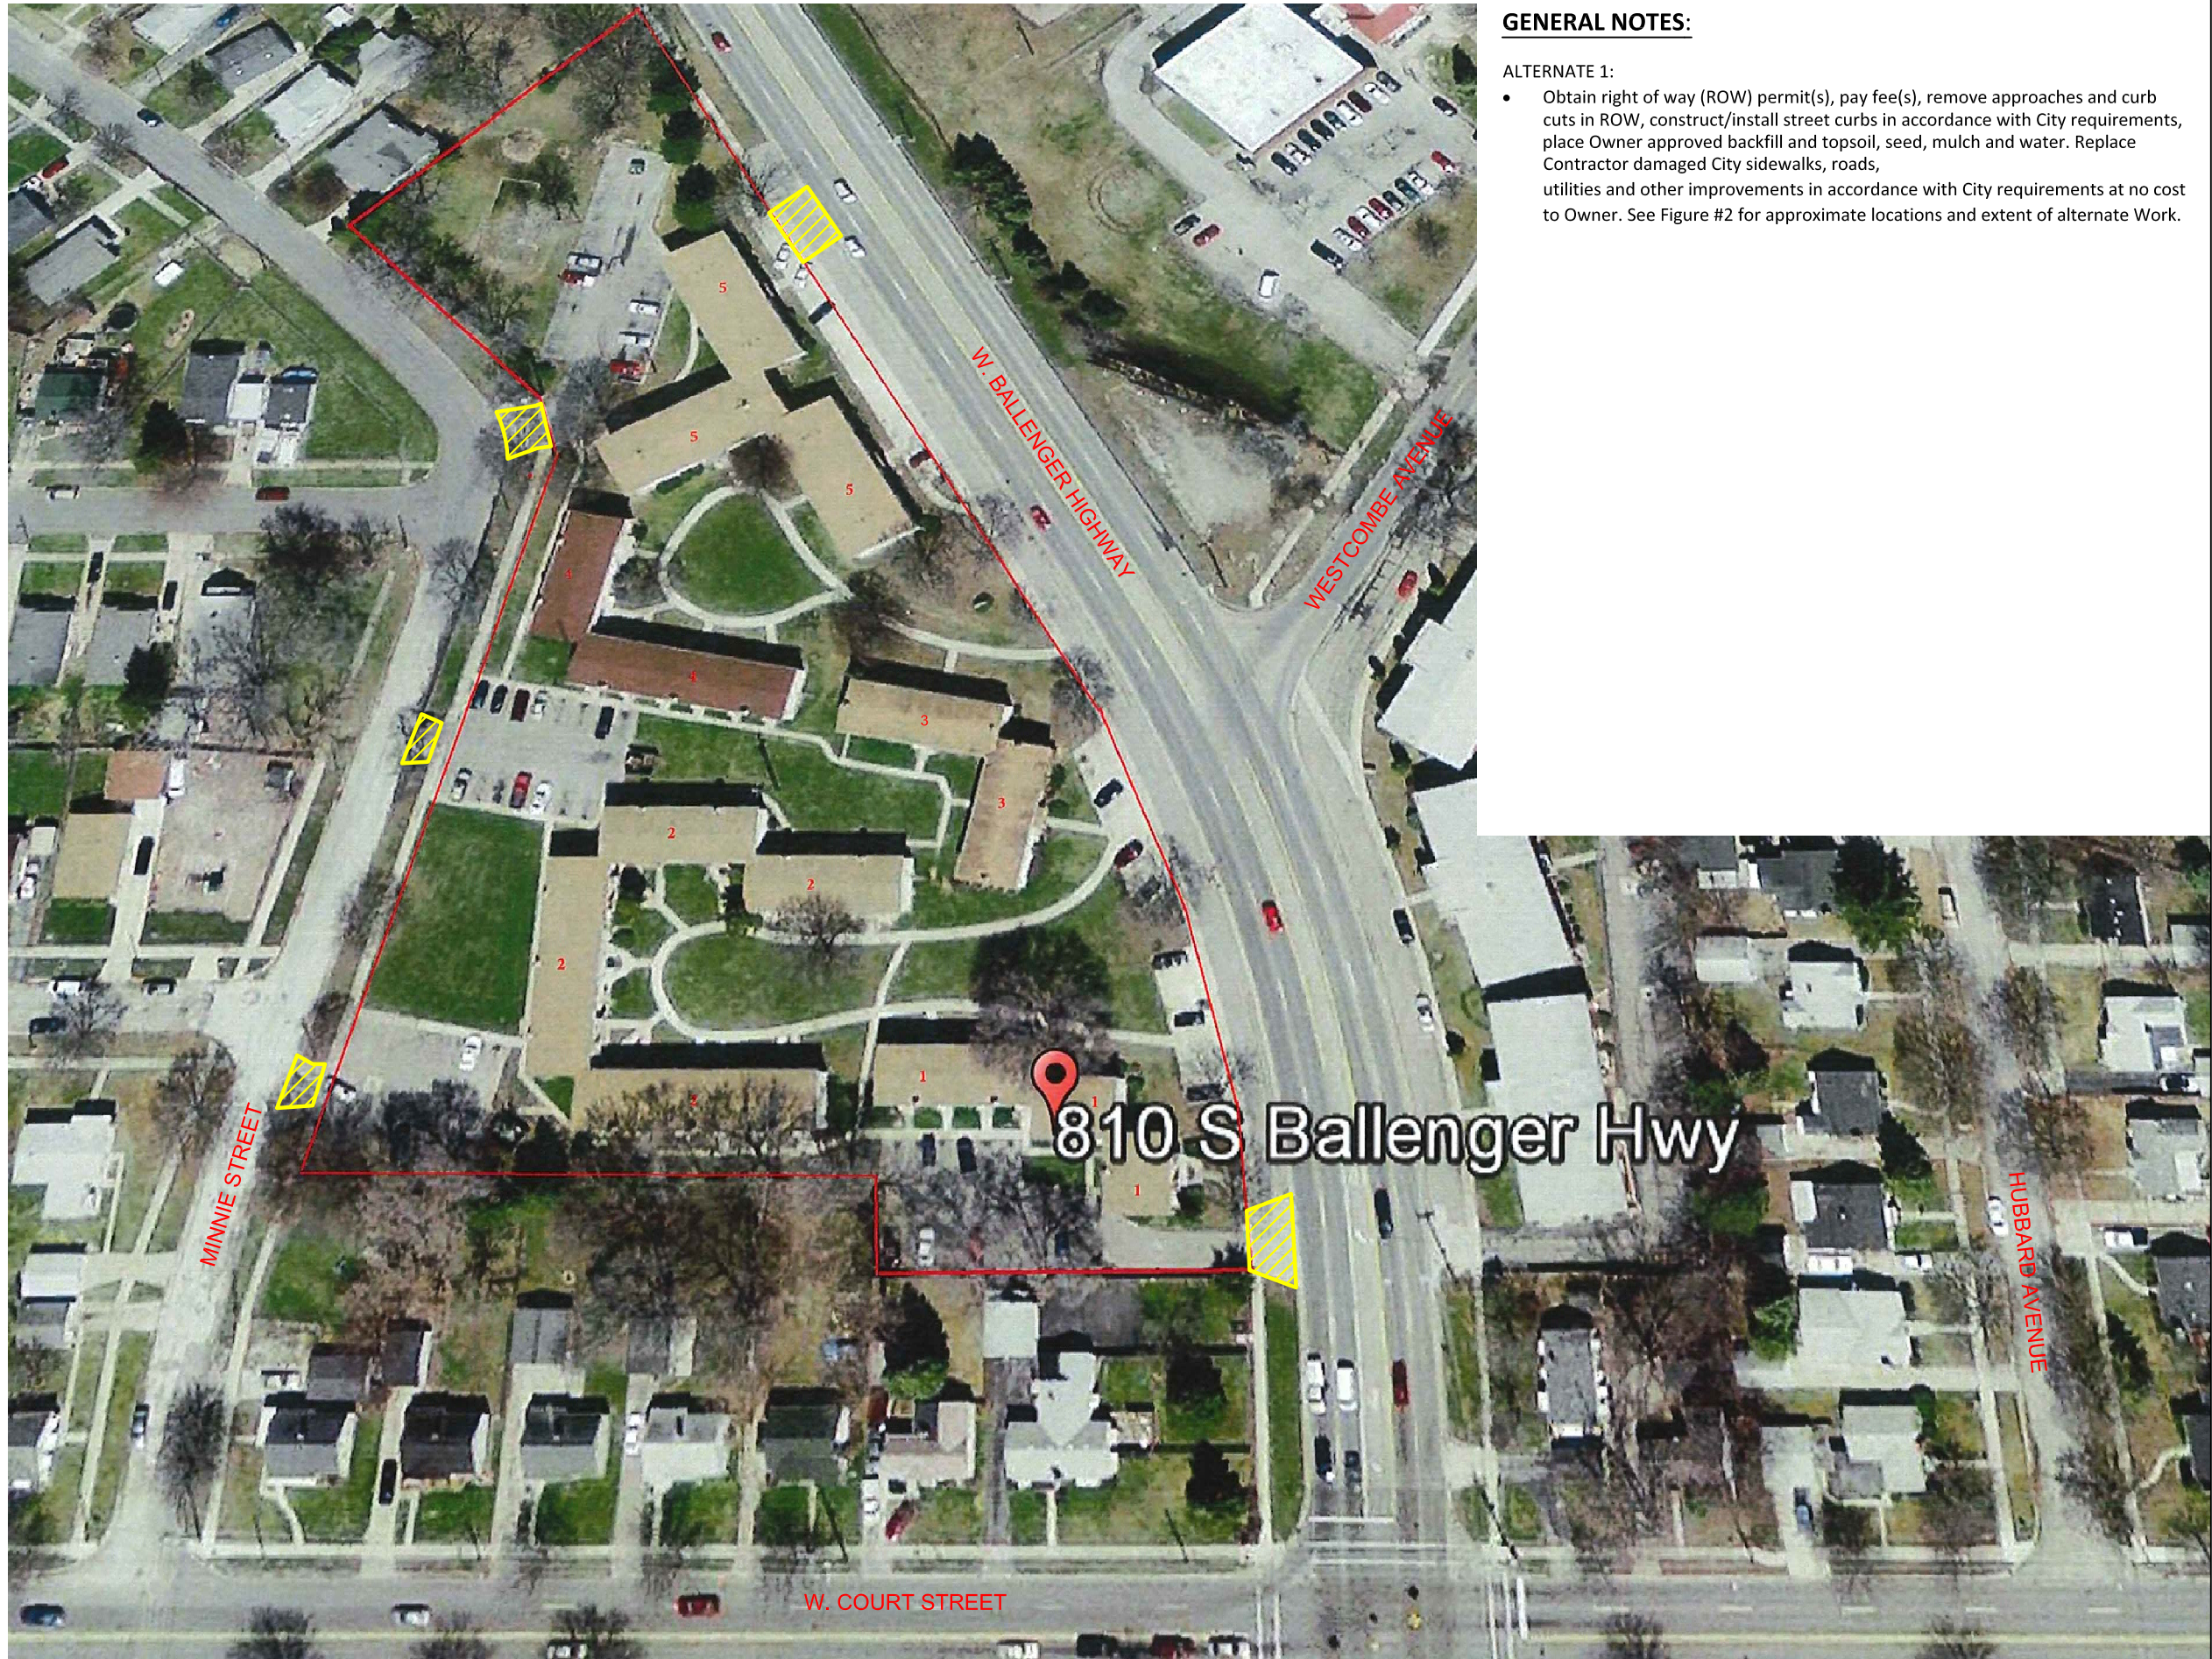
- ALTERNATE 1:
- Obtain right of way (ROW) permit(s), pay fee(s), remove approaches and curb cuts in ROW, construct/install street curbs in accordance with City requirements, place Owner approved backfill and topsoil, seed, mulch and water. Replace Contractor damaged City sidewalks, roads, utilities and other improvements in accordance with City requirements at no cost to Owner. See Figure #2 for approximate locations and extent of alternate Work.
