# Genesee County Land Bank Authority

## Neighborhood Stabilization Program 2 (NSP2)

### Invitation for Bids: 720 Dougherty – General Contractor

BID NUMBER: LB 11-012

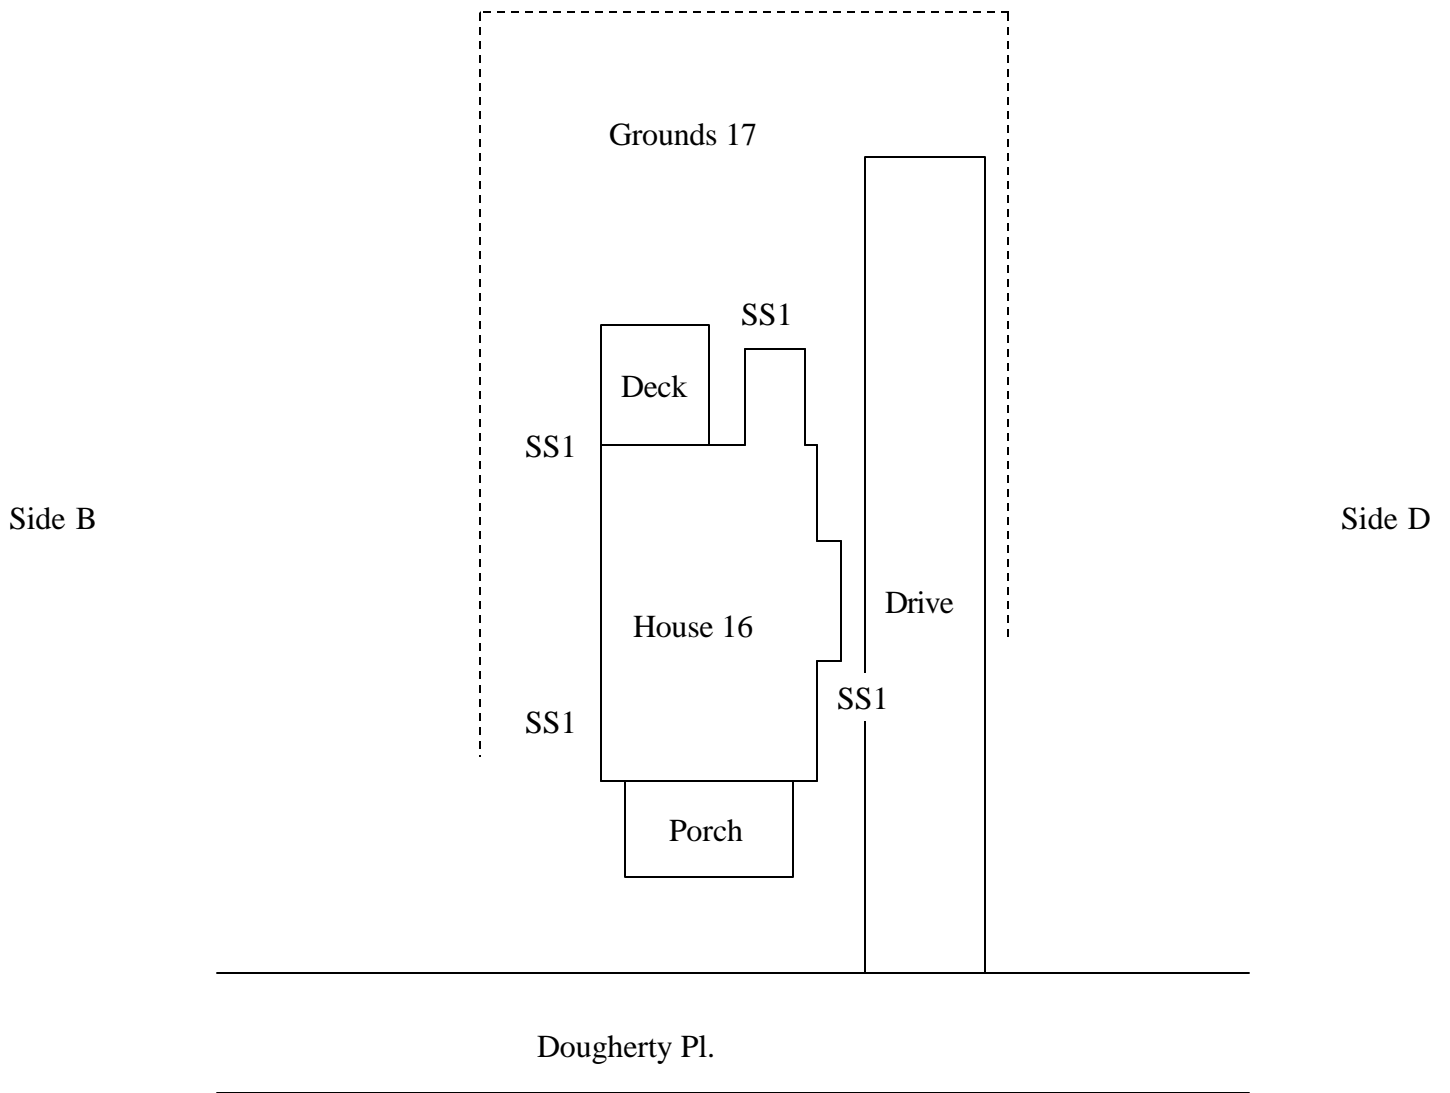
### Site Layout

- F = Floor Dust Wipe Sample
- S = Windowsill Dust Wipe Sample
- T = Window Trough Dust Wipe Sample
- W = Wood windows
- V = Vinyl windows
- A = Aluminum windows
- M = Metal windows
- GB = Glass block windows

Please Note: This is a rough floor plan only. All items, (doorways, Windows, etc.) may not be included in this illustration. Also, room and component sizes are not drawn to scale.

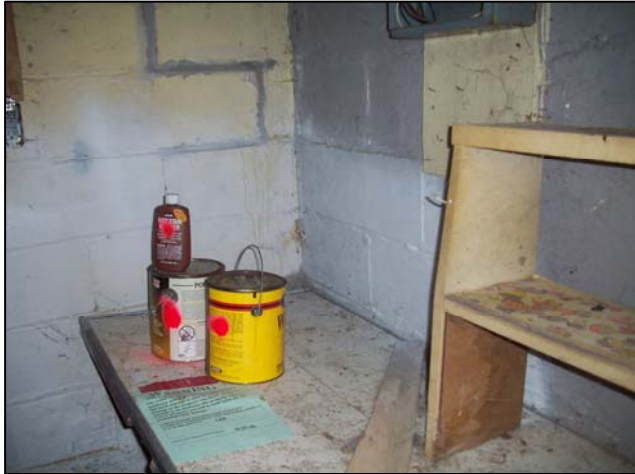
Paint and Rust Remover  
Basement

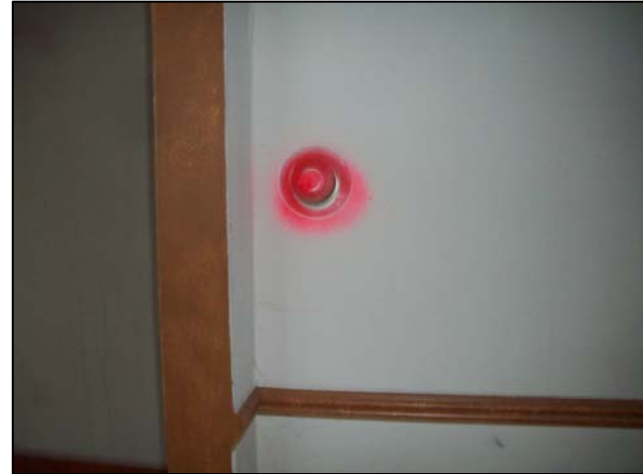
Mercury Thermostat  
Living Room
